Resilient Vertical Forest Renovation of Reinforced Concrete  
Structures in Seismic Prone Areas  
(H.F.R.I. Project Number 015376)

Recorded damages to common and VF buildings and  
lessons learned

Deliverable D1.4 Work package 1

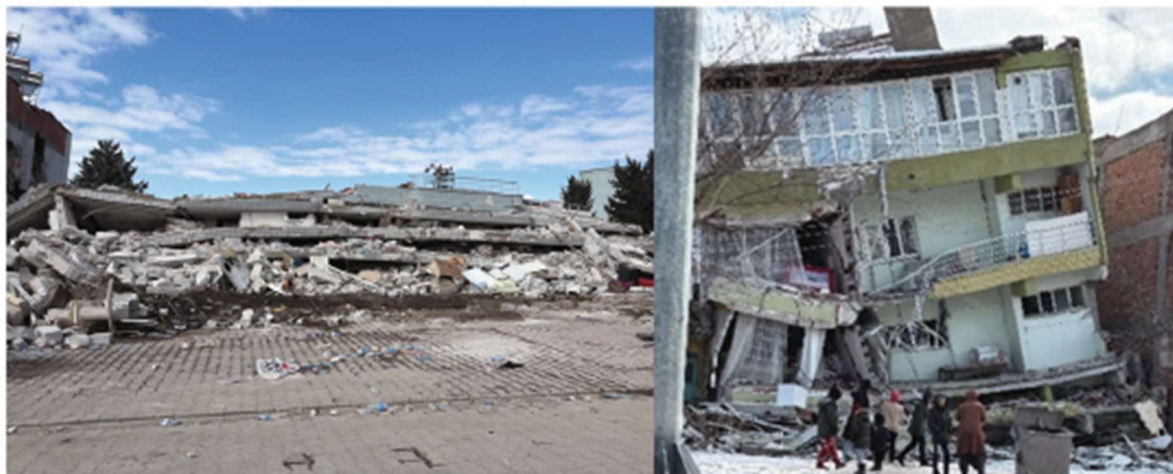
Figure 9 Pancake collapse (left) and soft story collapse (right), (Binici et al., 2023).

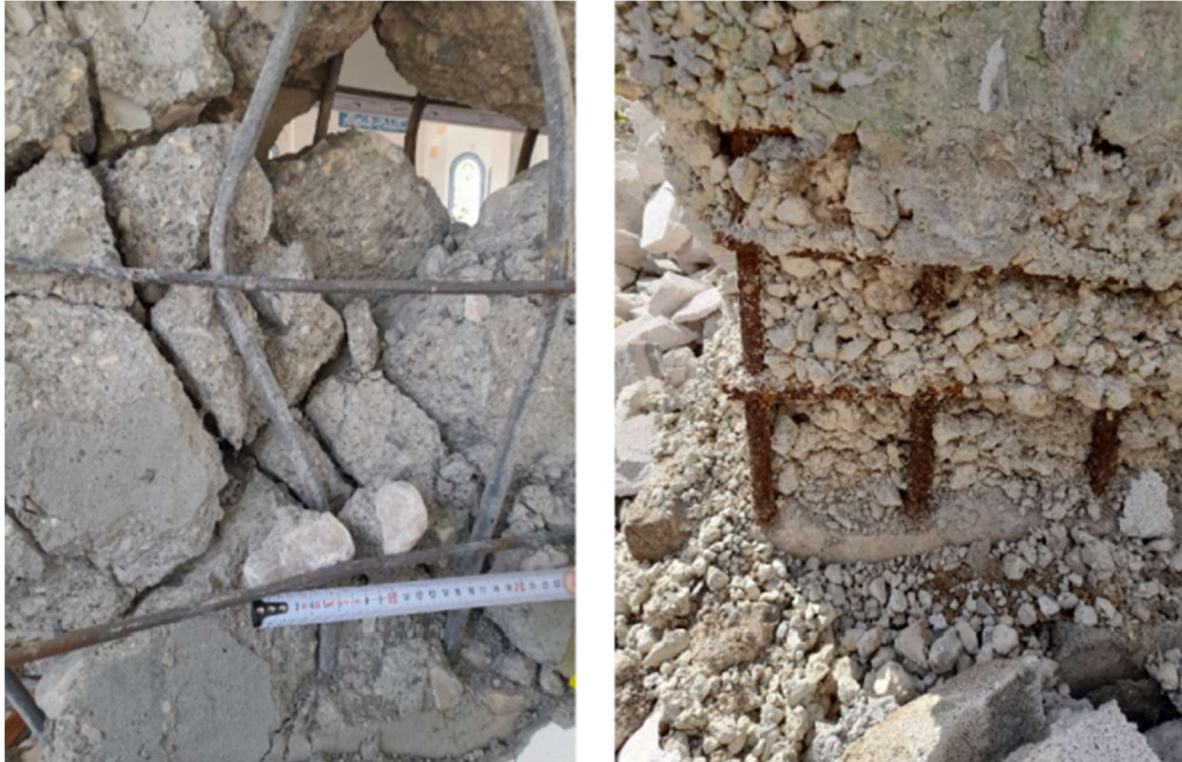
Material defects may involve poor quality of concrete, or poor maintenance leading to concrete carbonation and local concrete strength degradation due to cycles of corrosive environments (chlorides) followed by internally caused expansion due to internal steel corrosion. Steel bar and stirrup reinforcement corrosion itself reduces the effective area and diameter of the reinforcement locally (pitting) or over broader surfaces (Triantafyllou et al. 2017, Triantafyllou et al. 2019) and the bond of steel to concrete causing extensive concrete cracking (Figure 10). Abovementioned effects often lead to severe building damages and are revealed or exacerbated during strong earthquakes. Further, poor steel reinforcement detailing with sparse or of low yield stress or smooth stirrups and transverse steel reinforcements in general, column sections without crossties, or column-beam joints without transverse reinforcement or the common old practice of transverse reinforcement anchorage with hooks at 90 degrees instead of 135 degrees, as well as inadequate longitudinal steel bar lap splices at

*Figure 10 Damages due to inadequate concrete material performance and corrosion of steel reinforcement (İnce, 2024).*

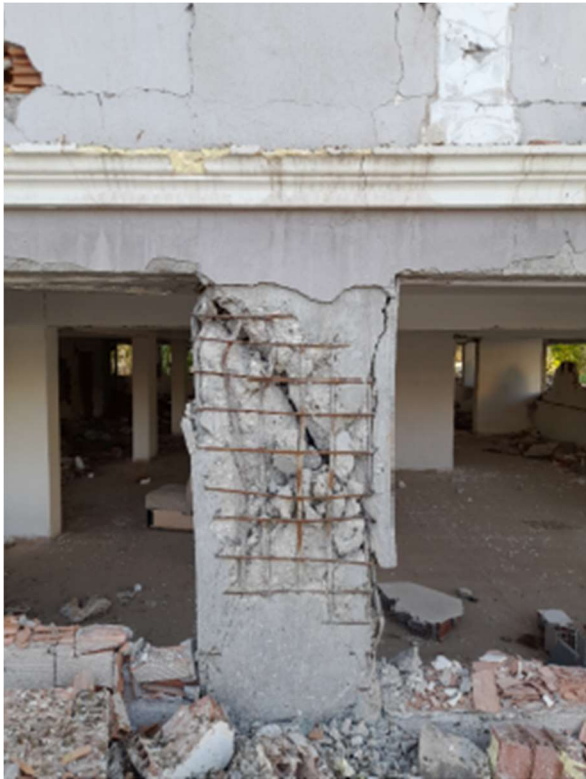
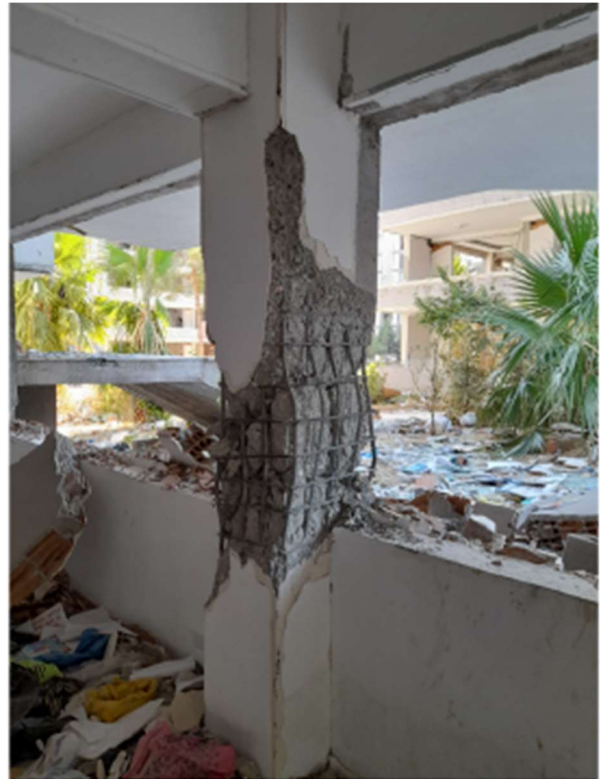
Figure 11 Damages due to short column effect (Ince, 2024).

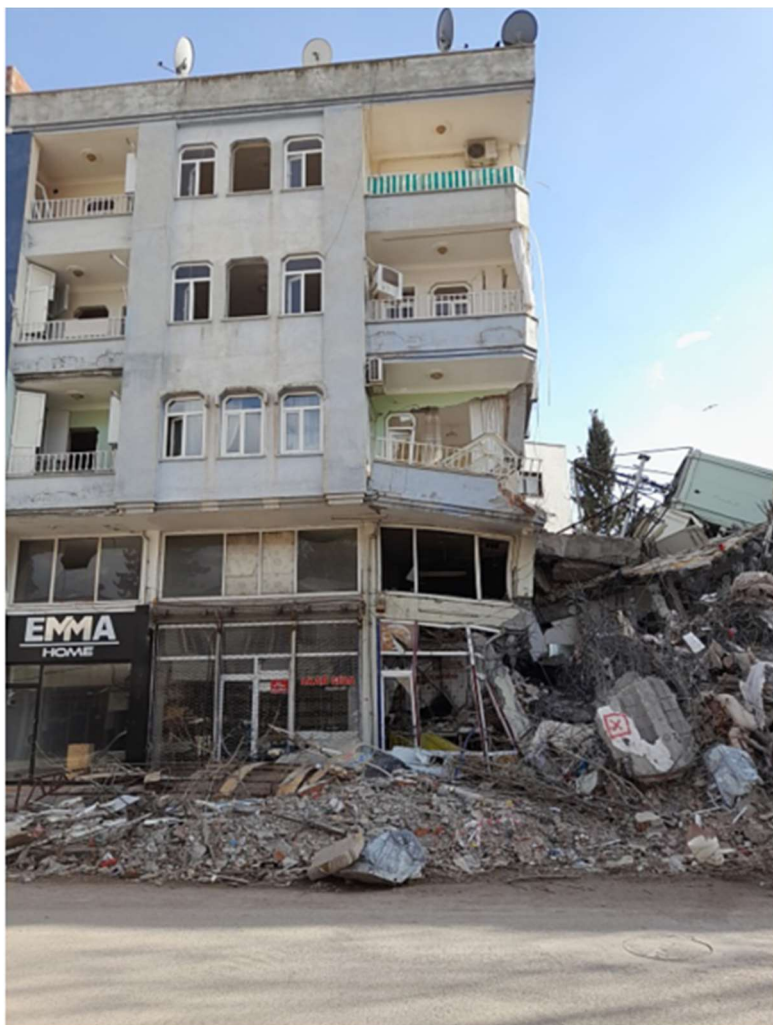
*Figure 12 Damages due to adjacent building's collapse (Ince, 2024).*

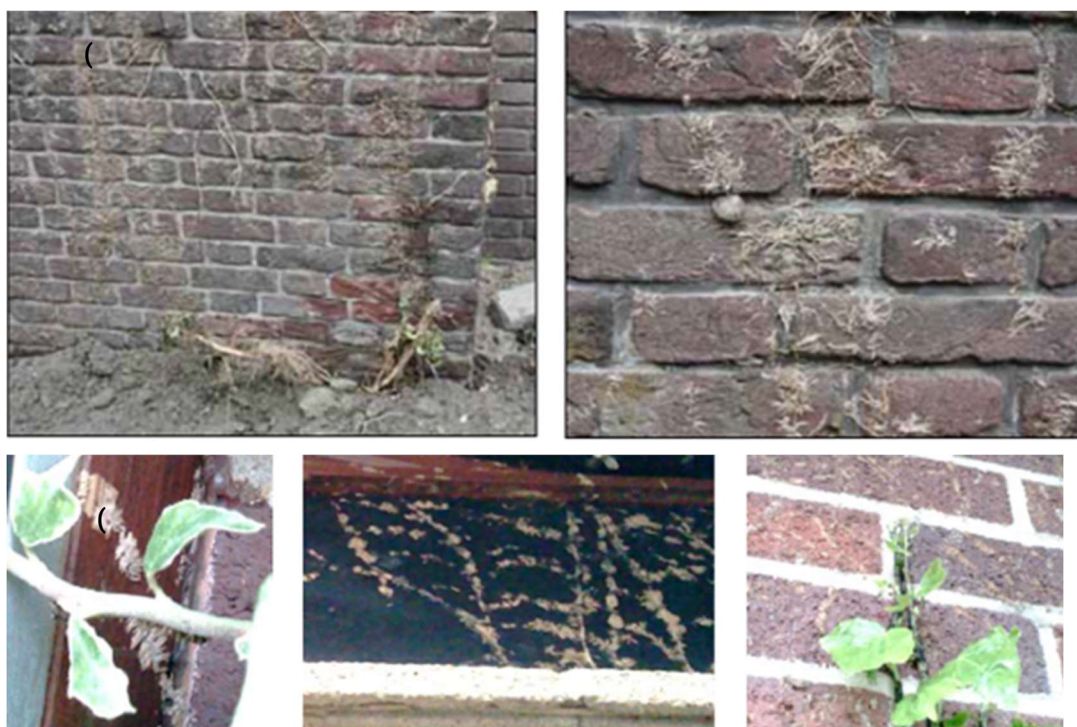
Figure 13 Root structure remains on the wall after green layer removal (a), and ivy scars on wood, painted wall and masonry (b) (Mir M.A, 2011; Thomsit-Ireland, 2018).

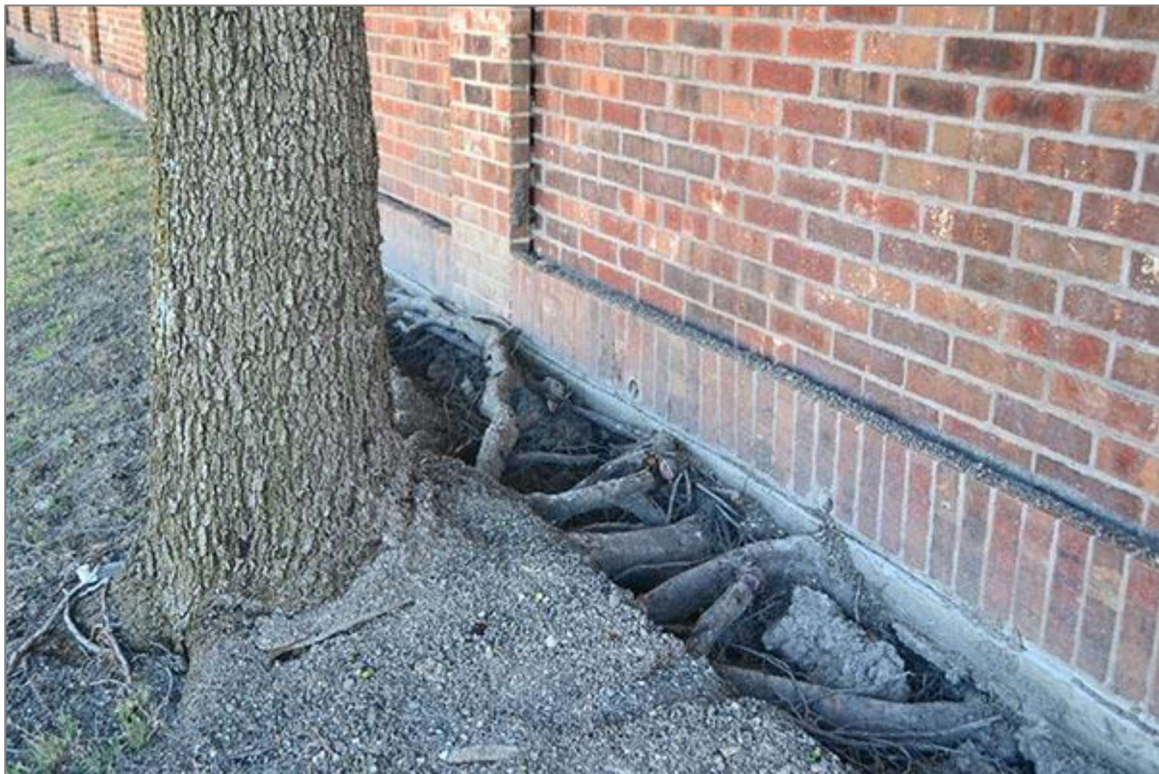
Trees can also indirectly cause structural damage to historical buildings and monuments, especially in the case of shrinkable soil types, such as certain clays, which expand and contract in response to soil moisture changes. In winter, shrinkable soil becomes wetter and increases in volume, while in summer, the opposite occurs. During the dry season, tree roots near buildings and monuments can extend towards the foundations, drawn by the higher moisture content compared to the surrounding soil. This reduction in soil moisture increases matric suction to remove interstitial water, resulting in a decrease in soil volume. This phenomenon occurs only where the roots penetrate, causing differential subsidence in the soil and leading to damage in the overlying masonry structures (Lantini, 2021).

*Figure 14 : Tree roots growing under foundations (Lantini, 2021).*

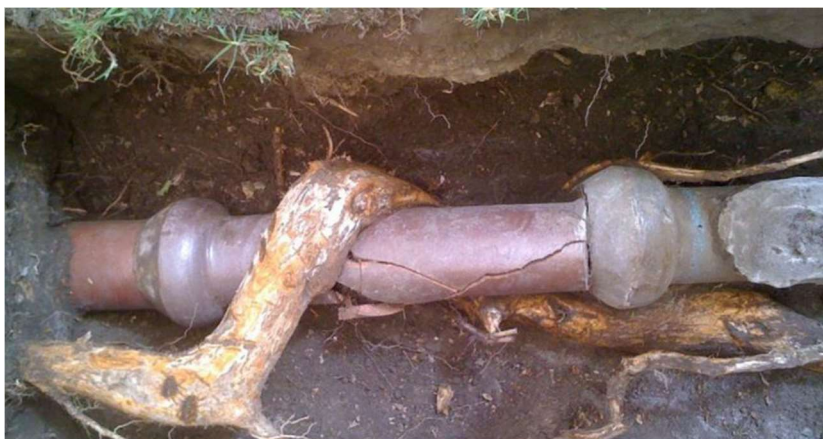
Underground services, especially drainage systems, are often obstructed or damaged by root growth. This deterioration typically occurs in older infrastructure, which was constructed using materials prone to decay over time. Roots are attracted to the moisture around pipes, which tend to maintain a lower temperature compared to the adjacent soil causing them to grow near the pipelines (Figure 15).

*Figure 15 Roots growing around a pipe (Lantini, 2021).*

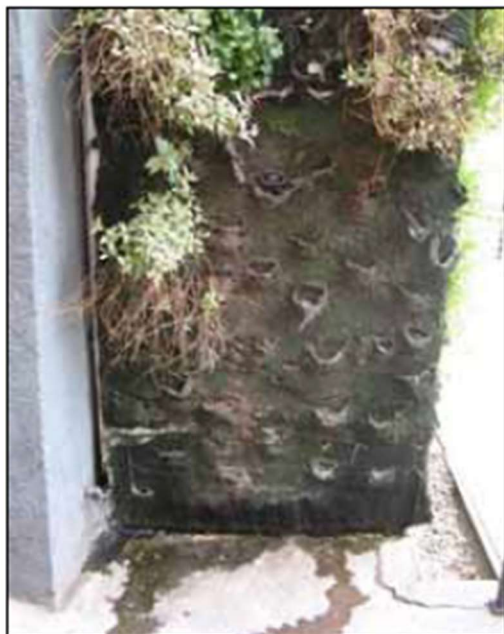
Due to evapotranspiration plants release water vapour into the surrounding air, especially during summer, increasing humidity (Ottel , 2011) and making walls vulnerable to damp. In addition, plants require systematic watering and irrigation, but excessive watering may lead to water pooling, leaks, and potential damage to the building structure and its components due to dampness (Figure 16).

*Figure 16 Water leakage and degradation of substrate of the vertical placed panel (Ottel , 2011)*

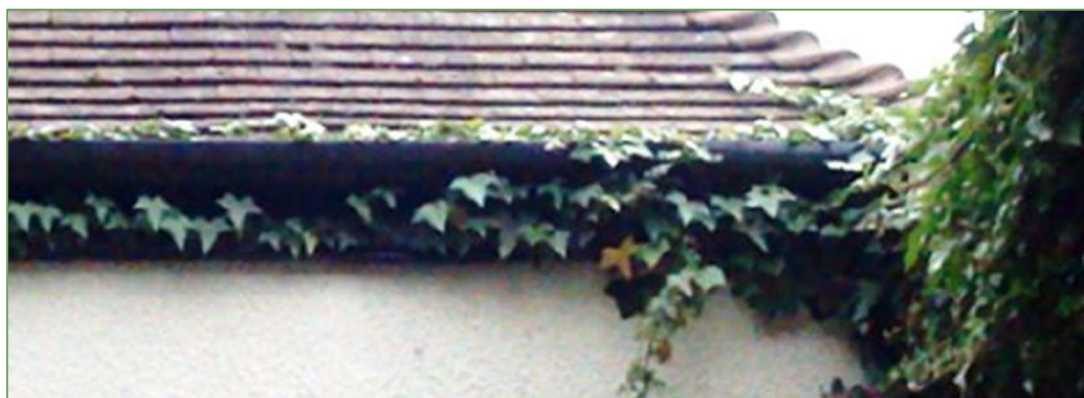
*Figure 17 Ivy growing in and around gutter (Thomsit-Ireland, 2018).*

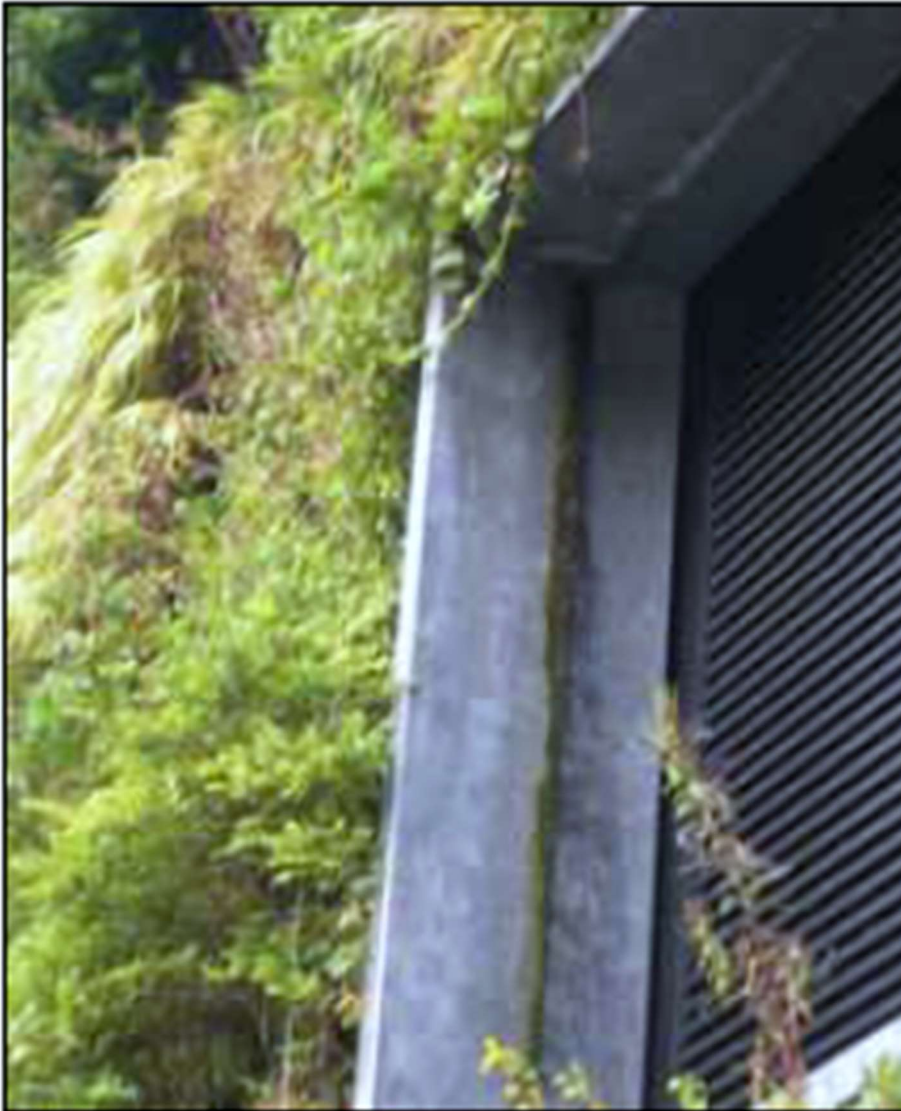
Vertical green facades and especially green living walls emerge moisture-related problems, as water drips around the edges of windows that cause streaking and possible corrosion of the wind envelope (Figure 18). In addition, it can cause mould development at the indoor space that is connected to those surfaces (Ottel , 2011; Thomsit-Ireland, 2018).

*Figure 18 Water leakage problems causing stripes and possible corrosion (Ottelé, 2011).*

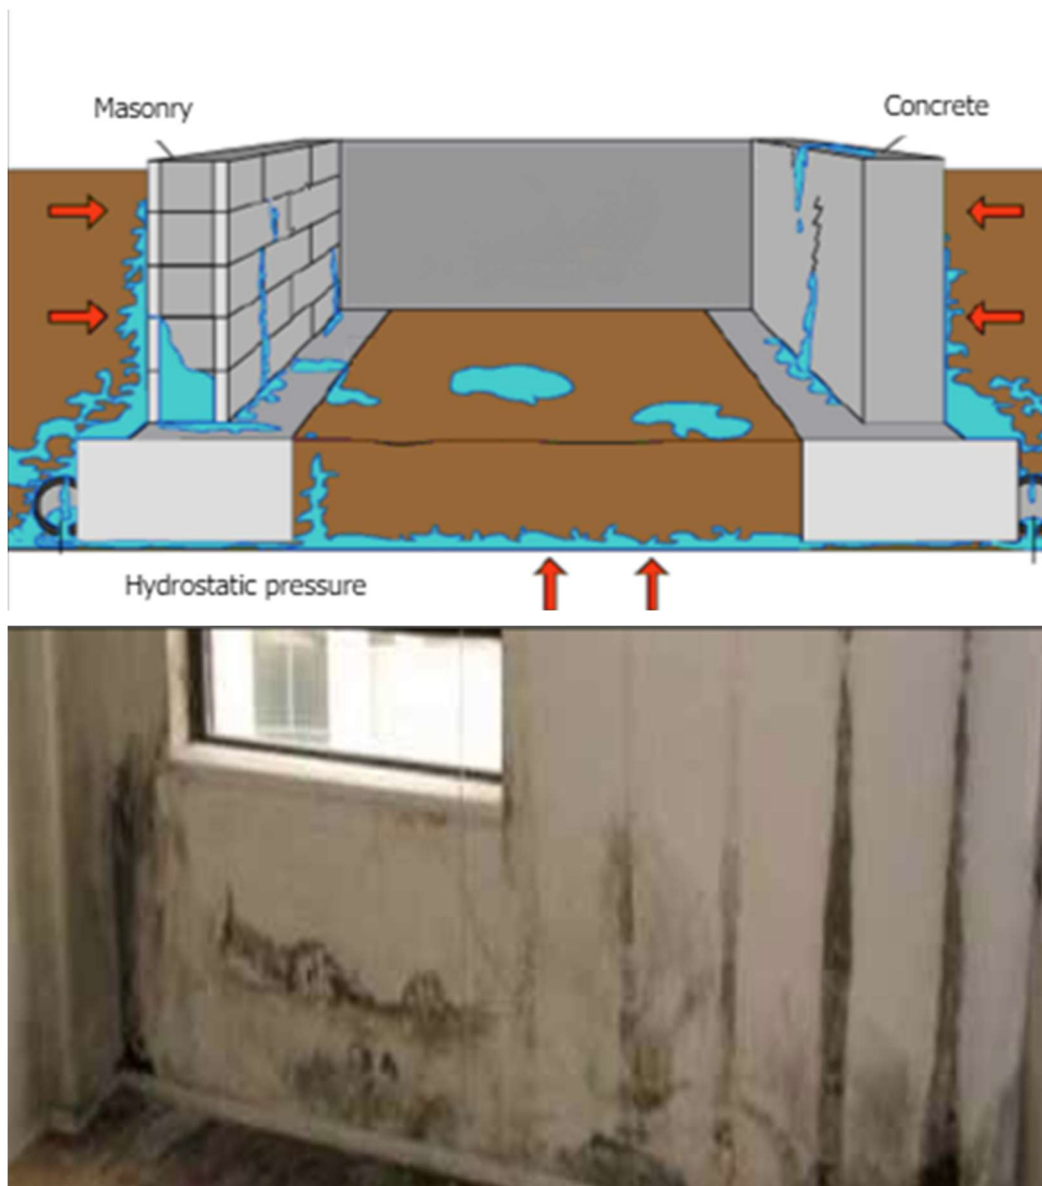
Figure 19 Open contact between foundation and the facade, where the wall would not be able to evaporate capillary moisture rapidly with the presence of vertical green (Mir M.A, 2011).

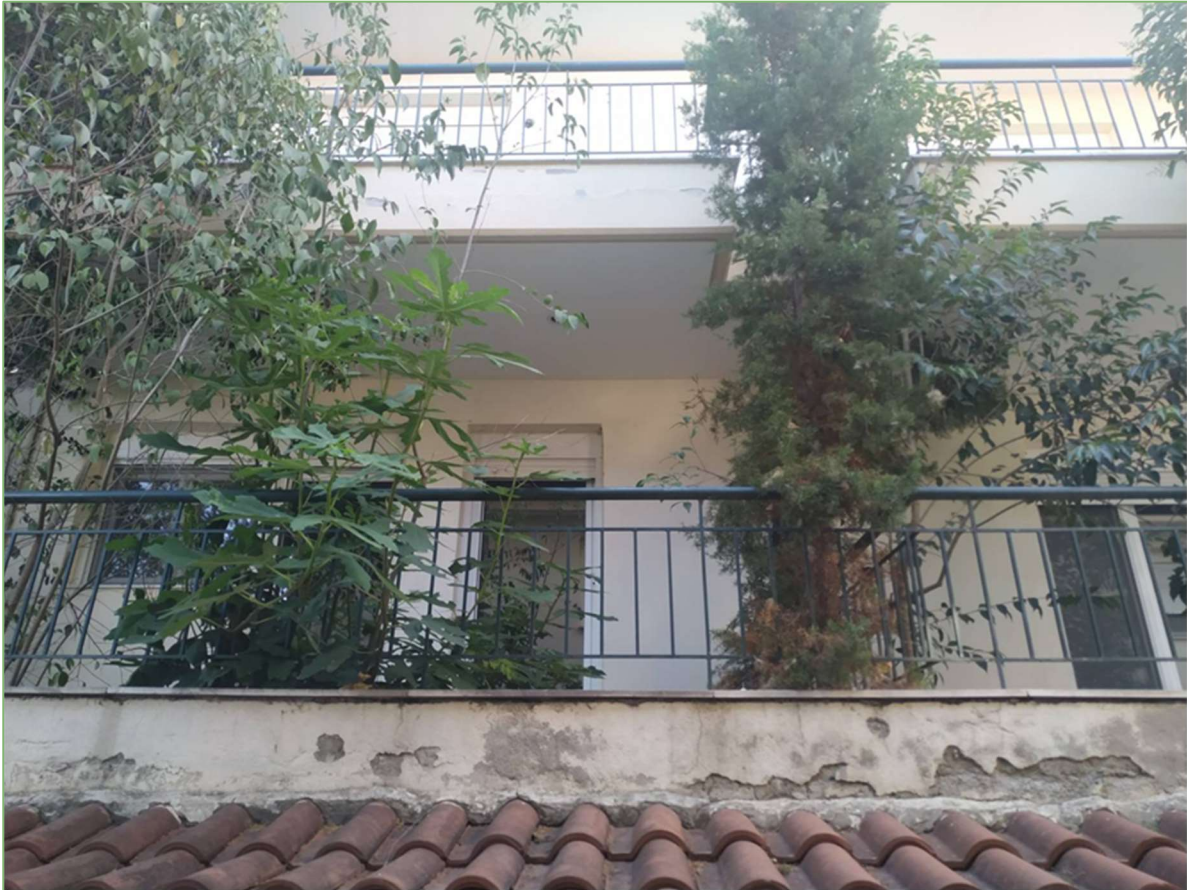
*Figure 20 Damaged wall with cracks and plaster removal due to high moisture levels at a planted balcony in Thessaloniki (Photograph by authors).*

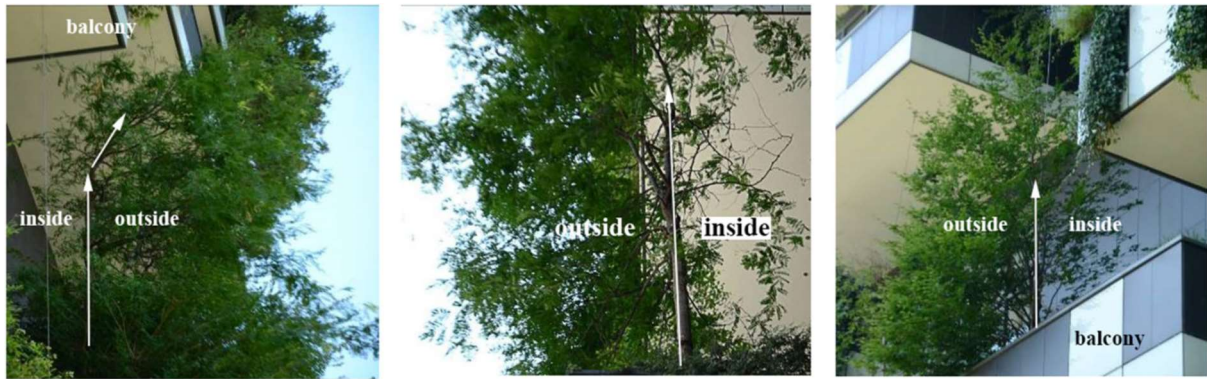
Figure 21 Distorted growth of trees regarding stem and branches and dense foliage, Bosco Verticale (Wang et al., 2020).

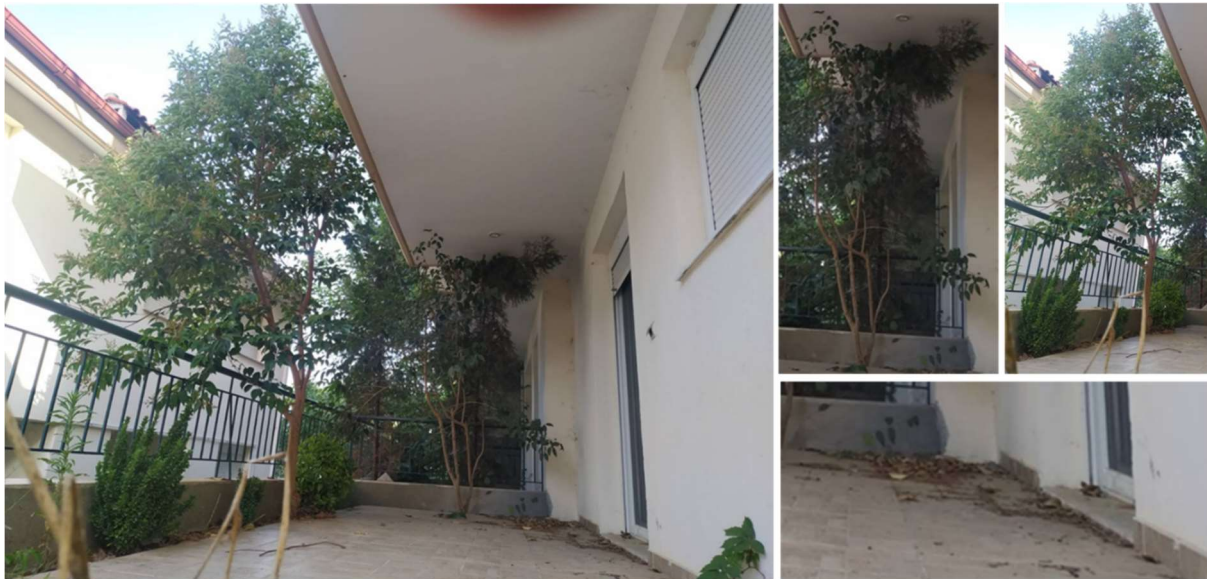
Figure 22 Distorted growth of trees and bio-debris at a planted balcony in Thessaloniki (Photograph by authors).

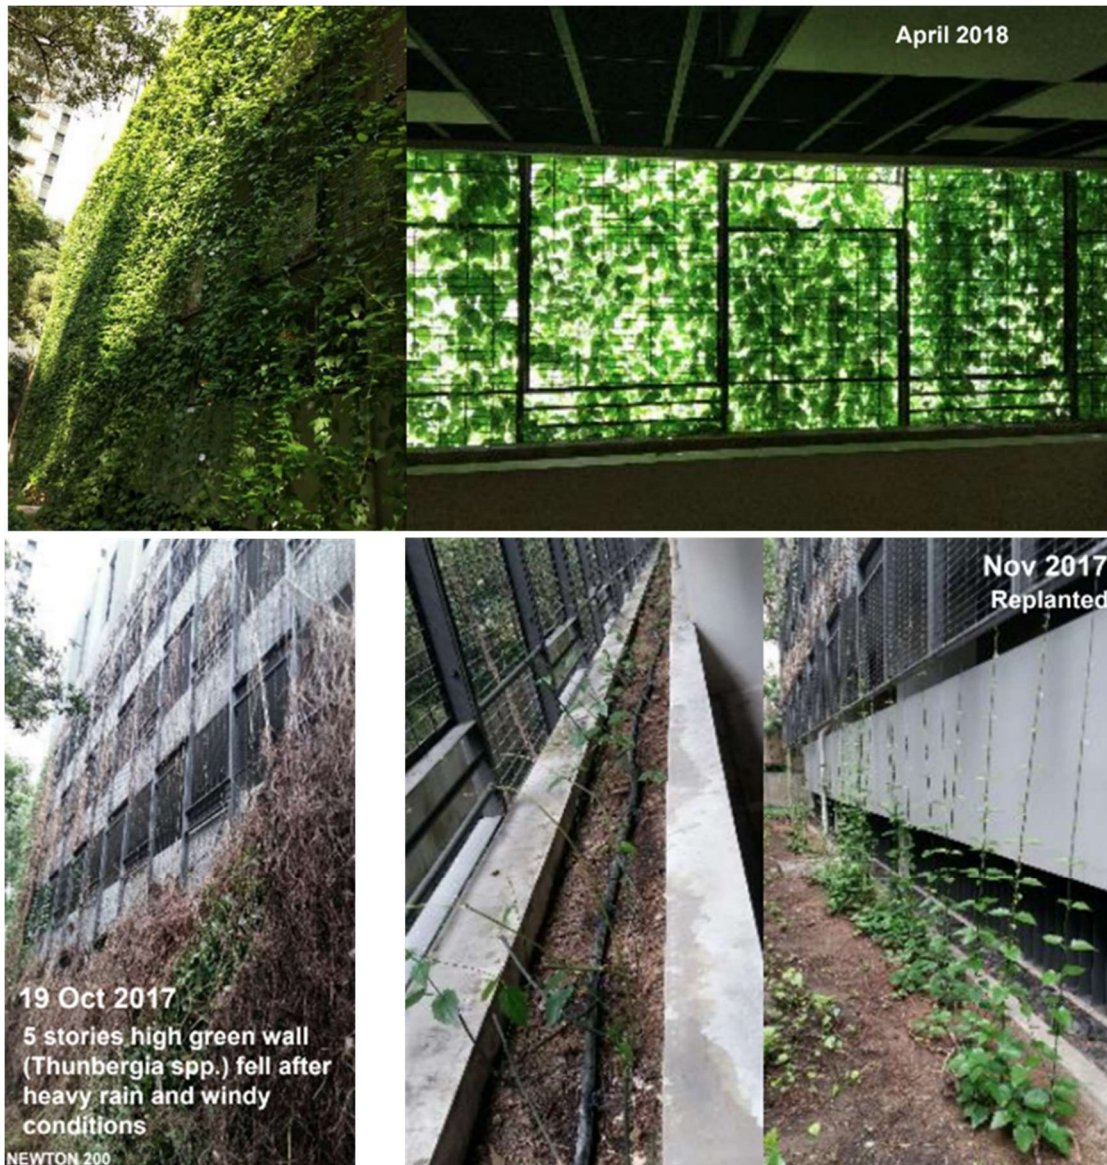
Figure 23 Green wall damage after heavy rain and windy conditions and restoration (Tan, 2020).

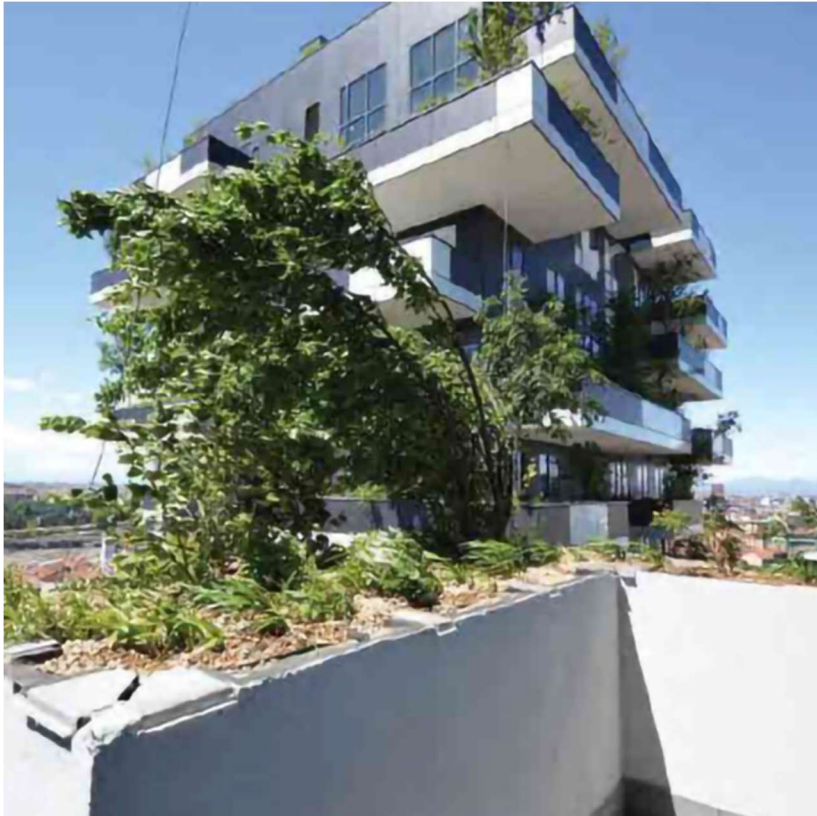
Figure 24 Bended tree on balcony under strong wind load, Bosco Verticale (Giacomello et al., 2015).

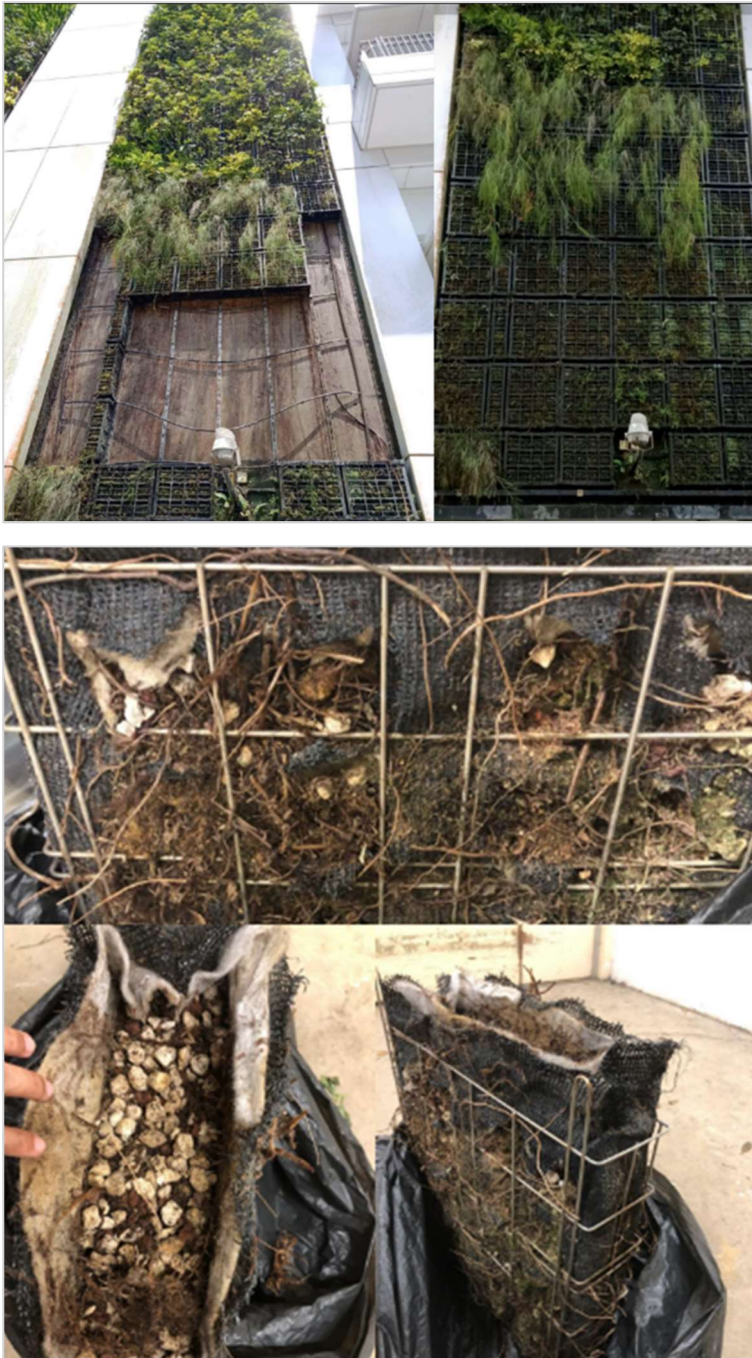
Figure 26 Loss and compaction of media after 5 years (up) and 10 years (down) respectively (Tan, 2020).

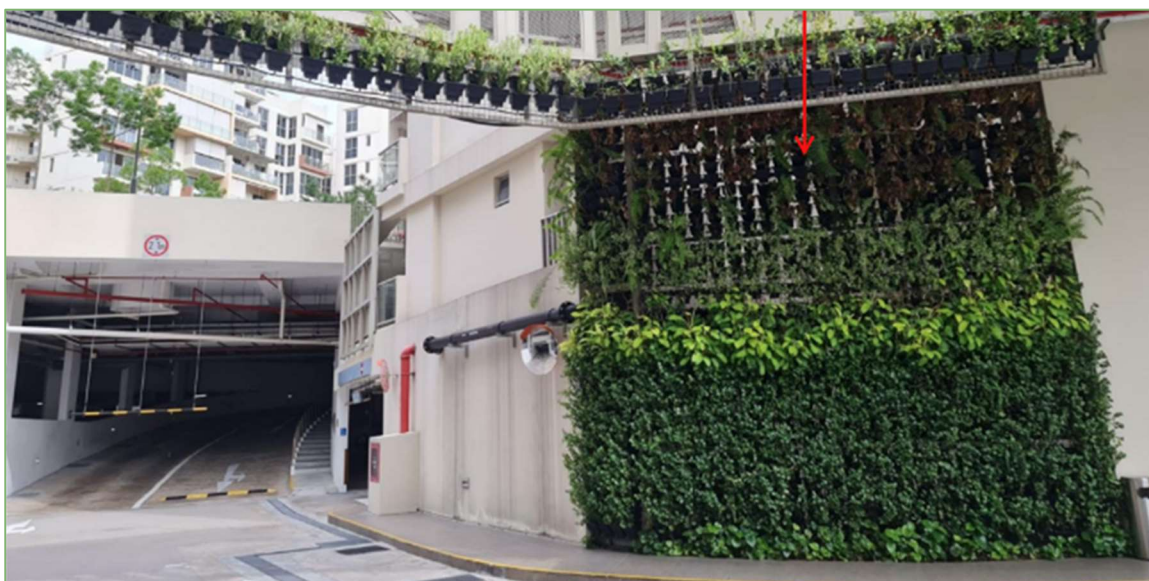
Figure 27 Irrigation choked problem leading to dry vegetation, dead plants and gaps in the continuity of vegetation (Tan, 2020).

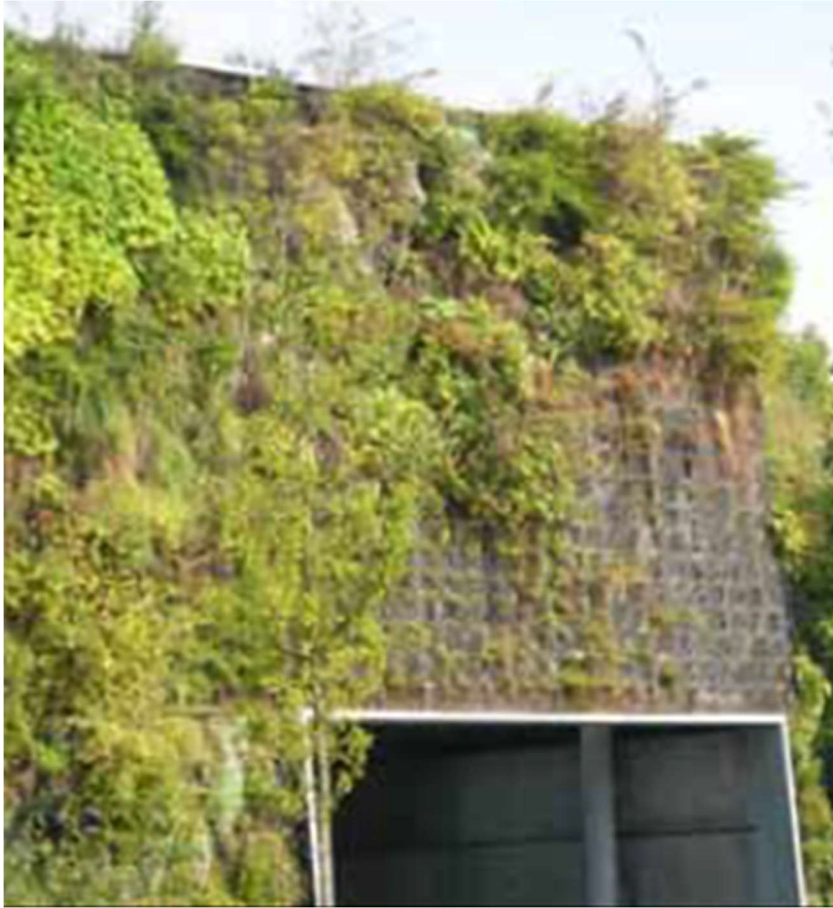
Figure 30 Dead plants at a building's green façade in Spain (Ottel , 2011).

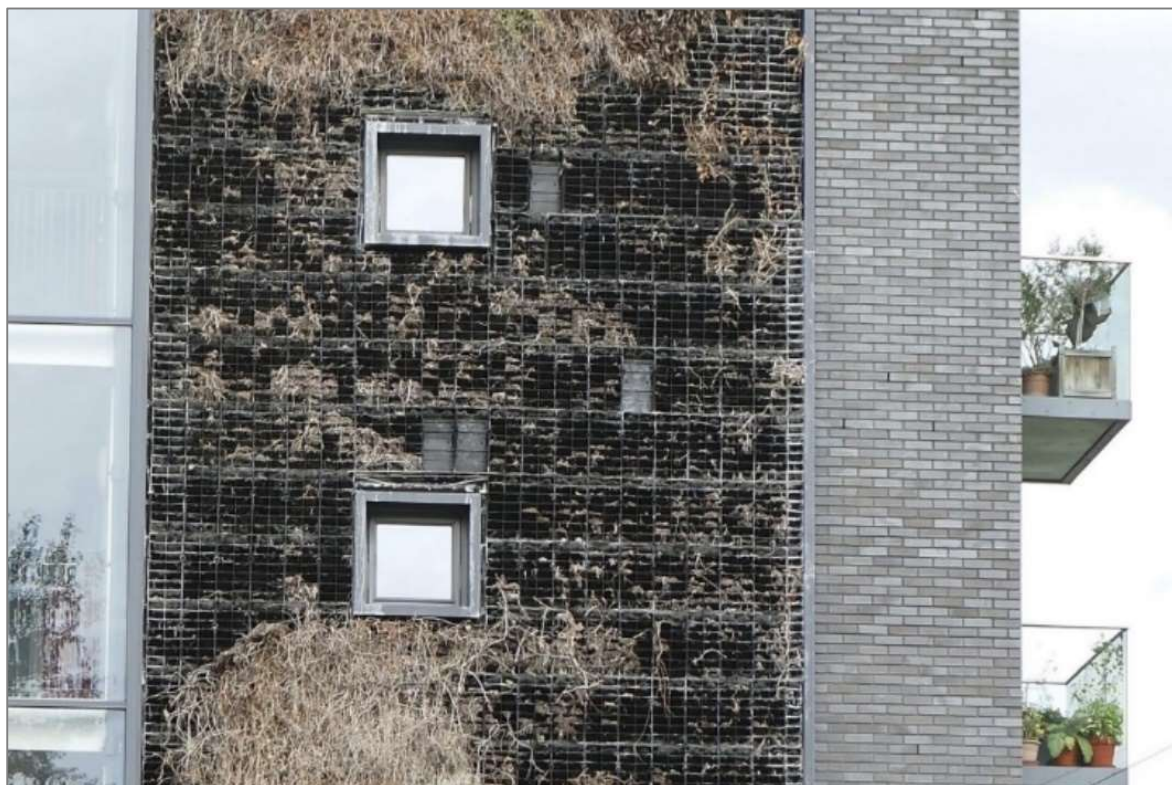
Figure 31 Dead green wall on a Pocket Living housing scheme in west London<sup>12</sup>

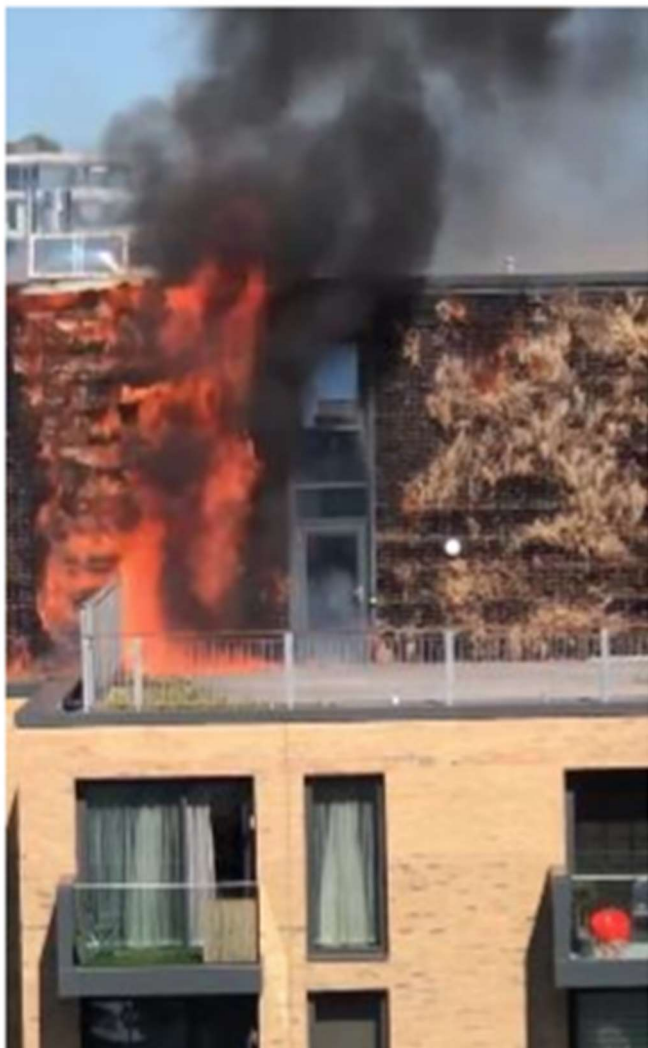
*Figure 33 Green wall fire in London, 2018 (Kotzen et al., 2023).*

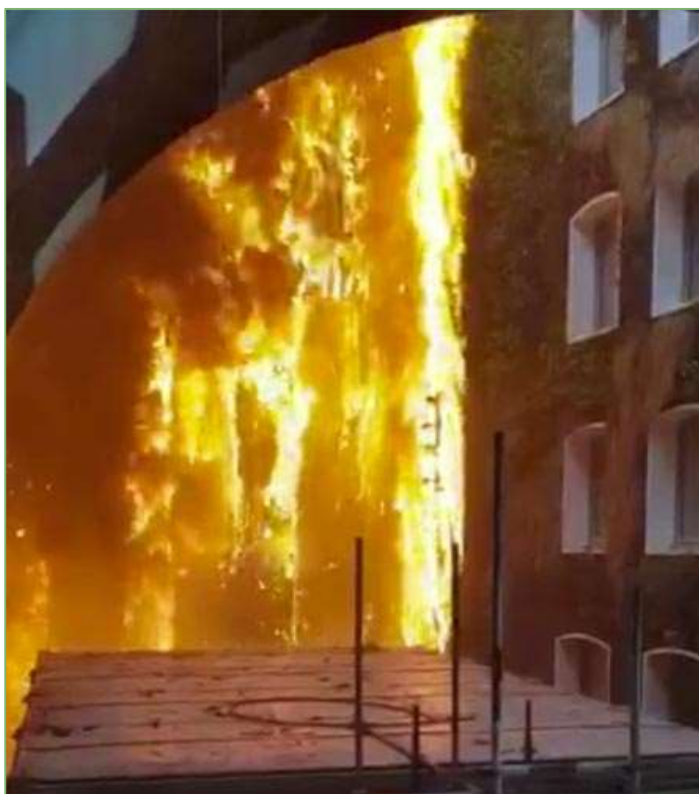
Figure 34 Living wall fire at the Mandarin Oriental Hotel Hyde Park in London, 2018<sup>13</sup>

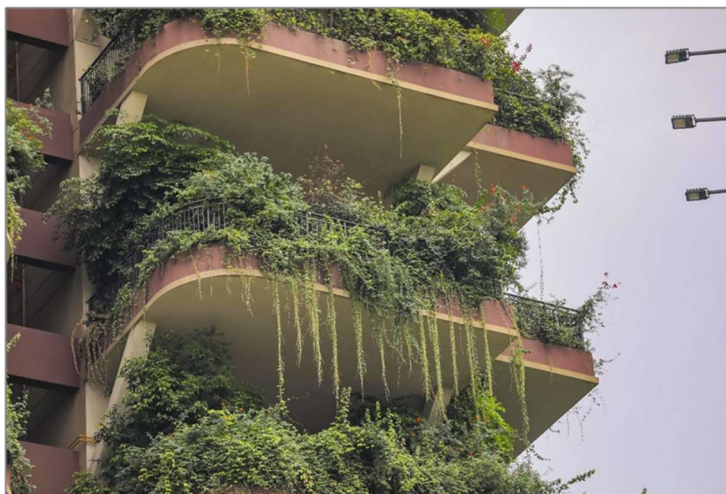
Figure 35 Balconies at Qiyi City Forest Garden residential buildings complex is overrun by plants in Chengdu, China, Sept. 15, 2020. (EPA Photo)

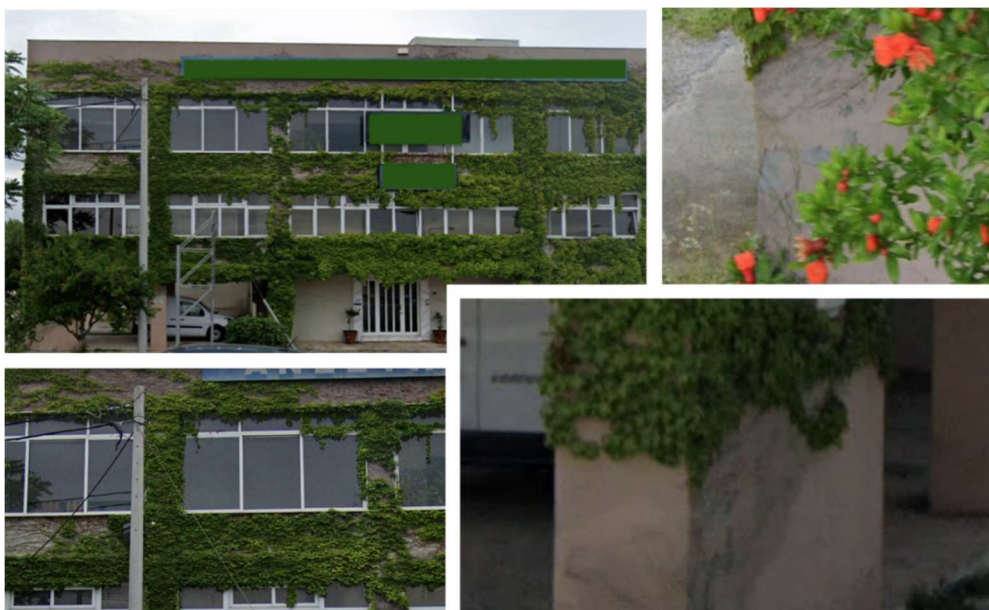
Figure 36 Green façade on a company's building in Thessaloniki with recorded damages on vegetation and building's envelope <https://maps.app.goo.gl/6ethyiDjWyXcnLJG6> (Source: Google Street View).

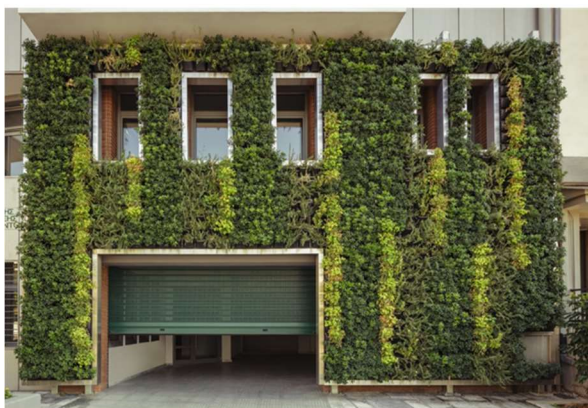
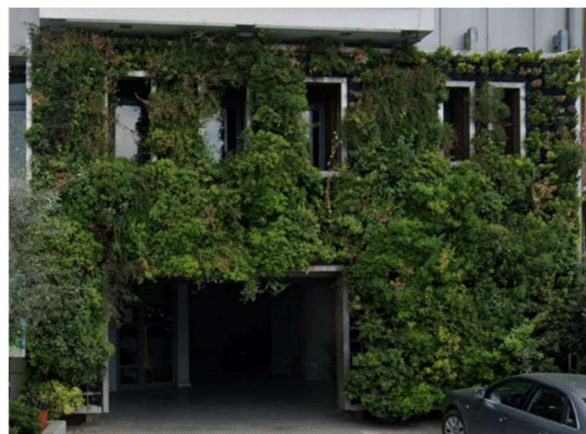
Figure 38 Green façade over the building of the Directorate of Urban Environment Management of the Municipality of Thessaloniki with overgrown vegetation <https://maps.app.goo.gl/EU3bcfW1n6J63NTx5> (Source: Google Street View).

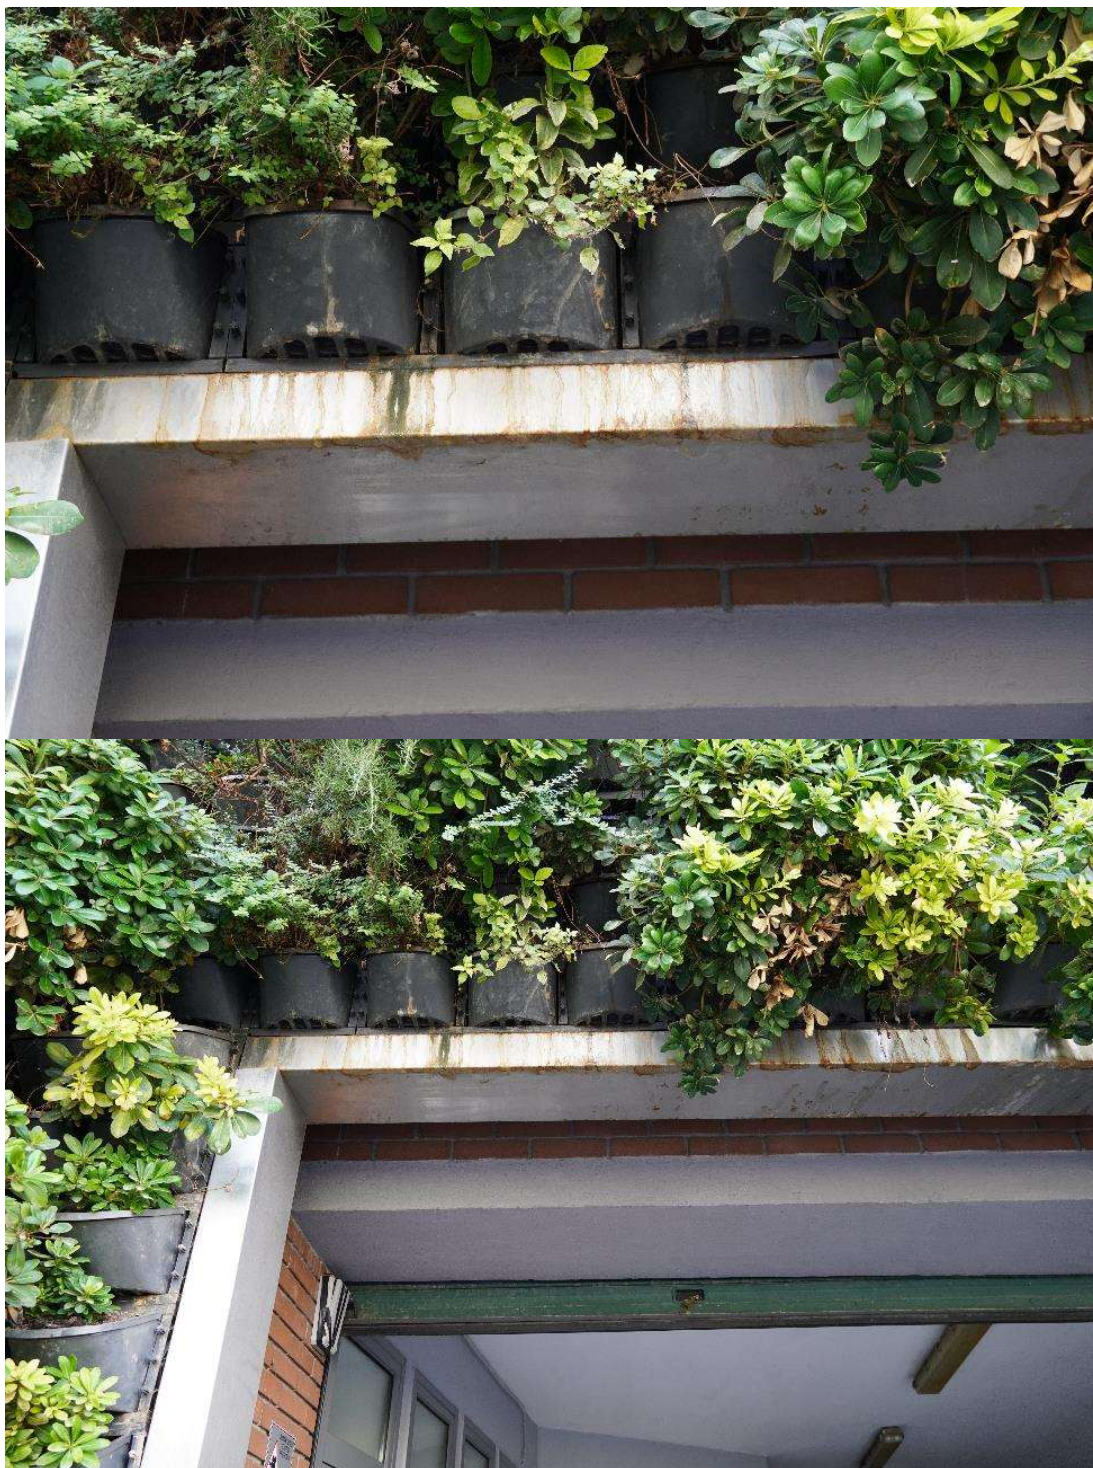
Figure 40 Corrosion phenomena of a metal infrastructure in the applied in the building of the Directorate of Urban Environment Management of the Municipality of Thessaloniki <https://maps.app.goo.gl/EU3bcfW1n6J63NTx5> (Source: In situ survey for the GREENERGY project-October 2024).

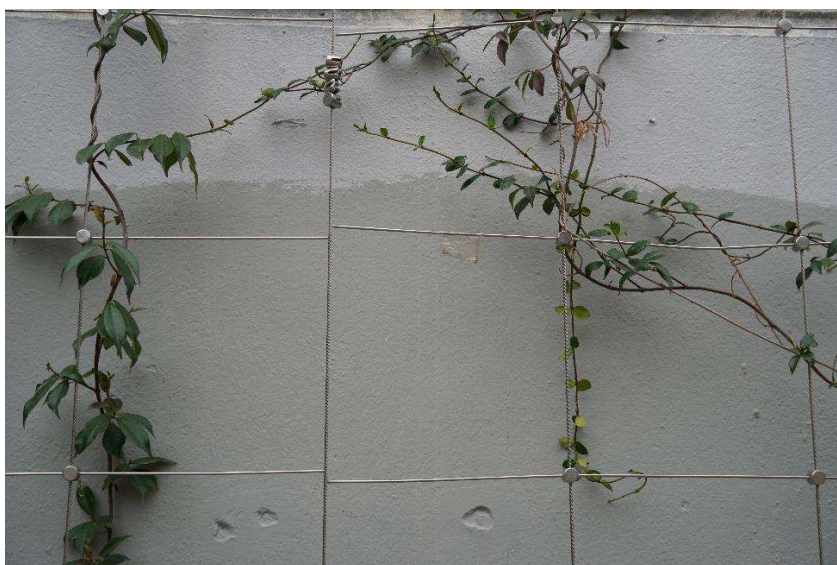
Figure 44 Vandalism and construction failures in the green façade in the Community Centre of the Municipality of Thessaloniki, <https://maps.app.goo.gl/cHY6b6JcR9s1svVD9> (Source: In situ survey for the GREENERGY project-October 2024).

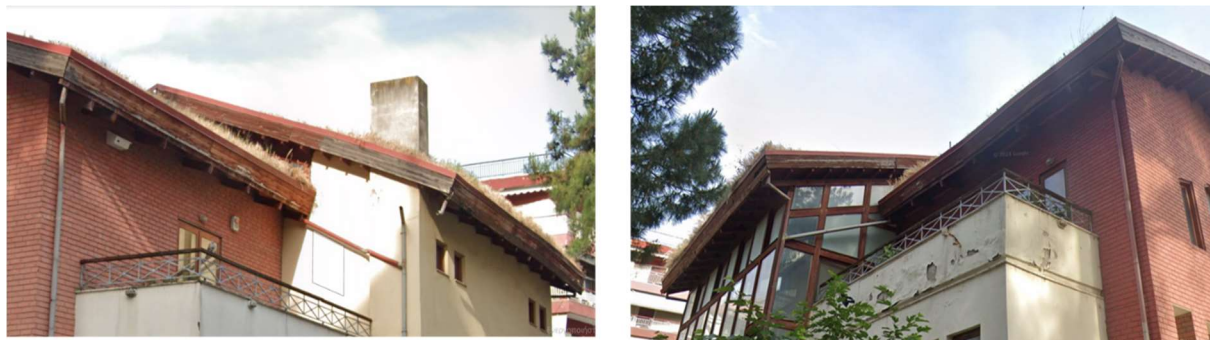
*Figure 46 Green roofs and green covered façades of the Environmental Education Center in Eleftherio-Kordelio, Thessaloniki, with dry vegetation and damages on the building's envelope (<https://maps.app.goo.gl/hntTBYyeyCa9Ab4LA>) (Source: Google Street View).*
