Resilient Vertical Forest Renovation of Reinforced Concrete  
Structures in Seismic Prone Areas  
(H.F.R.I. Project Number 015376)

Recorded damages to common and VF buildings and  
lessons learned

Deliverable D1.4 Work package 1

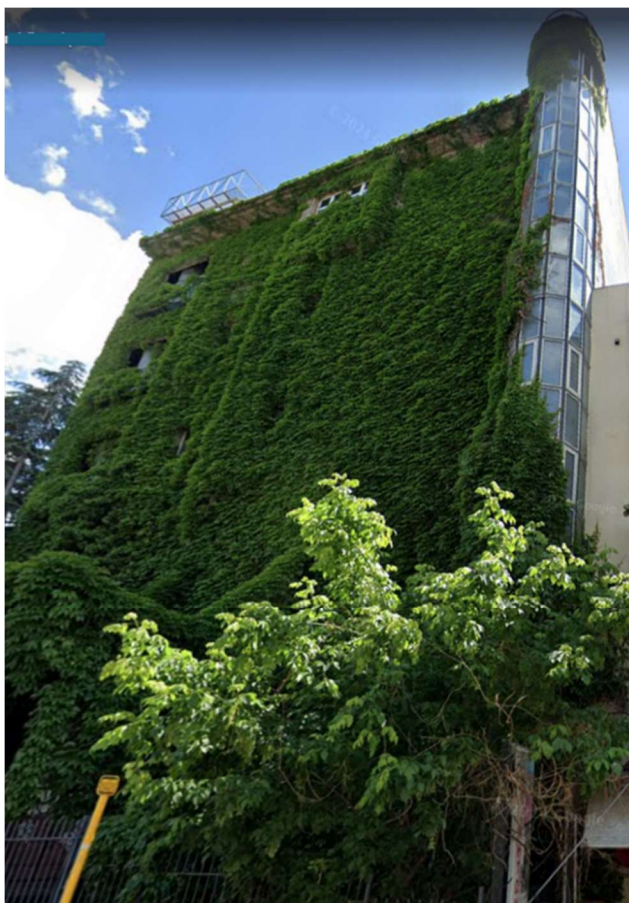
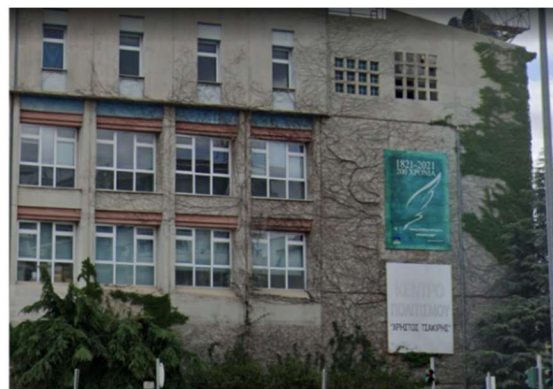
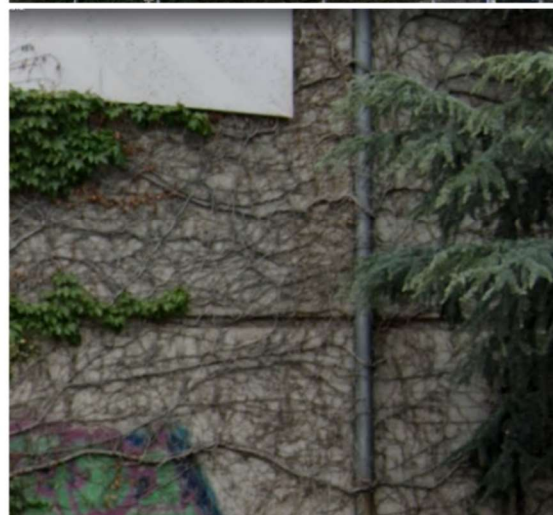
Figure 47 Self-climbing plants over the façades of "Christos Tsakiris" - Center of Culture (Municipality of Pavlos Melas) in Thessaloniki. The plants are either overgrown or dry (<https://maps.app.goo.gl/i9F1b2LkiGBTipyi9>) (Source: Google Street View).

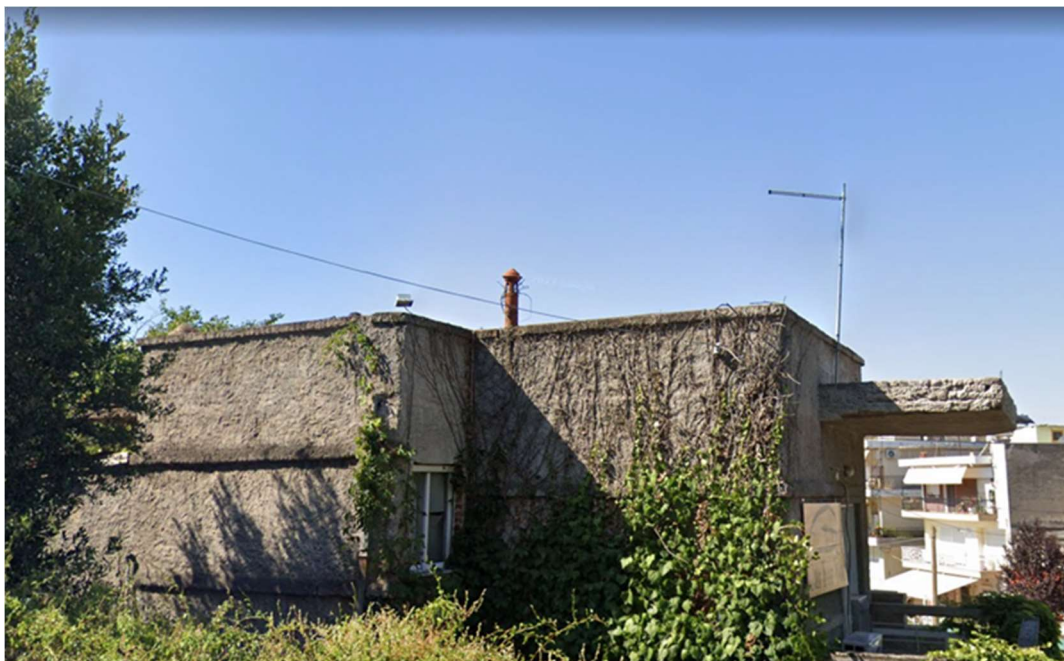
Figure 48 Dry ivy on façades of a private property in Thessaloniki (<https://maps.app.goo.gl/8uRomSae2V9wqKBh9>) (Source: Google Street View).

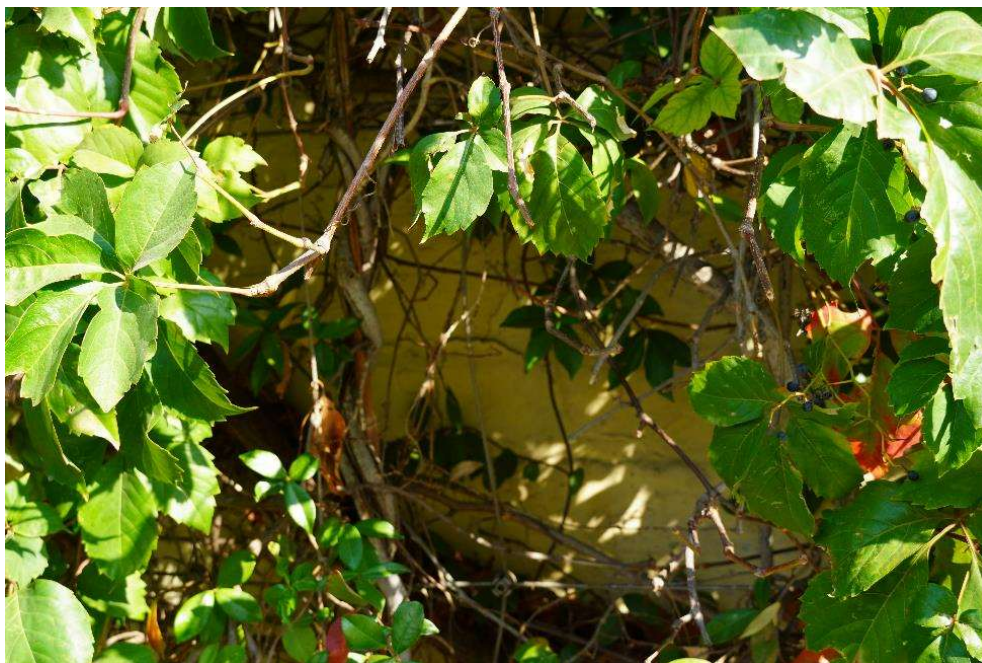
Figure 50 Wall cracks underneath the green façade in the building hosting the Historical Archives of Macedonia <https://maps.app.goo.gl/SWY5F674hJ12NqnJ9> (Source: In situ survey for the GREENERGY project-October 2024).

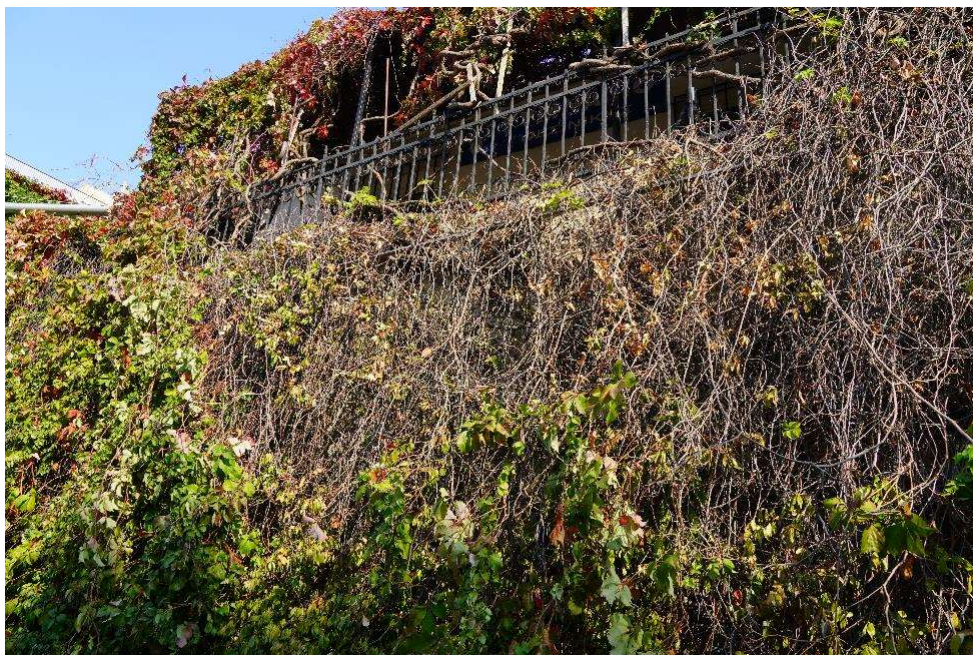
Figure 51 Excess dry matter within the green façade in the building hosting the Historical Archives of Macedonia <https://maps.app.goo.gl/SWY5F674hJ12NqnJ9> (Source: In situ survey for the GREENERGY project-October 2024).

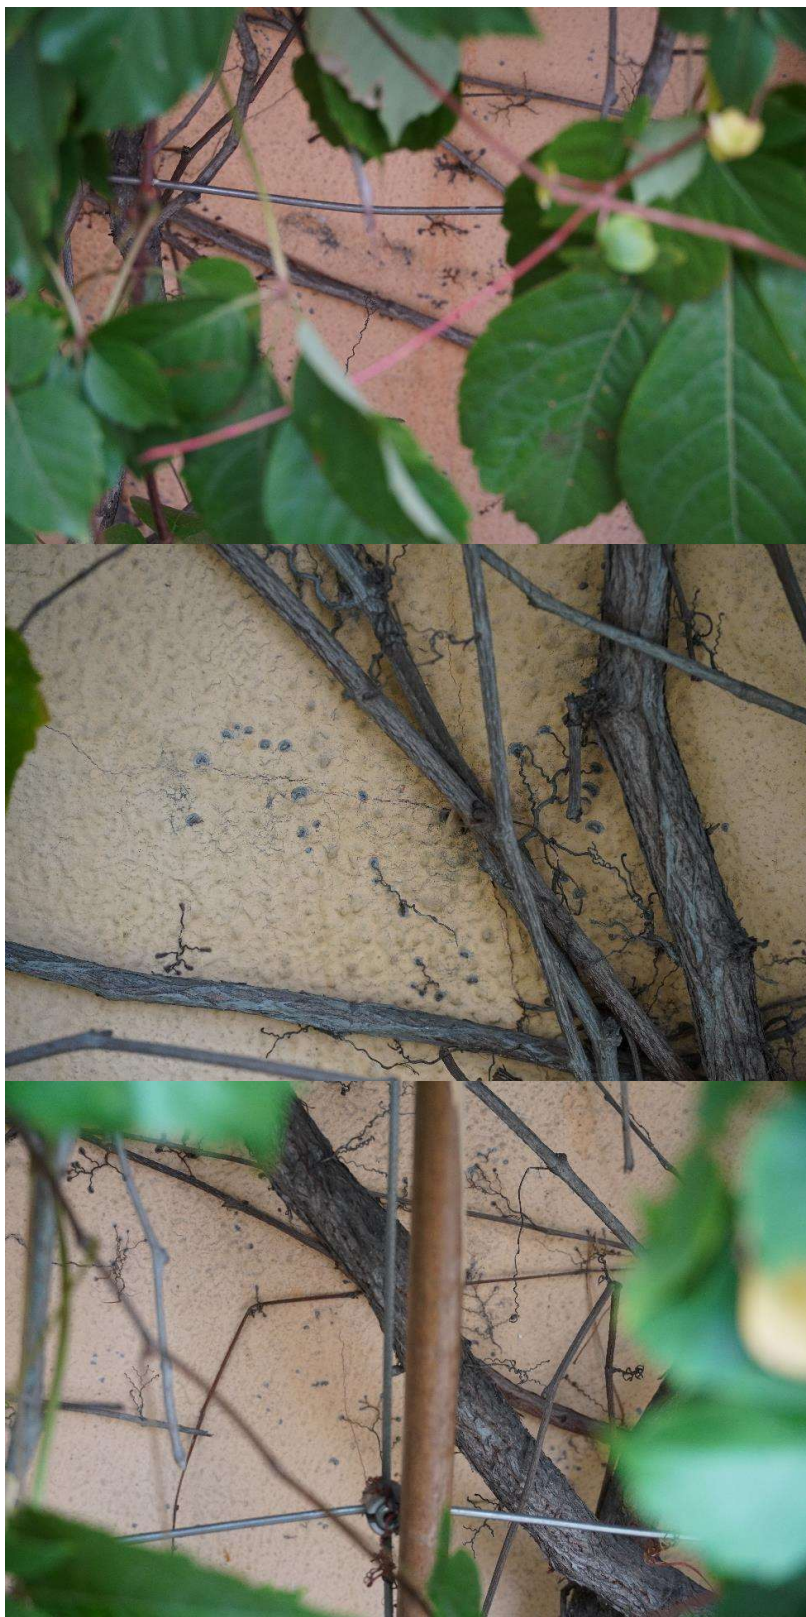
Figure 53 Erosion, cracks and mould development over the building 35<sup>th</sup> and 37<sup>th</sup> primary schools of Thessaloniki <https://maps.app.goo.gl/oZELaqJDvpm4TUyU6> (Source: In situ survey for the GREENERGY project-October 2024).
