Resilient Vertical Forest Renovation of Reinforced Concrete  
Structures in Seismic Prone Areas  
(H.F.R.I. Project Number 015376)

Designs and photos of detailing and instrumentation  
and structural, energy, forestry retrofit of renovated 3d  
VF structure

Deliverable D2.2 Work package 2

June 2025

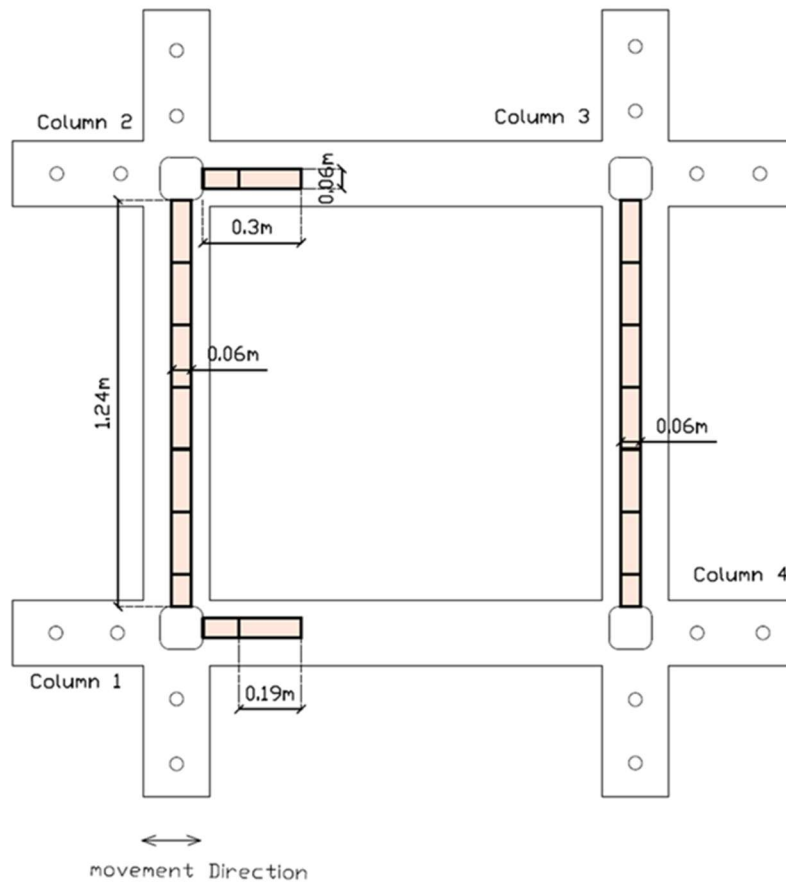
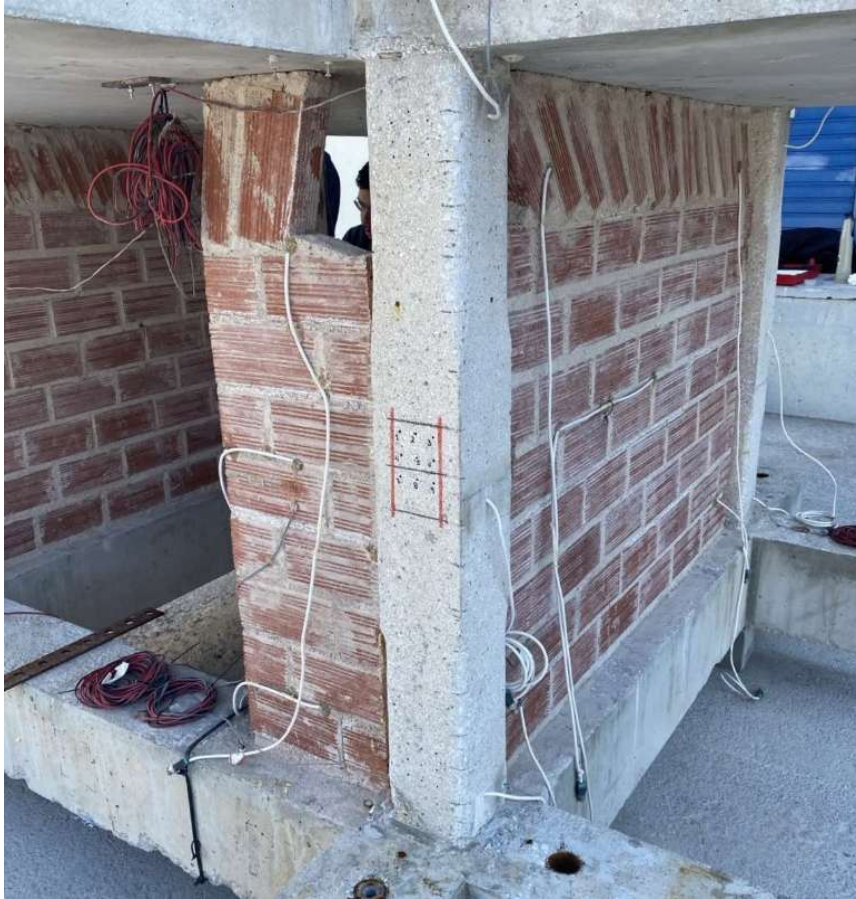
*Figure 3.1 (a) Floor plan and (b) column with rounded corners of section*

The corners of the columns were rounded with a radius of curvature ranging from 1.6cm – 2.2cm. The resulting plan view of the columns is shown in Figure 3.1(a) and the column 2 in Figure 3.2(b).

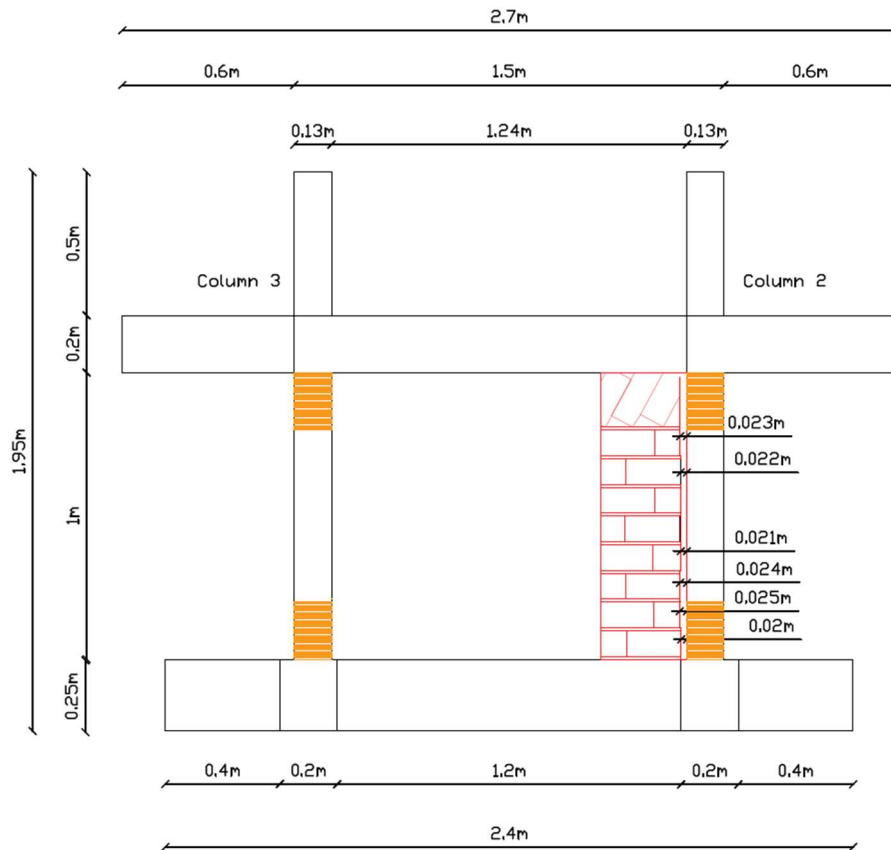
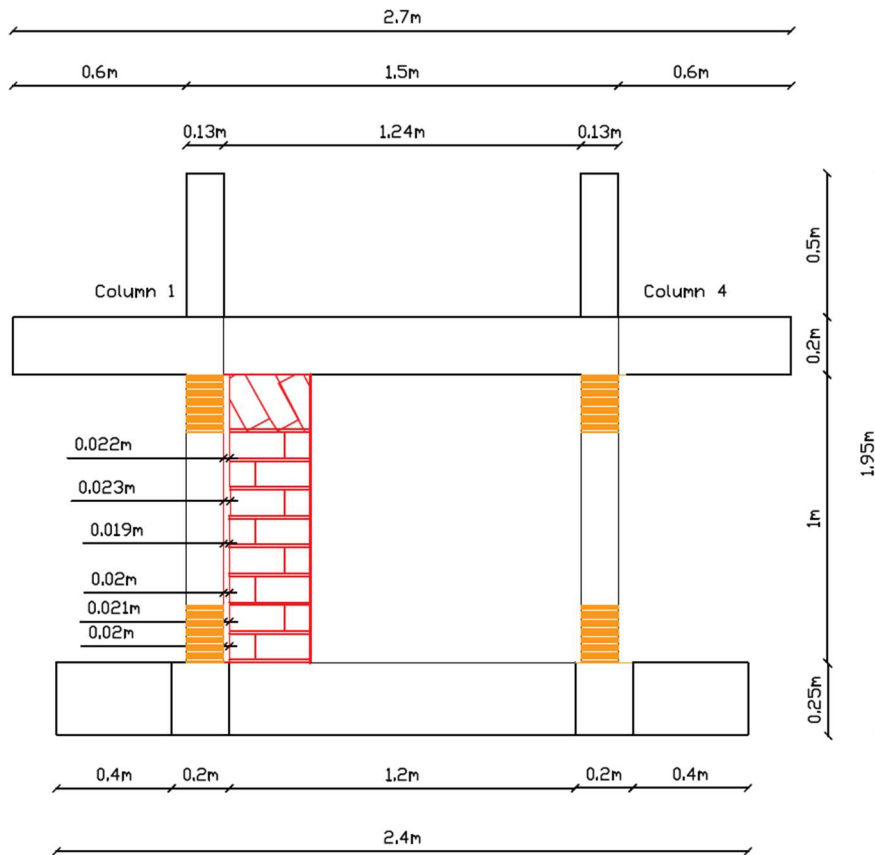
Figure 3.6 Application of basalt rope (a) on column 2 and gap dimension with partial infill 3-2 and (b) on column 1, partial infill 1-4

Continuous basalt rope was wrapped around the column sections to provide additional confinement of concrete. The 1 layer of rope covered 20 cm at the bottom and top regions of the column. The second layer served only the self anchorage of the columns. The rope coils in each layer are given below. In Figure 3.6 and Figure 3.7, the reinforced concrete columns for the partial and full masonry are shown respectively.

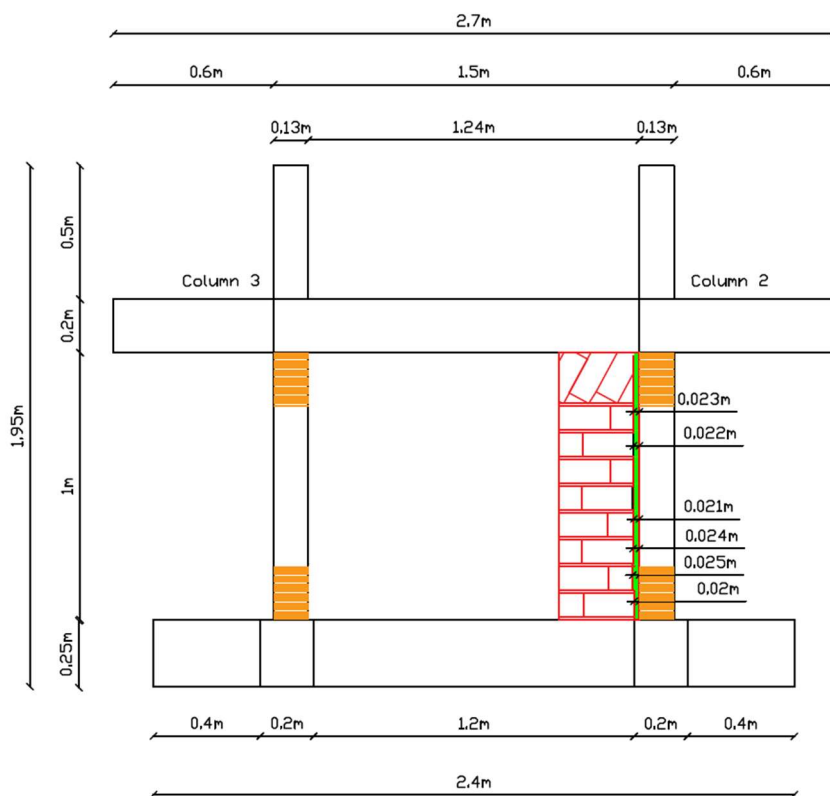
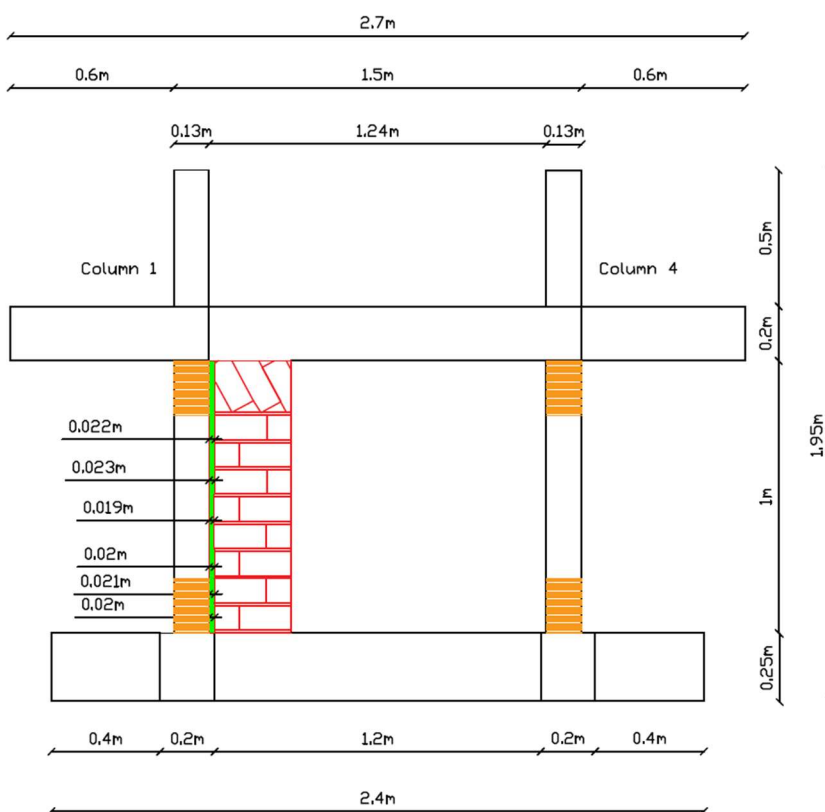
*Figure 3.8 Cured PUFJ (polyurethane flexible joint) (a), (b) in the partial infill and application of the primer resin for the bonding of the glass grid (c)*

Primer was applied on the surfaces that would receive the PM joint. The PM resin was poured into the joint with the help of ewooden molds of 20cm height. Therefore, each joint was completed after 5 sequential castings. The polyurethane hardens within half an hour, so it needs to be applied quickly before it cures.

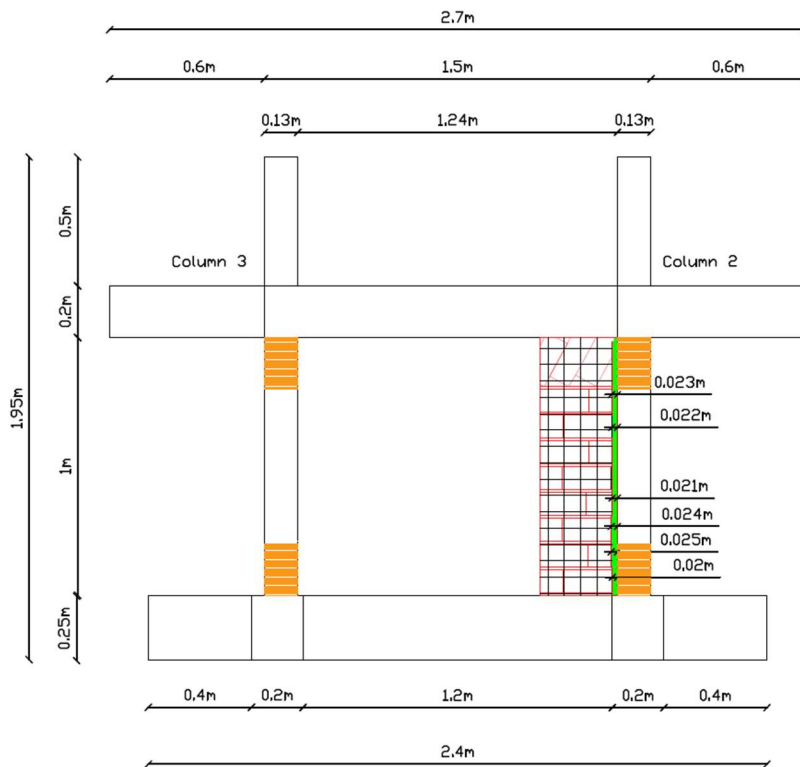
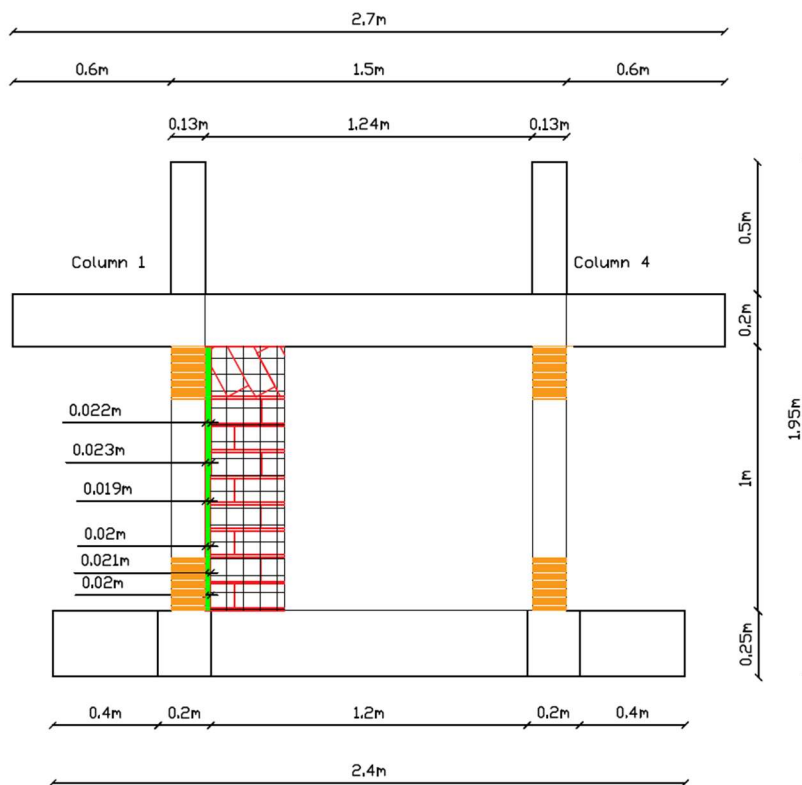
Figure 3.11 (a), (b) Application of grid

To apply the grid, first, the masonry was cleaned. Then, a layer of primer was applied before the application of the PS polyurethane layer. The grid was placed on the PS layer and then the voids of the grid were covered with a final layer of the same PS polyurethane.

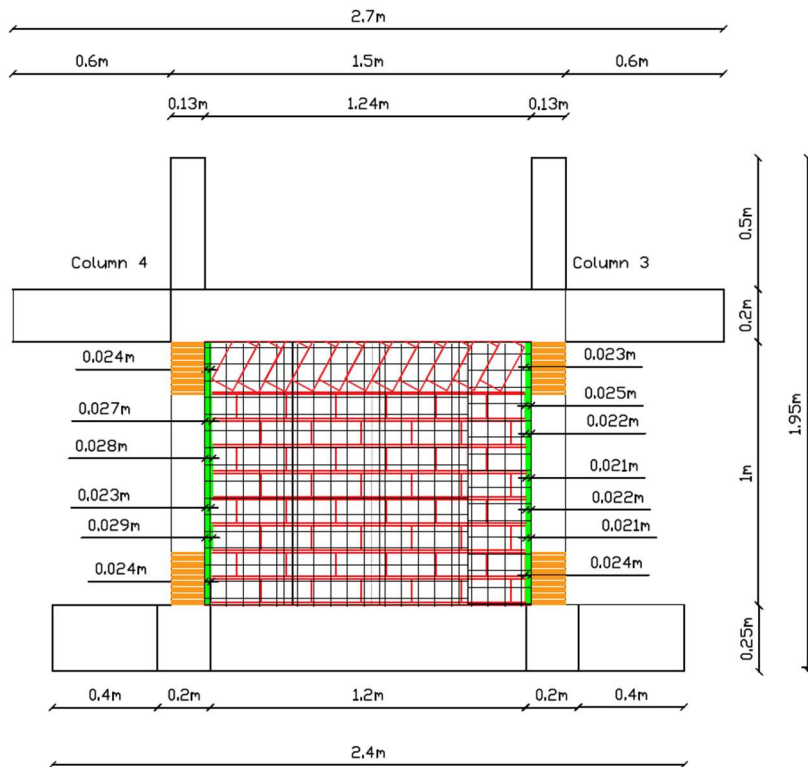
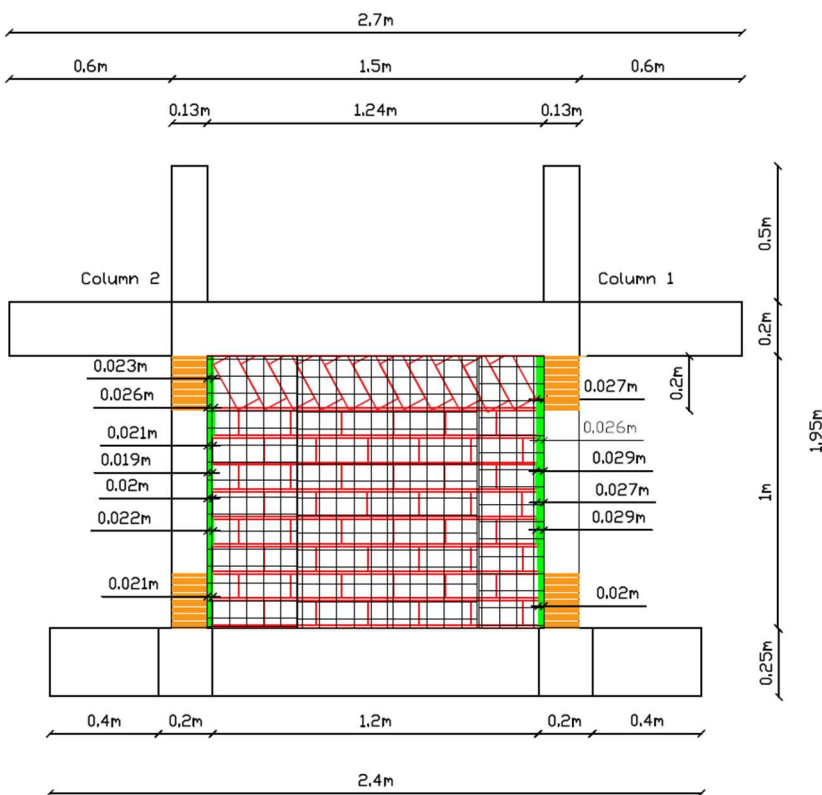
Figure 3.12 Constructed FRPU (glass grid & PS polyurethane) one-sided jacket on the full infill (a), (b), (c)

The grid was cut into two different dimensions, one piece of  $1.10 \times 0.24 \text{ m}^2$  and three pieces of  $1.10 \times 0.33 \text{ m}^2$  for the full masonry (without vertical overlapping), and one piece of  $1.10 \times 0.30 \text{ m}^2$  for the partial masonry (Figure 3.10). The grid was placed on the partial masonry as shown in Figure 3.11 and on the full masonry Figure 3.12.

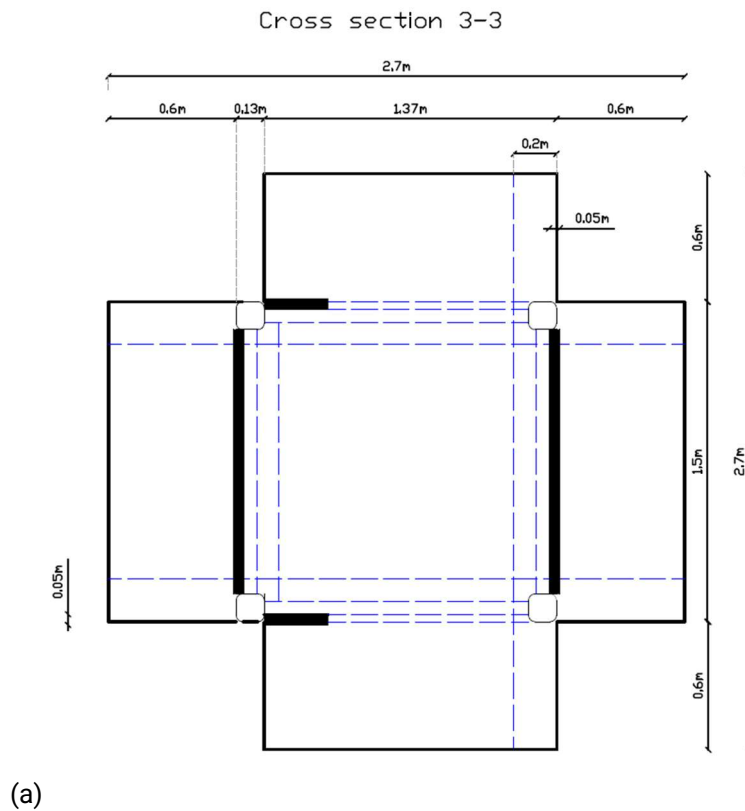
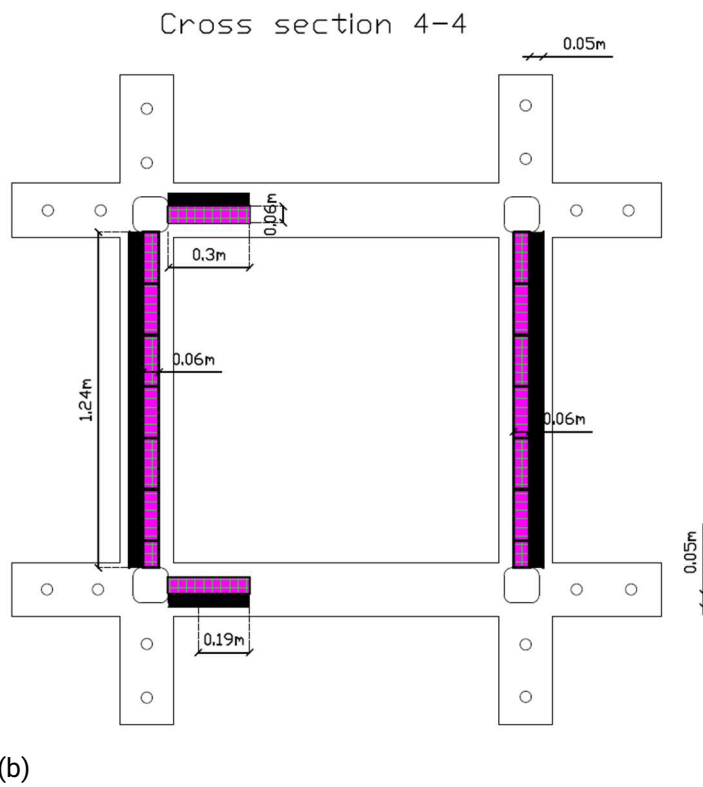
Figure 3.14 Concrete surfaces on the slab (a) and on the foundation (b) with bonded glass grid FRPU

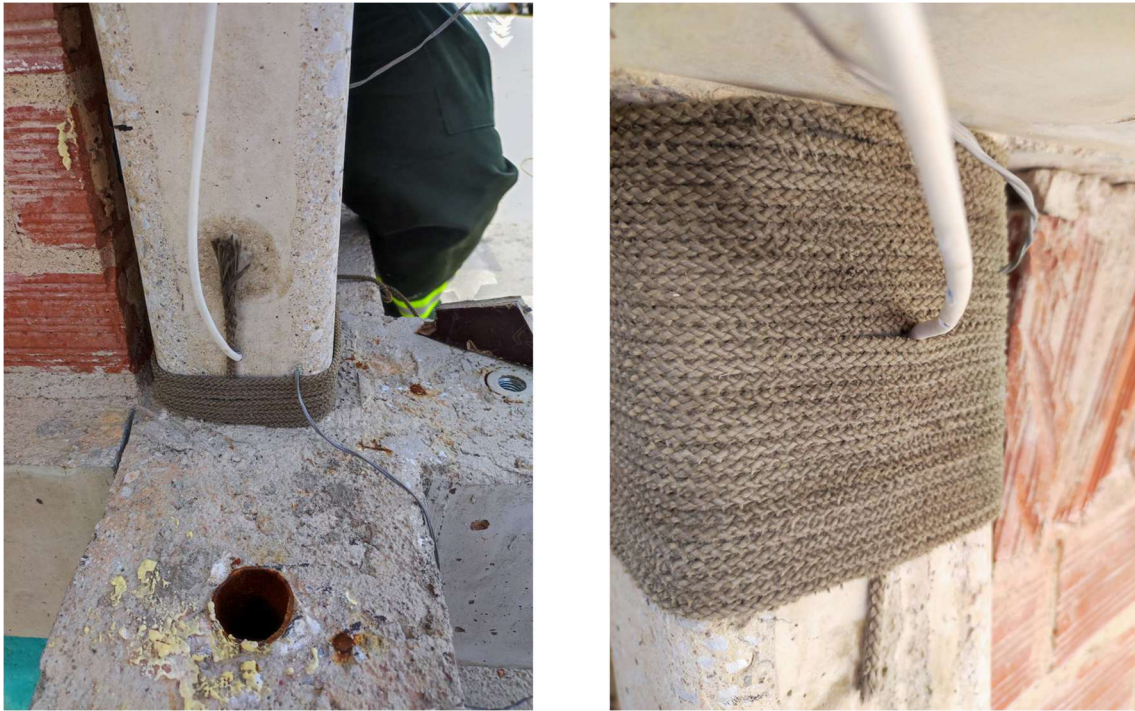
*Figure 4.4 Application of the basalt ropes concerning the PZT patches that were already installed in the as-built structure.*

In this case, the PZT patches are positioned at several locations to receive results for the structural health of the renovated 3d VF structure. Basalt rope reinforcement was applied in two layers around

the top and bottom to improve structural performance. Throughout the wrapping process, special care was taken to keep the pre-installed PZT wires safe and intact. The basalt rope was tightly coiled with consistent tension to ensure full contact without affecting the PZT functionality. This method provides effective reinforcement while preserving the integrity of the PZT wiring. The following figure illustrates the basalt ropes wrapped around the top and bottom sections of the column, showing how the reinforcement is applied carefully to protect the PZT patches and their wires.
