Resilient Vertical Forest Renovation of Reinforced Concrete  
Structures in Seismic Prone Areas  
(H.F.R.I. Project Number 015376)

Assessment of the performance of tested renovated  
3d VF structure.

Deliverable D2.6 Work package 2

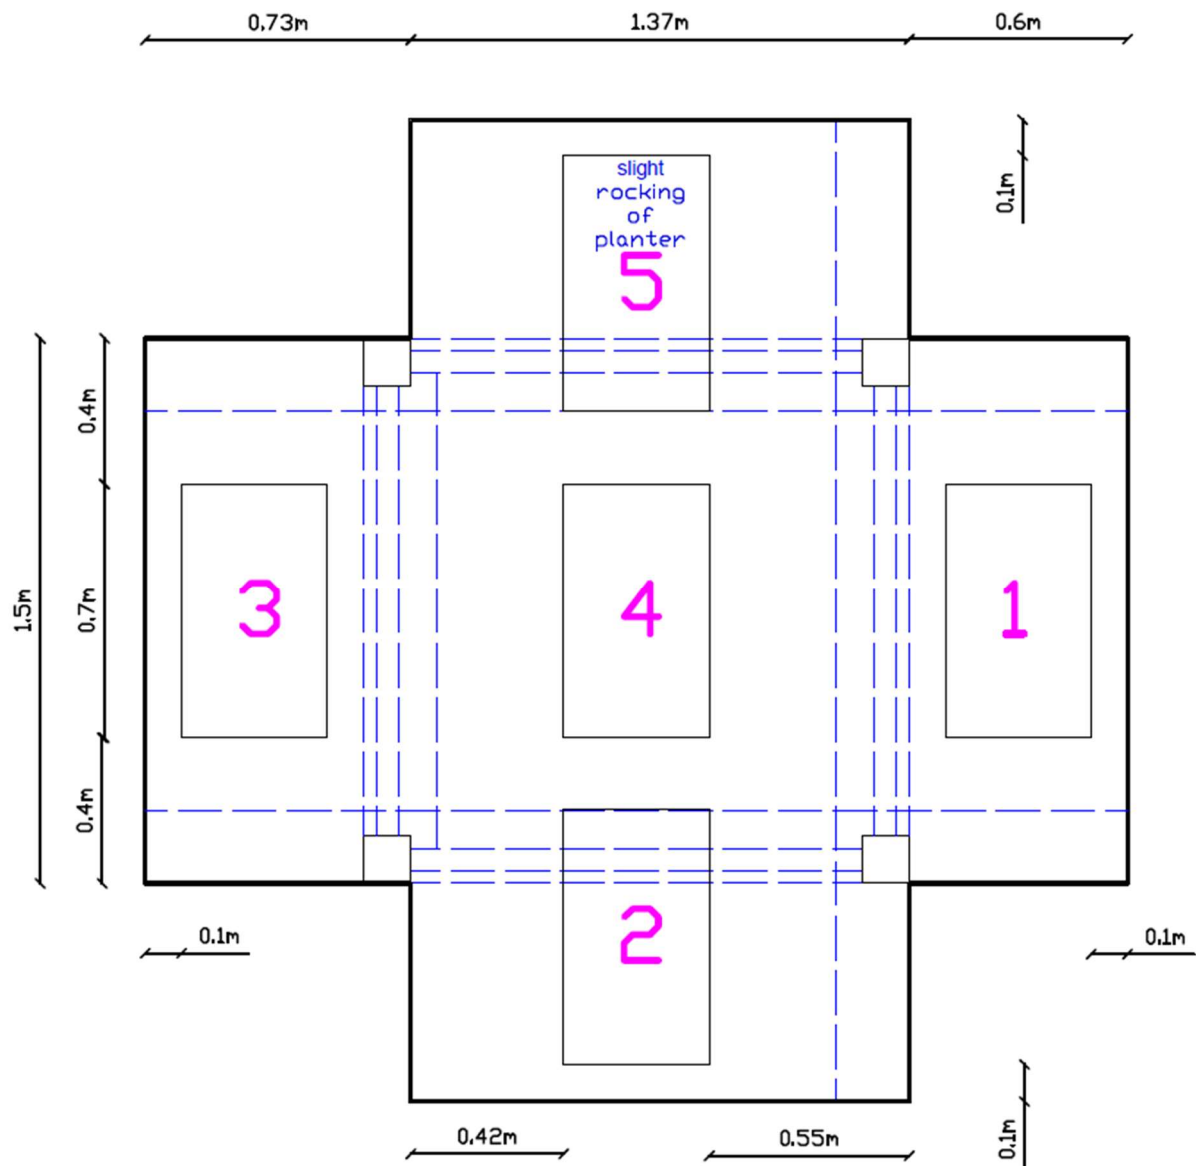
Figure 3.3.1 Observed damage after Wnb0.07g(without), Wnb0.07g, EQ0.07g, EQ0.1g, Wnb0.14g tests:.. Slight rocking of planter 5.

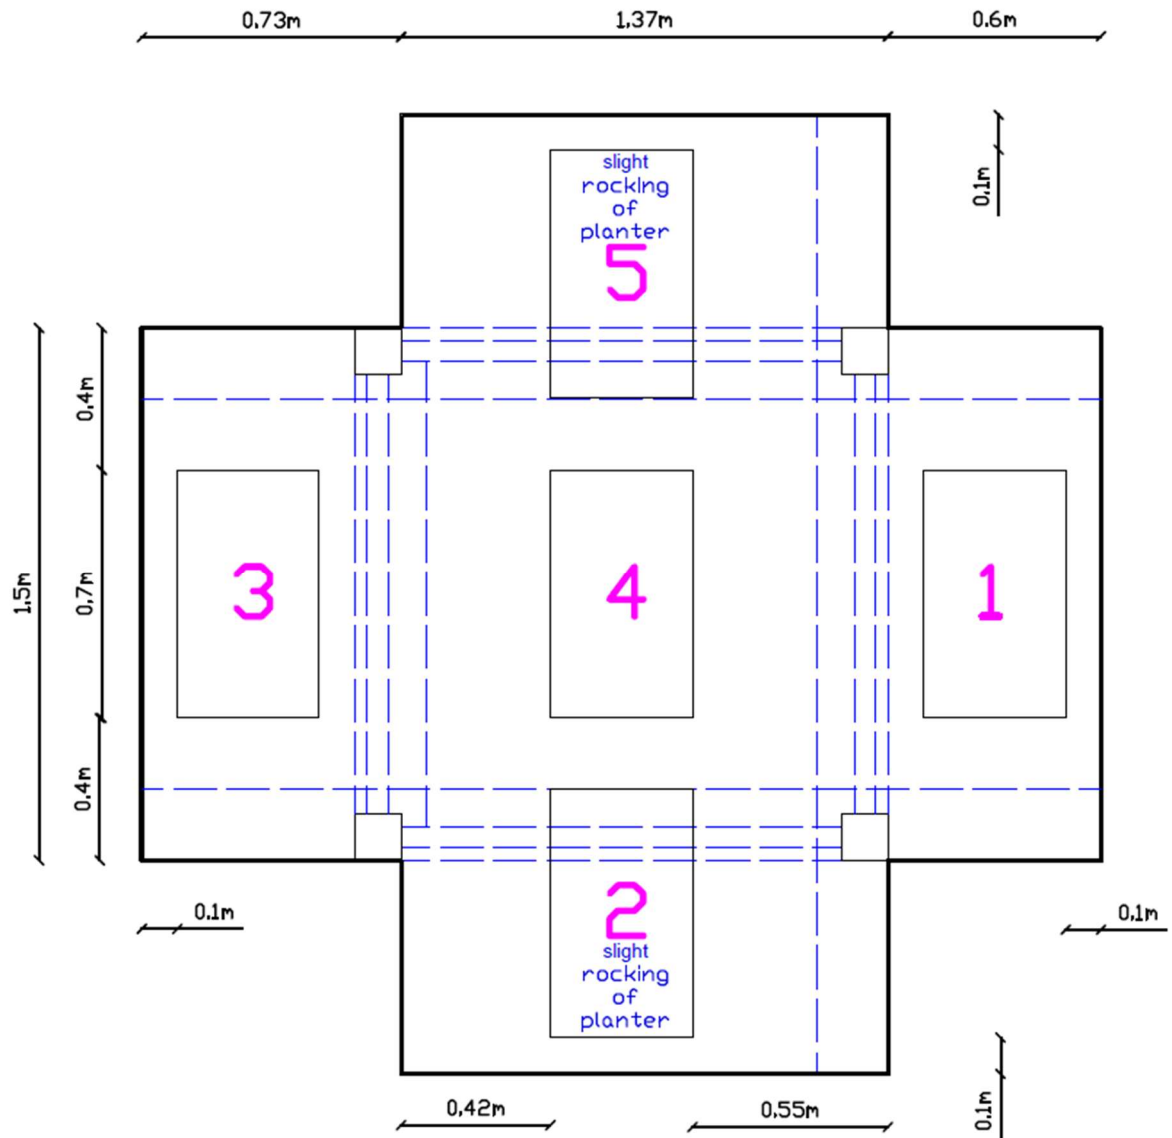
Figure 3.3.2 Observed damage after EQ0.14g, EQ0.2g, Wnb0.34g, Wnb0.5g, Wnb0.55g tests:.. Slight rocking of planter 2 and 5.

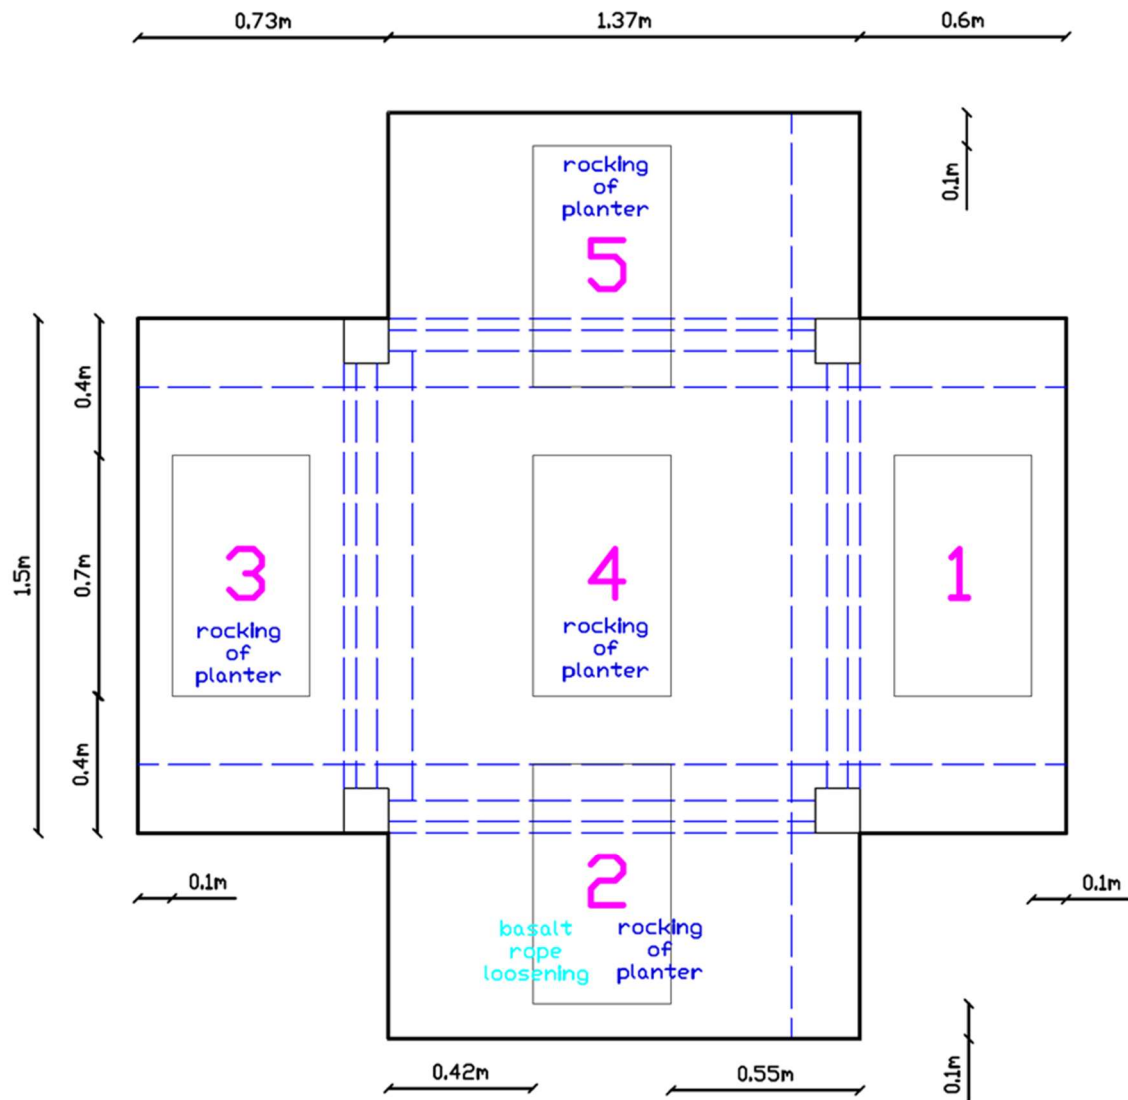
EQ0.34g

Figure 3.3.3 Observed damage after EQ0.34 test: Planter 2 basalt rope loosening was observed, then it was tightened. Rocking of planter 2, 3, 4 and 5.

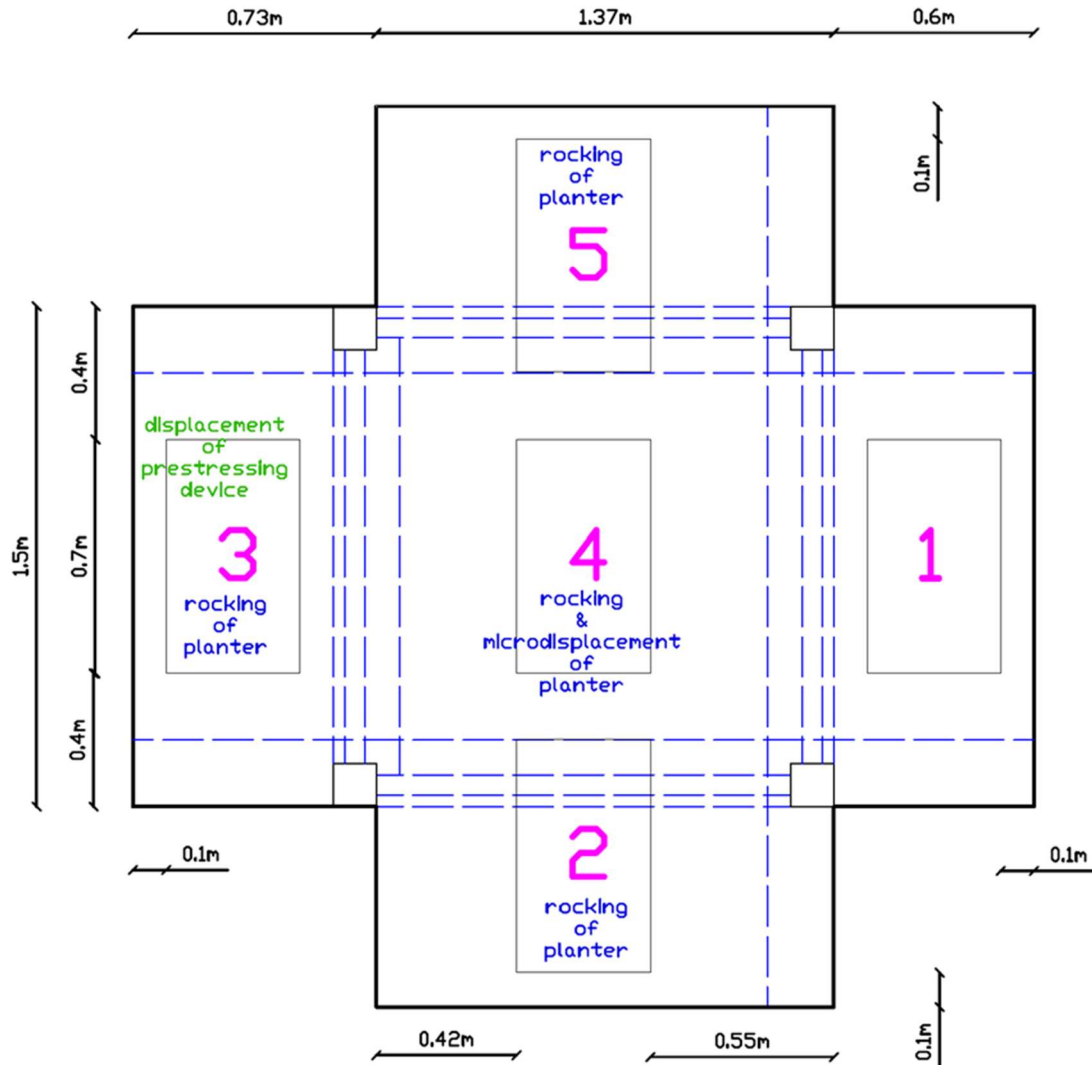
EQ0.55g

Figure 3.3.6 Observed damage after EQ0.55 test: Planter 3 displacement of prestressing device was noticed and it was tightened again. Rocking of planter 2, 3, 4 and 5. Micro-displacement of planter 4.

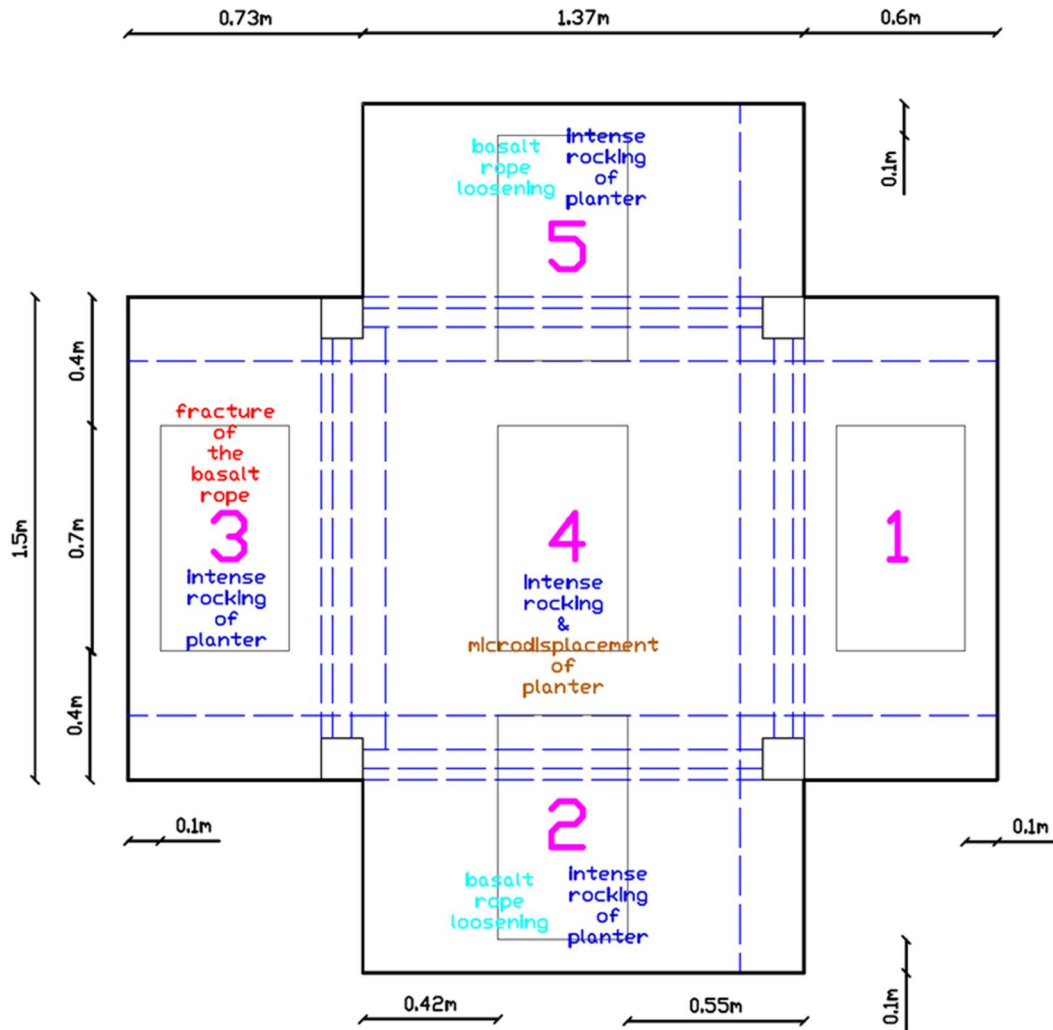
Figure 3.3.7 Observed damage after EQ0.74g test: Fracture of the basalt rope of planter 3. Basalt rope loosening of planters 2,5 and tightened again. Intense rocking of planter 2, 3, 4 and 5. Micro-displacement of planter 4.

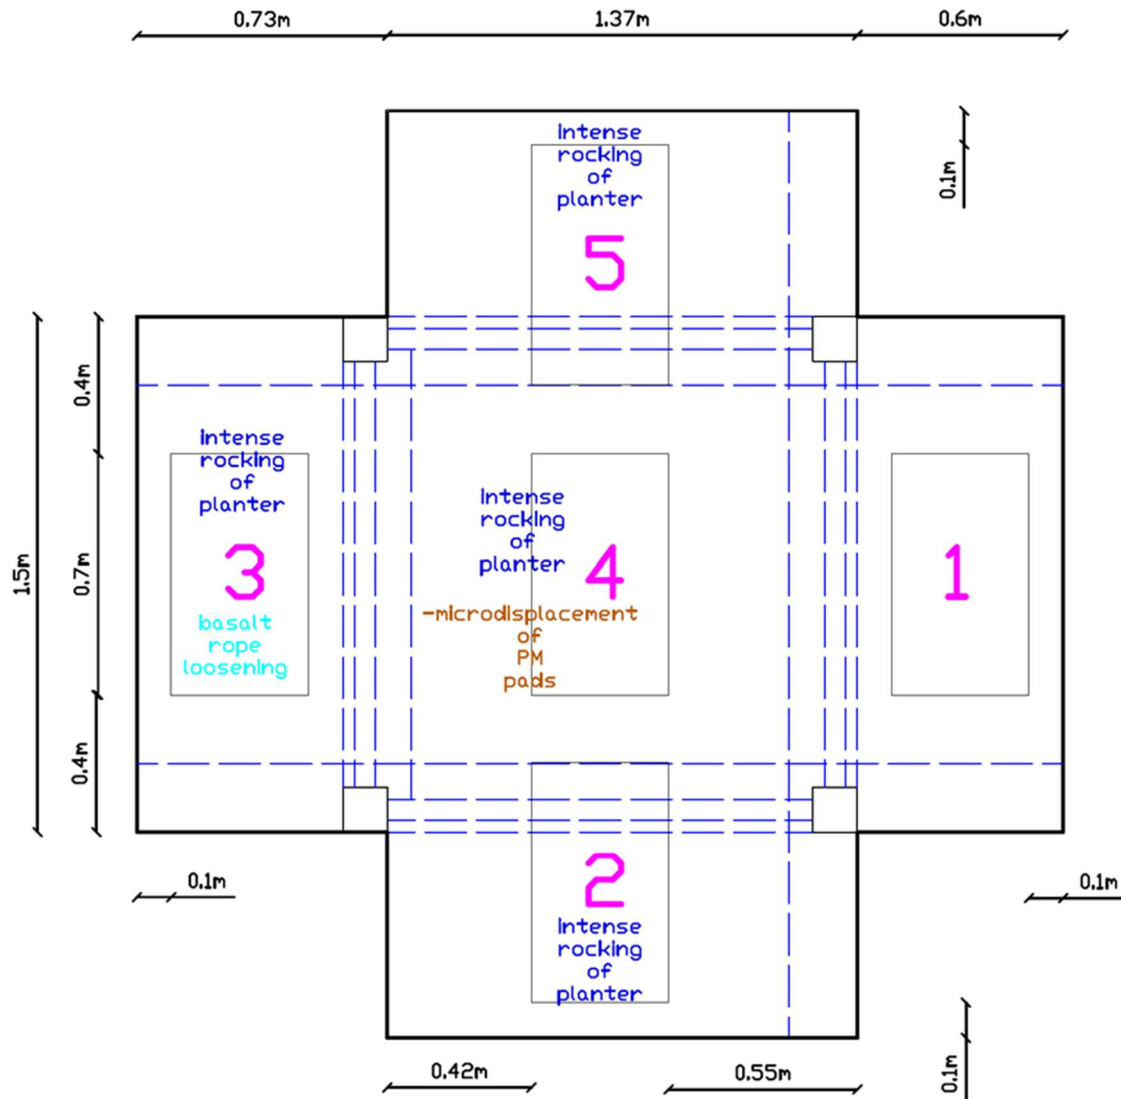
**EQ0.8g**

Figure 3.3.8 Observed damage after EQ0.80g test: Intense rocking of planter 4 leading to micro displacement of the PM pads and of the planter itself. Planter 3 basalt rope was loosening. Intense rocking of planter 2, 3 and 5.

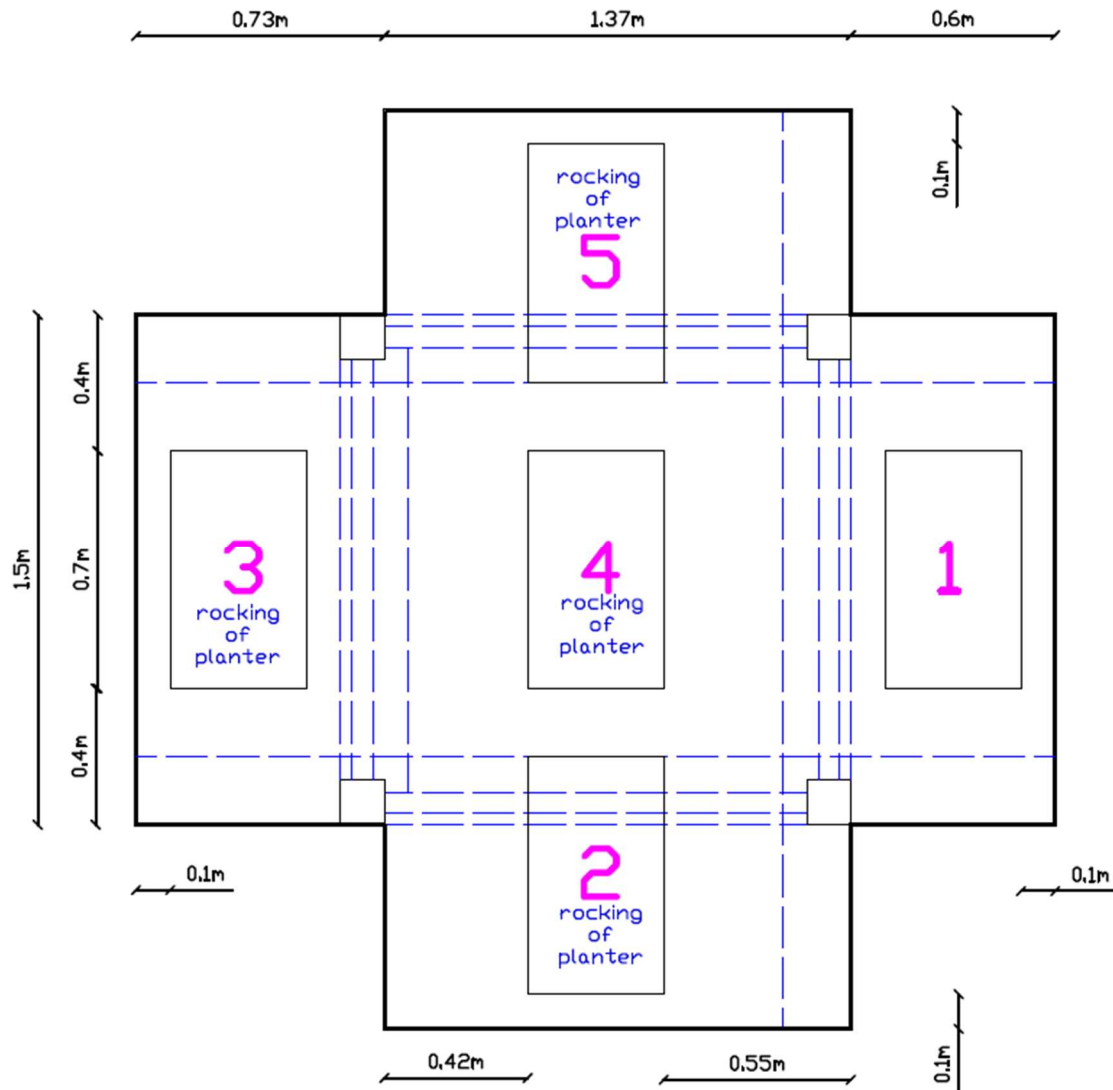
Figure 3.3.9 Observed damage after Wnb1.1g, Wnb1.3g, Wnb1.4 test: Rocking of planter 5, 4, 3, 2.

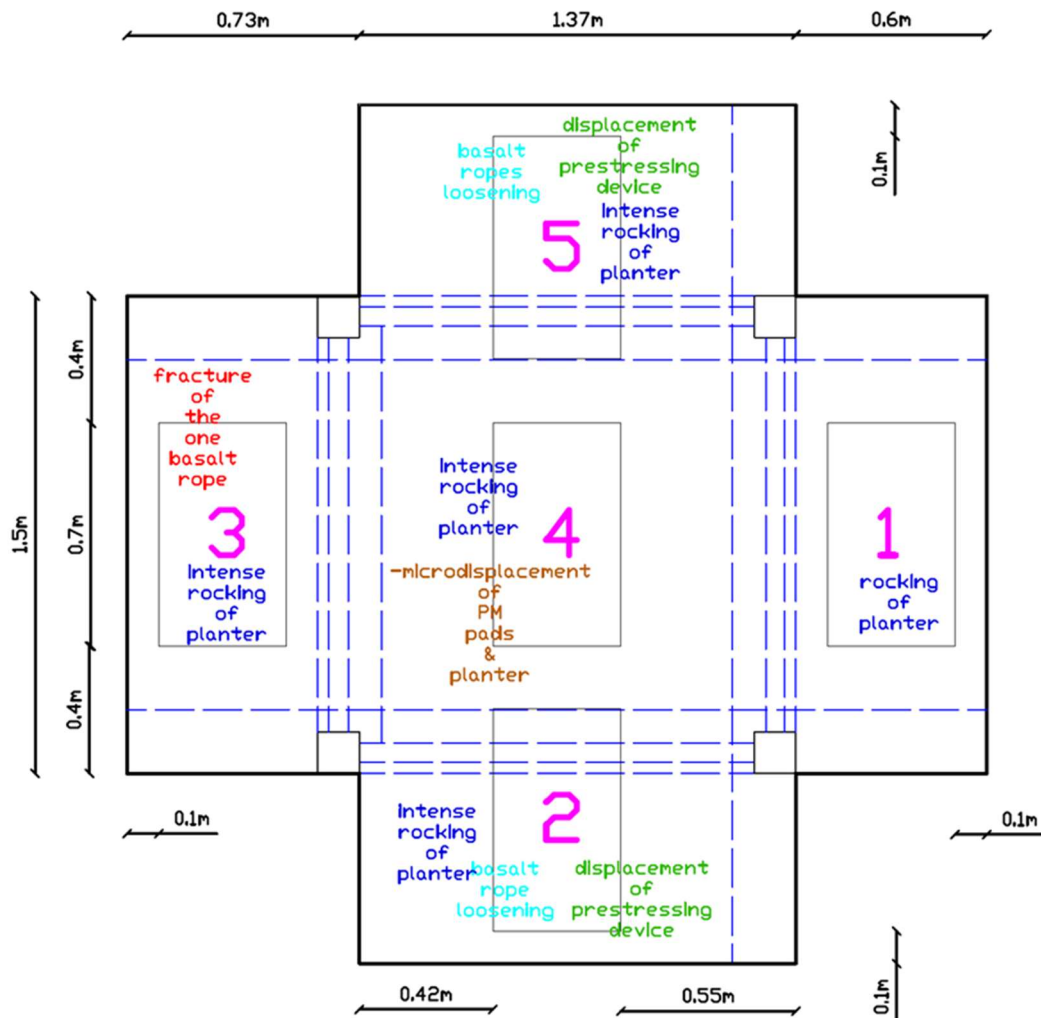
**EQ1.1g**

Figure 3.3.10 Observed damage after EQ1.1g test: intense rocking of planter 4 leading to micro displacement of the PM pads and of the planter itself. Fracture of the one basalt rope of planter 3. Displacement of prestressing devices of planter 2 and 5 and loosening of basalt ropes. Intense rocking of planter 2, 3, 5 and rocking of planter 1.

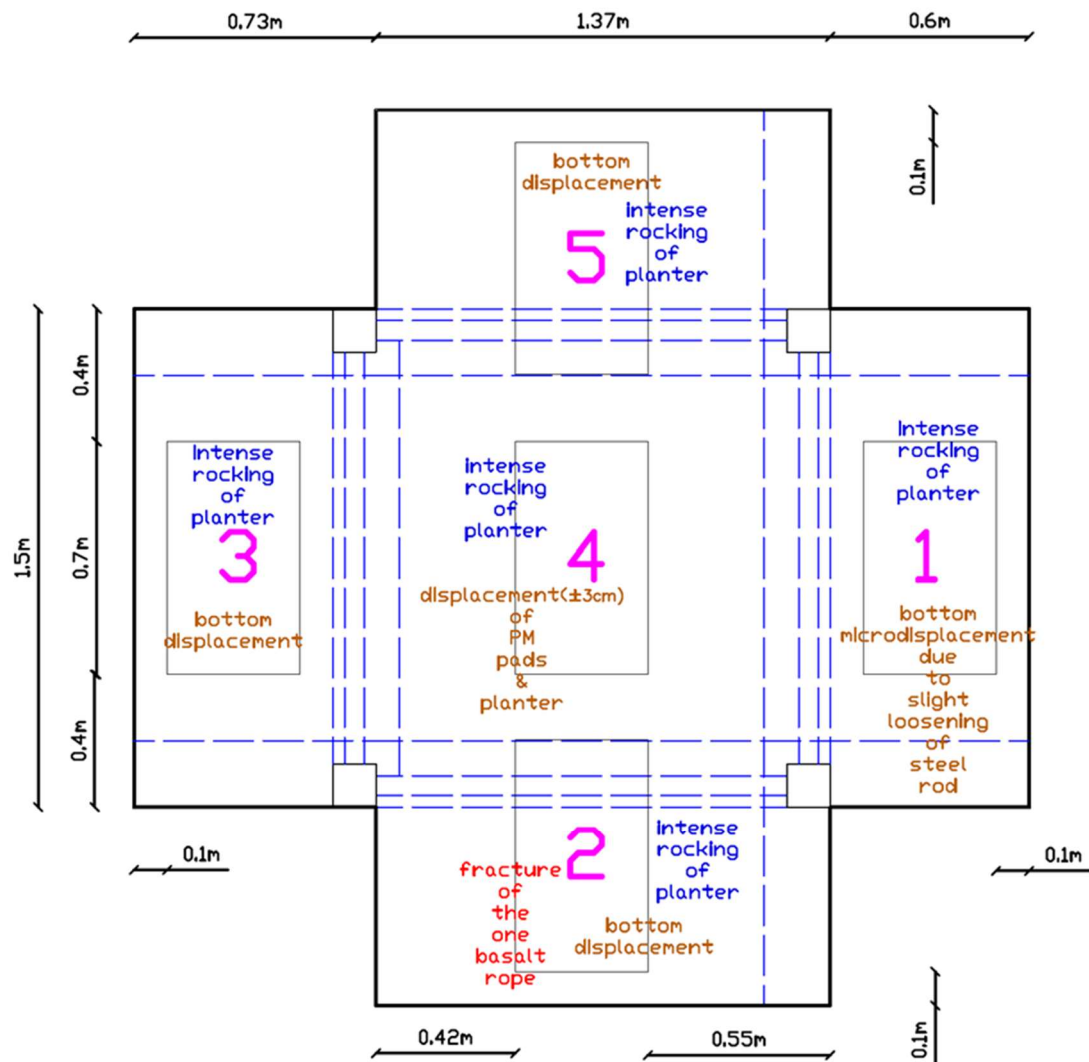
Figure 3.3.11 Observed damage after EQ1.3g test: Intense rocking of planter 4 leading to displacement ( $\pm 3$  cm) of the PM pads and of the planter itself. Planter 1 showed bottom microdisplacements because of slight loosening of the steel rod. Fracture of the one basalt rope of planter 2. Planters 2,3 and 5 showed bottom displacements. Intense rocking of all planters.

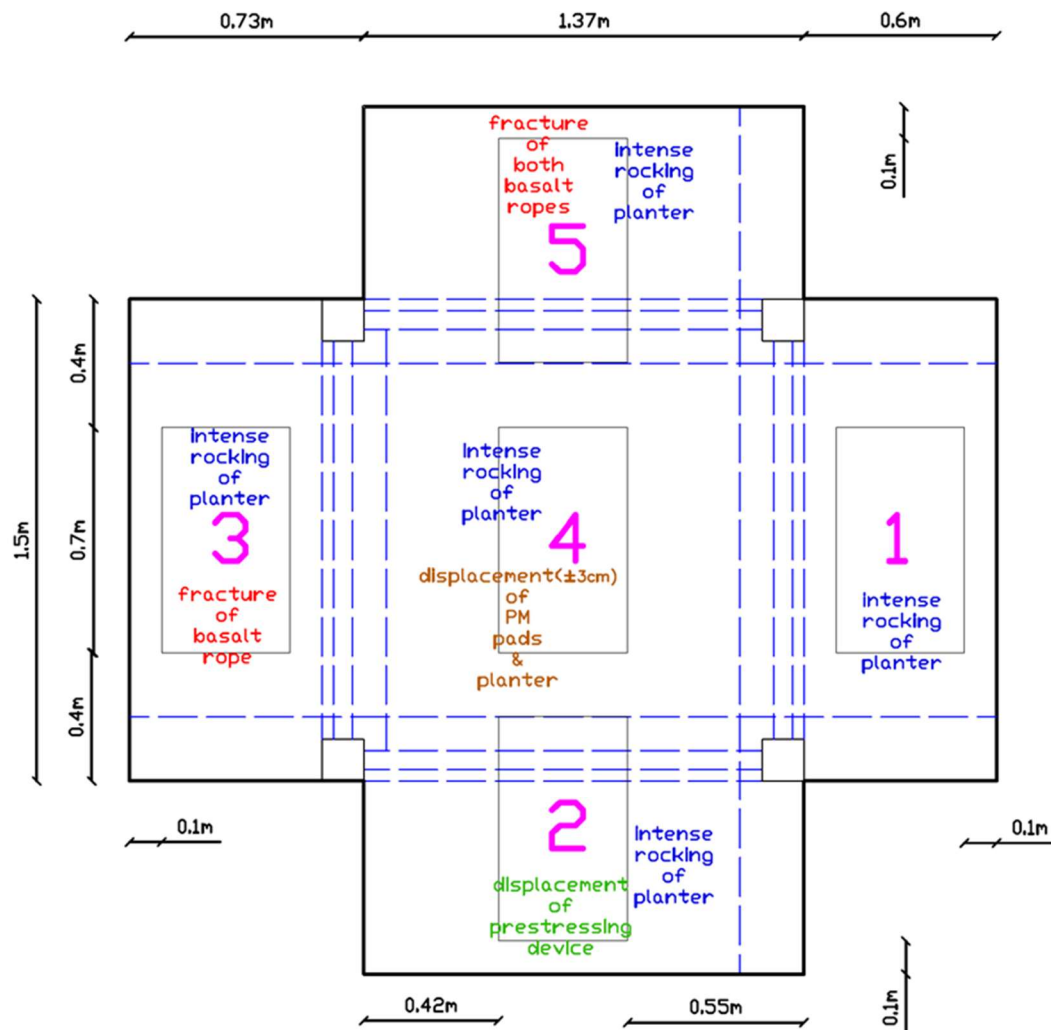
Figure 3.3.13 Observed damage after EQ1.3g(2) test: Intense rocking of planter 4 leading to displacement ( $\pm 3\text{ cm}$ ) of the PM pads and of the planter itself. Fracture of basalt rope of planter 3. Fracture of both basalt ropes of planter 5. Displacement of prestressing device of planter 2. Intense rocking of all planters.

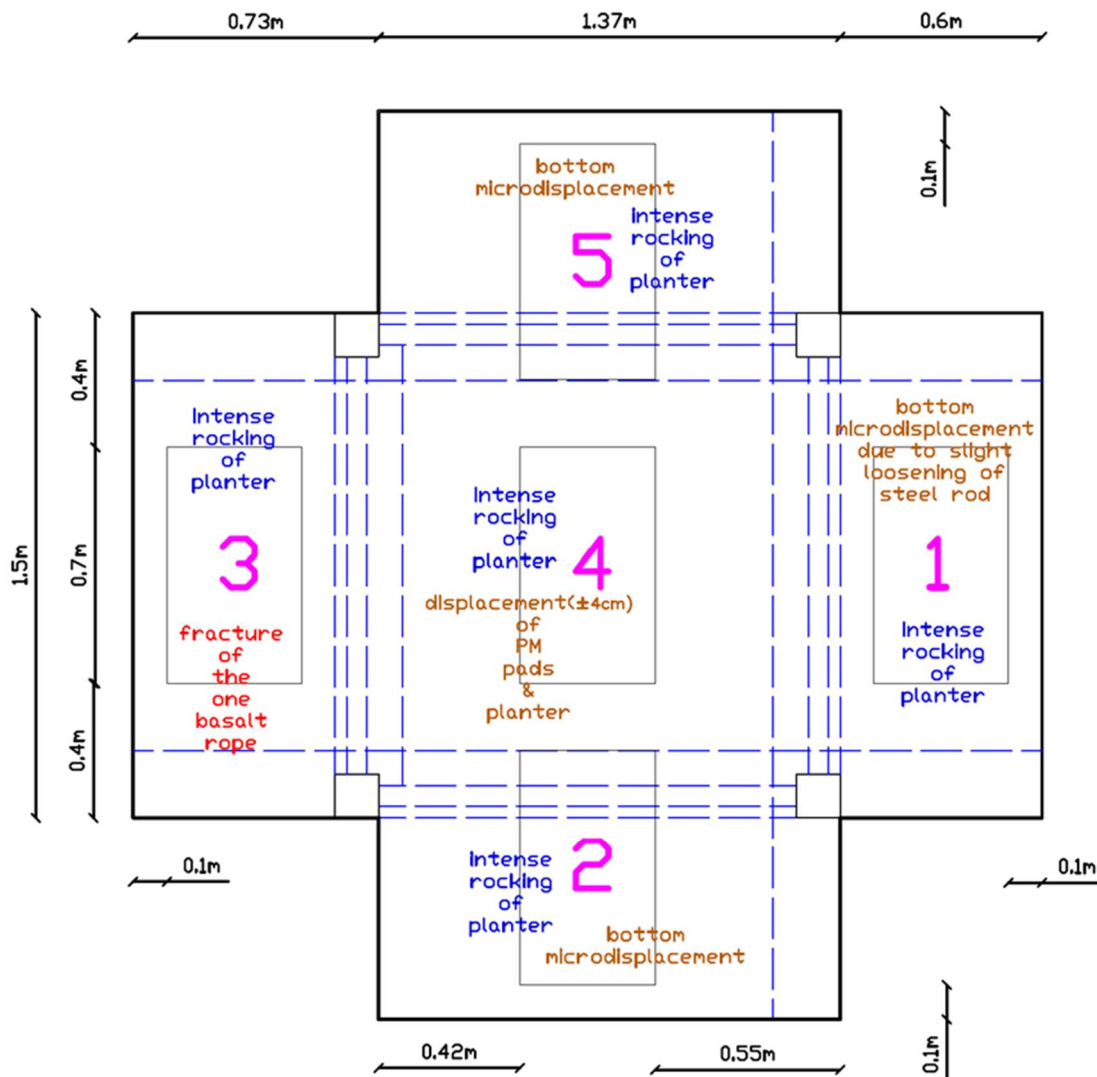
EQ1.4g

Figure 3.3.14 Observed damage after EQ1.3g(2) test : Intense rocking of planter 4 leading to displacement ( $\pm 4$  cm) of the PM pads and of the planter itself. Planter 1 showed bottom micro displacements because of slight loosening of the steel rod. Fracture of the one basalt rope of planter 3. Planter 5 and 2 showed bottom micro displacements. Intense rocking of all planters.

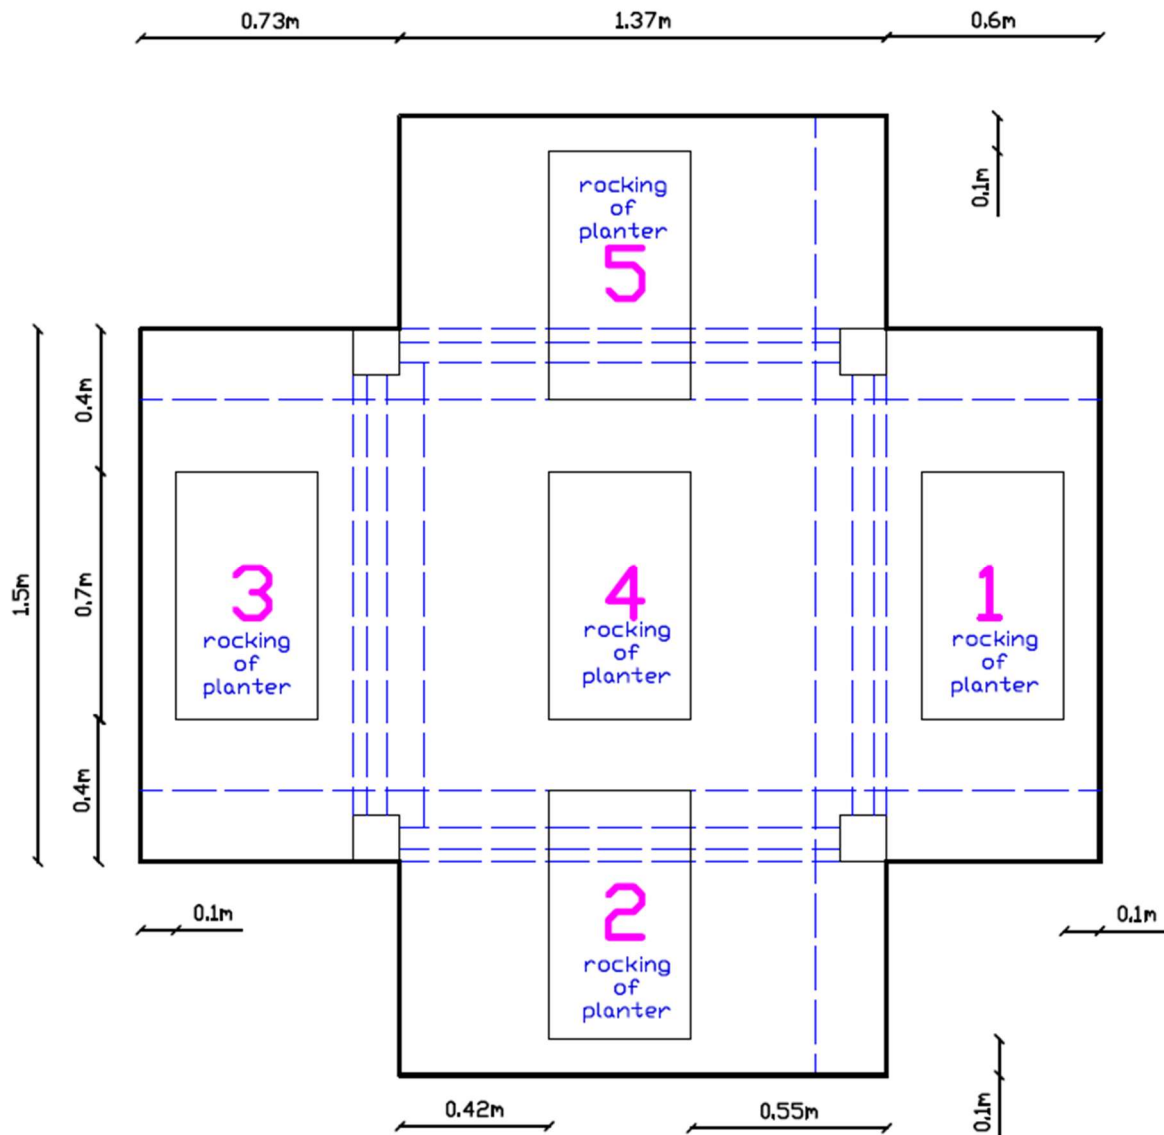
Figure 3.3.15 Observed damage after Wnb0.2g, EQ0.2g, Wna0.2g tests: Rocking of all planters.

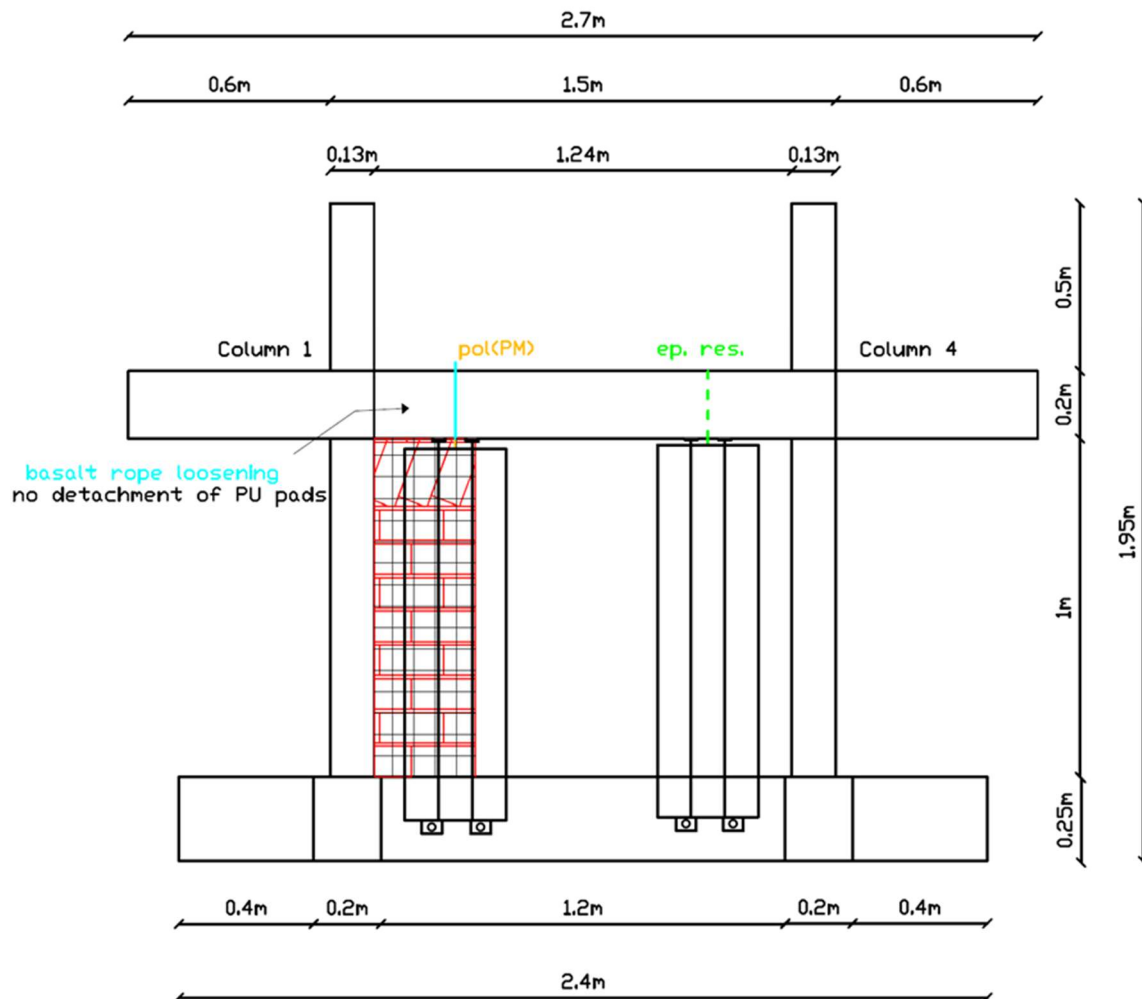
Figure 3.3.16 Observed damage after 1.1g test: Left living wall LW1-4L, showed basalt rope loosening without detachment of PU pads allowing micromovements for high direct horizontal loads (severe wind) but no living wall collapse was observed.

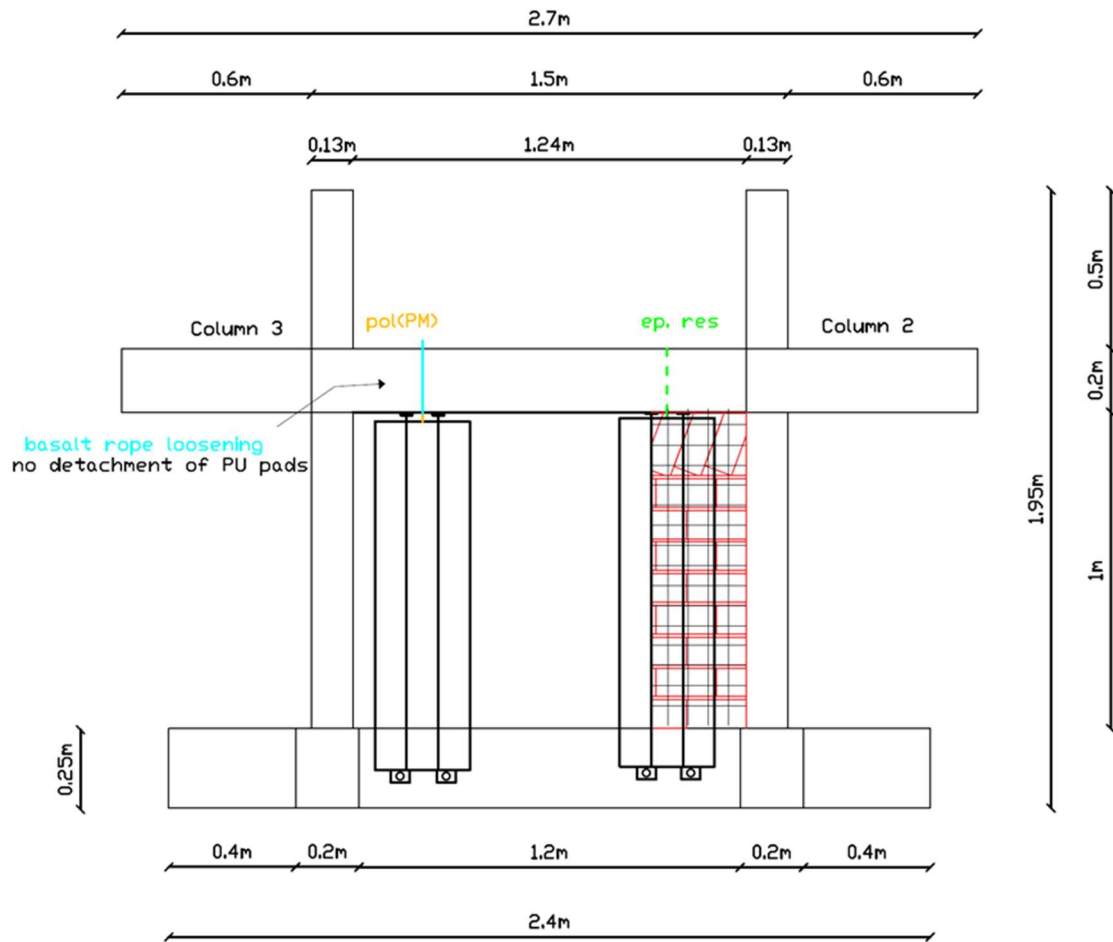
Figure 3.3.17 Observed damage after 1.1g test: Left vertical living wall LW3-2L showed basalt rope loosening without detachment of PU pads allowing micromovements for high direct horizontal loads (severe wind) but no living wall collapse was observed.

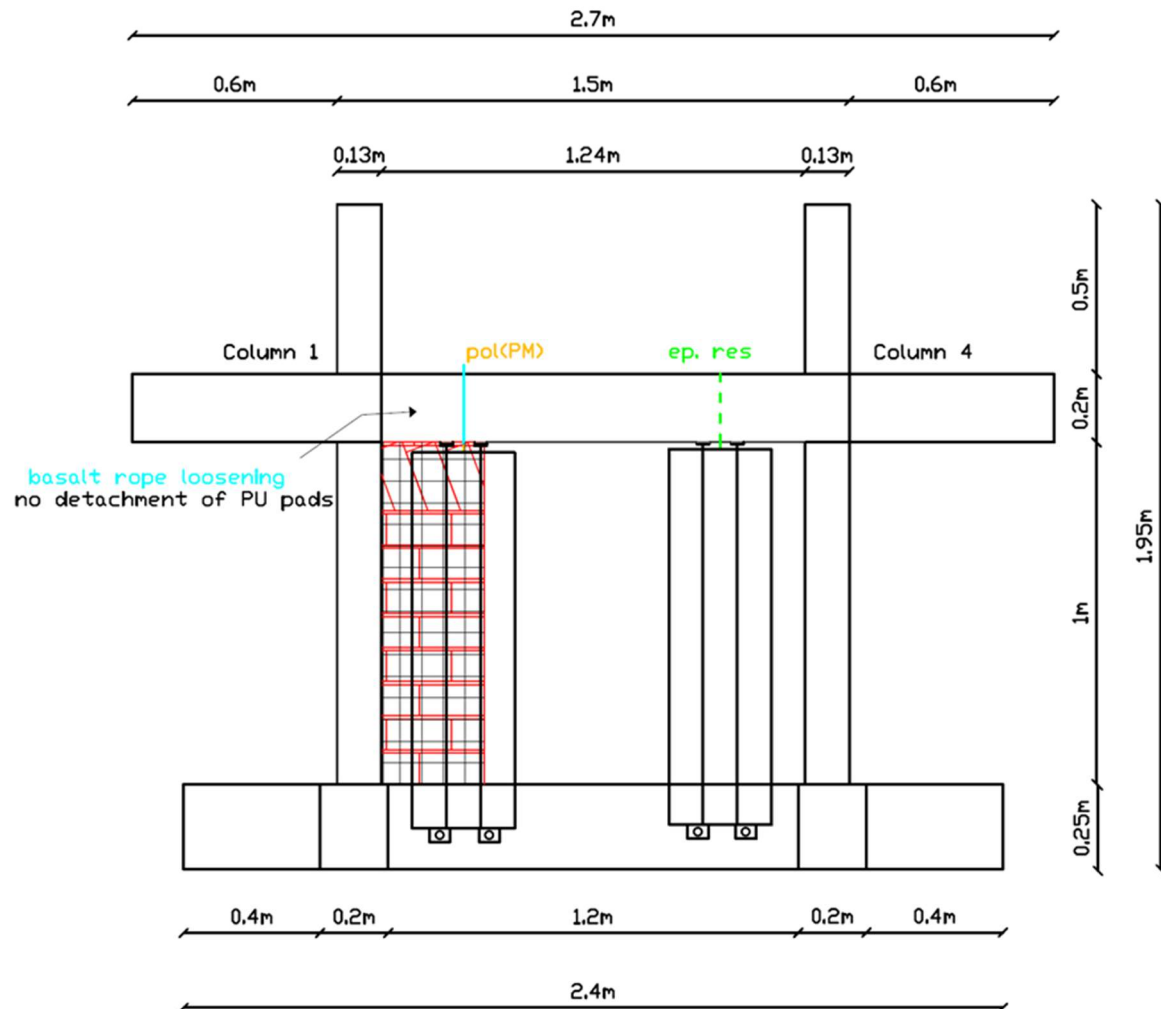
Figure 3.3.18 Observed damage after 1.3g test: Left living wall LW1-4L, showed basalt rope loosening without detachment of PU pads allowing micromovements for low direct horizontal loads (frequent wind) but no living wall collapse was observed.

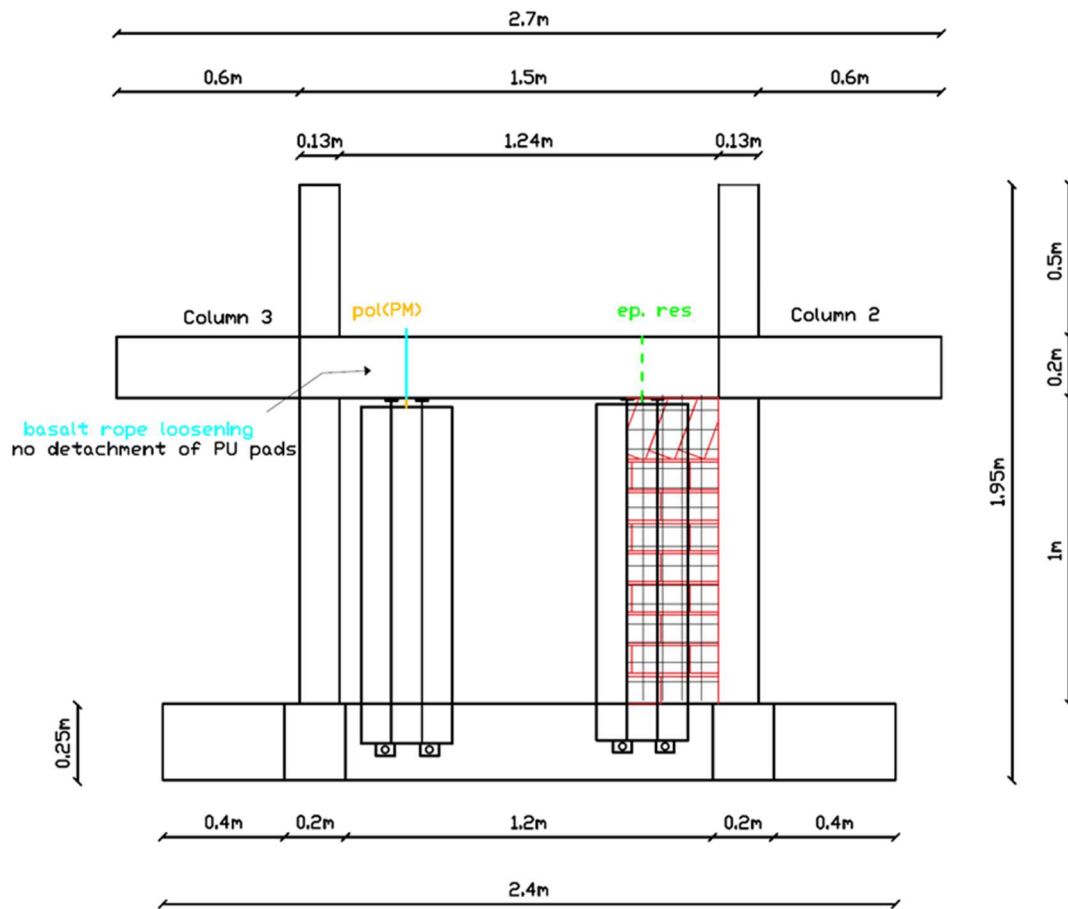
Figure 3.3.19 Observed damage after 1.3g test: Left vertical living wall LW3-2L showed basalt rope loosening without detachment of PU pads allowing micromovements for low direct horizontal loads (frequent wind) but no living wall collapse was observed.

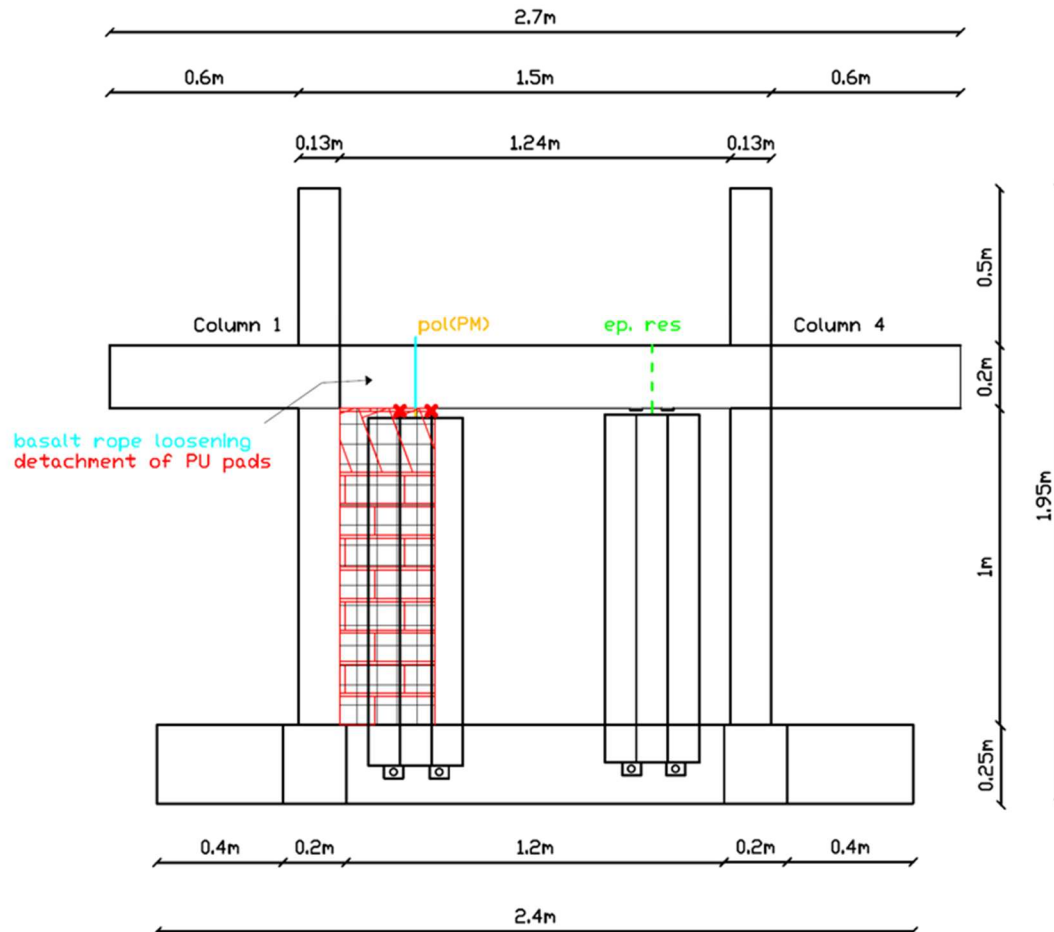
Figure 3.3.20 Observed damage after 1.3g(2) test: Left living wall LW1-4L, showed basalt rope loosening leading to detachment of PU pads allowing micromovements for low direct horizontal loads (frequent wind) but no living wall collapse was observed.

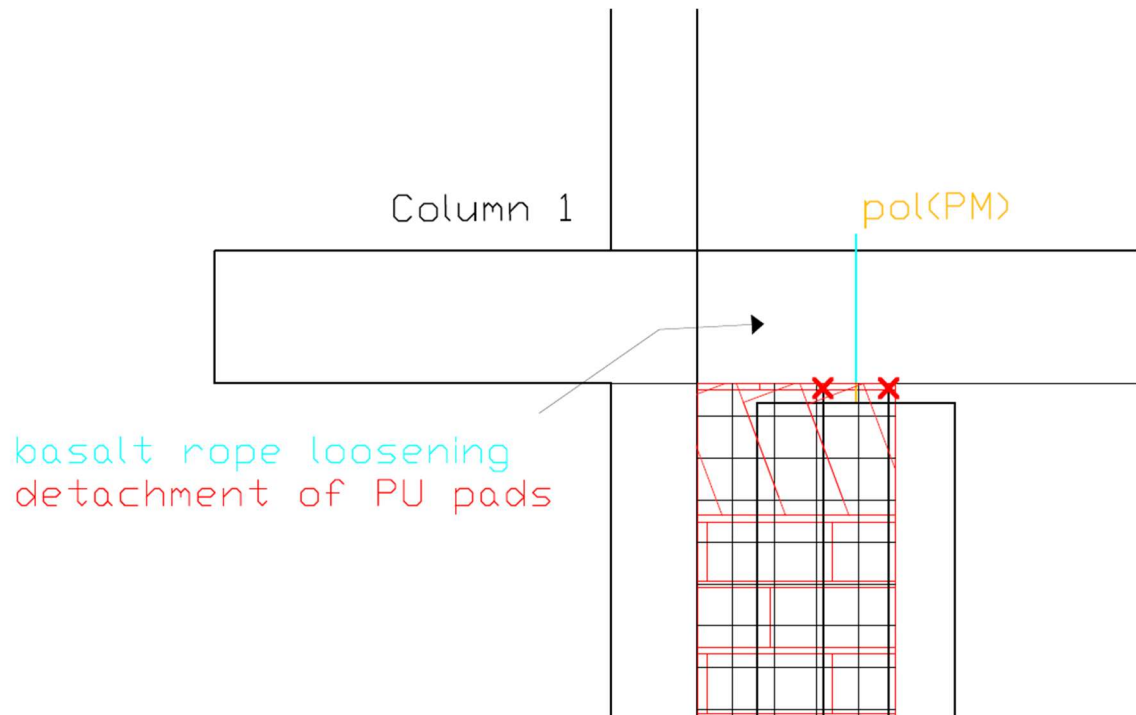
Figure 3.3.21 Anchoring details and PU pads dimensions (under the top slab), left living wall LW1-4L: detachment of PU pads after EQ1.3g (2)

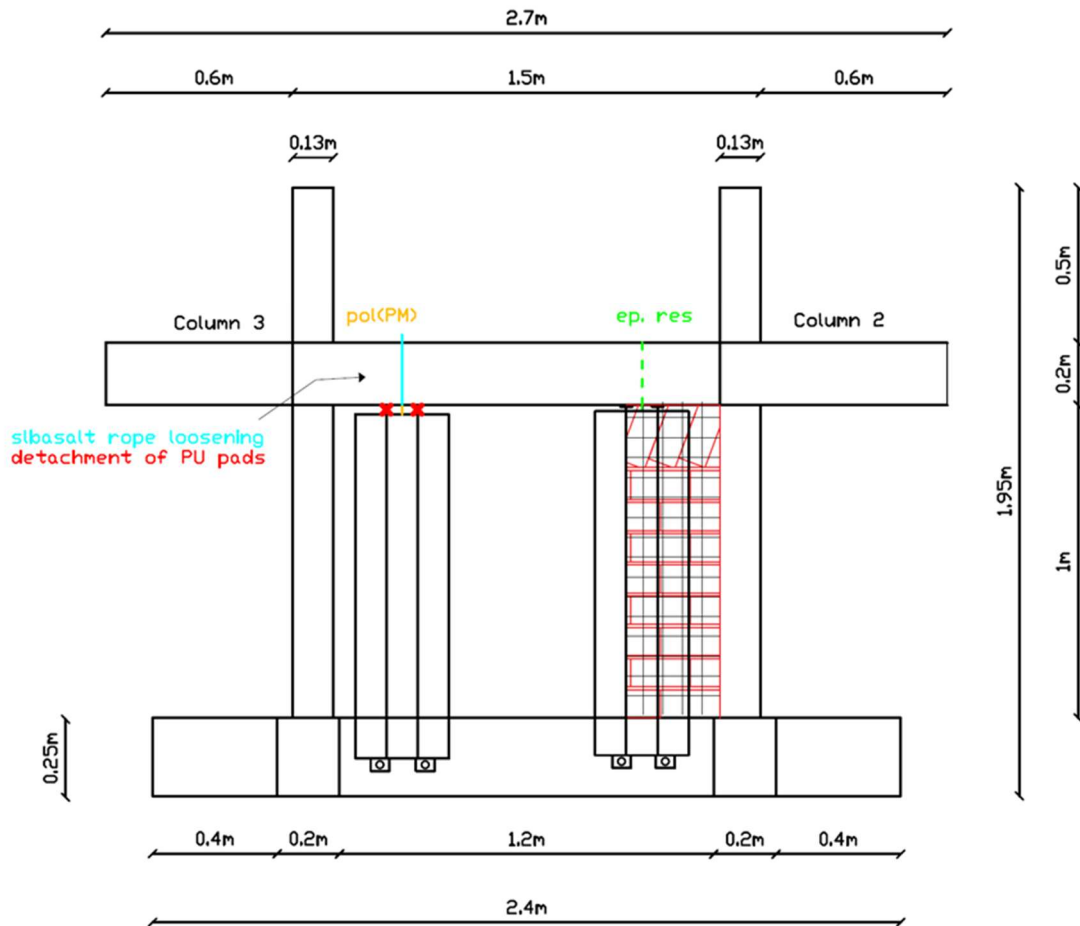
Figure 3.3.22 Observed damage after 1.3g(2) test: Left vertical living wall LW3-2L showed basalt rope loosening leading to detachment of PU pads allowing micromovements for low direct horizontal
