Resilient Vertical Forest Renovation of Reinforced Concrete  
Structures in Seismic Prone Areas  
(H.F.R.I. Project Number 015376)

Assessment of the performance of tested renovated  
3d VF structure.

Deliverable D2.6 Work package 2

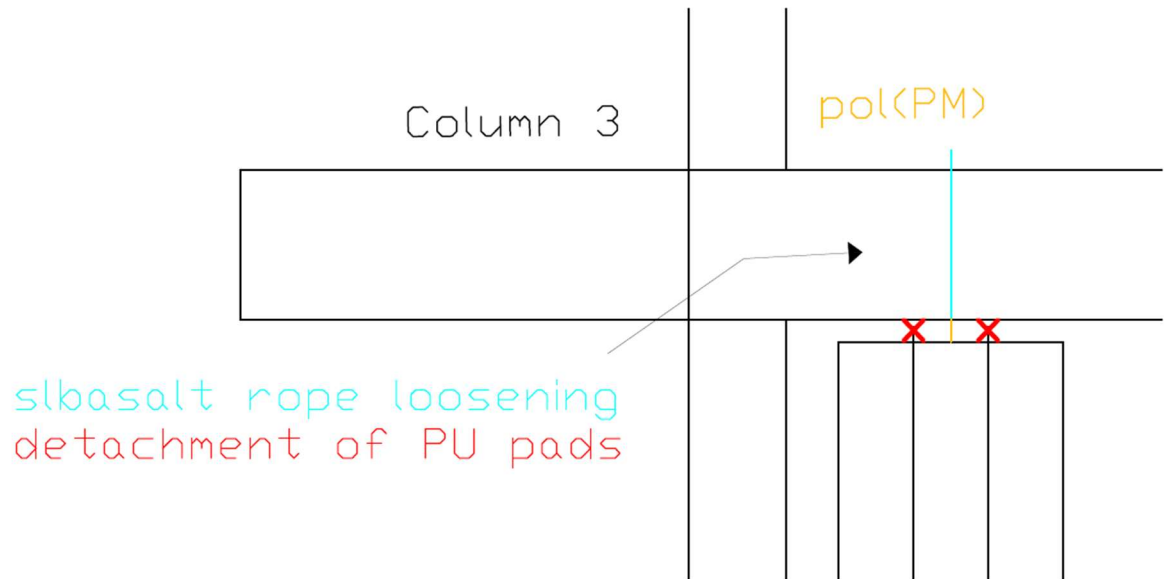
Figure 3.3.23 Anchoring details and PU pads dimensions (under the top slab), left living wall LW3-2L: detachment of PU pads after EQ1.3g (2)

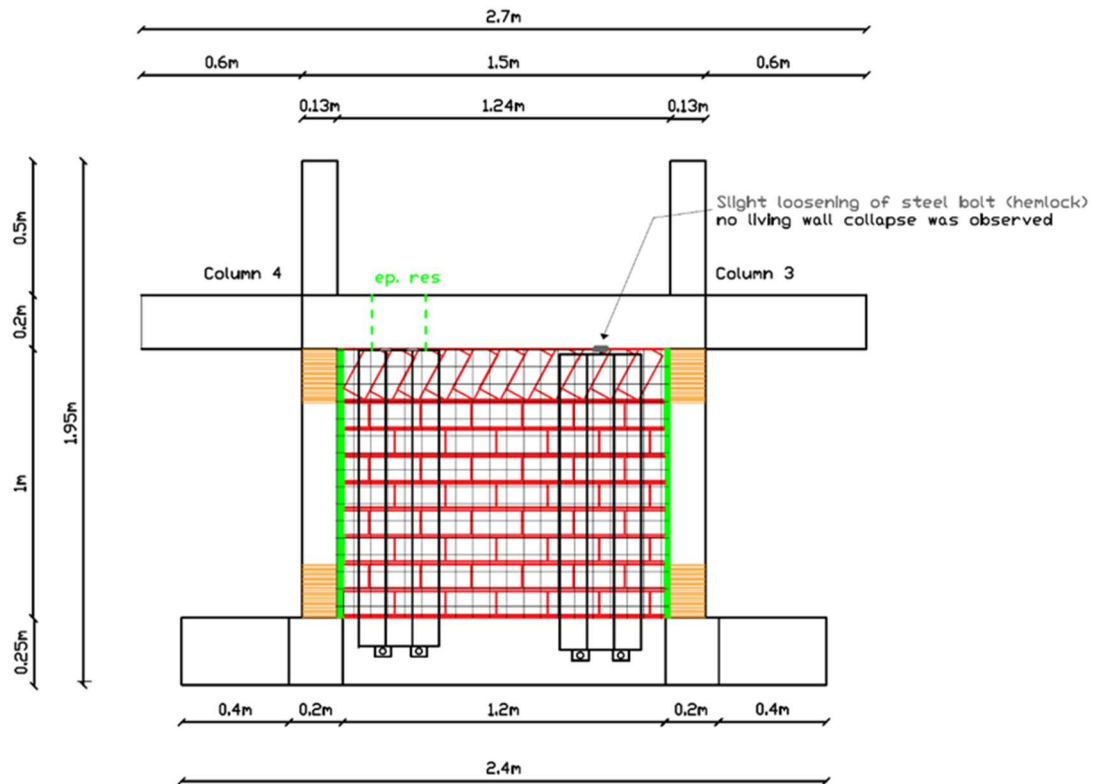
Figure 3.3.24 Observed damage after 1.3g(2) test: Steel rod (hemlock) slight loosening at the top of living wall LW3-4R allowing micromovements for low direct horizontal loads (frequent wind) but no living wall collapse was observed.

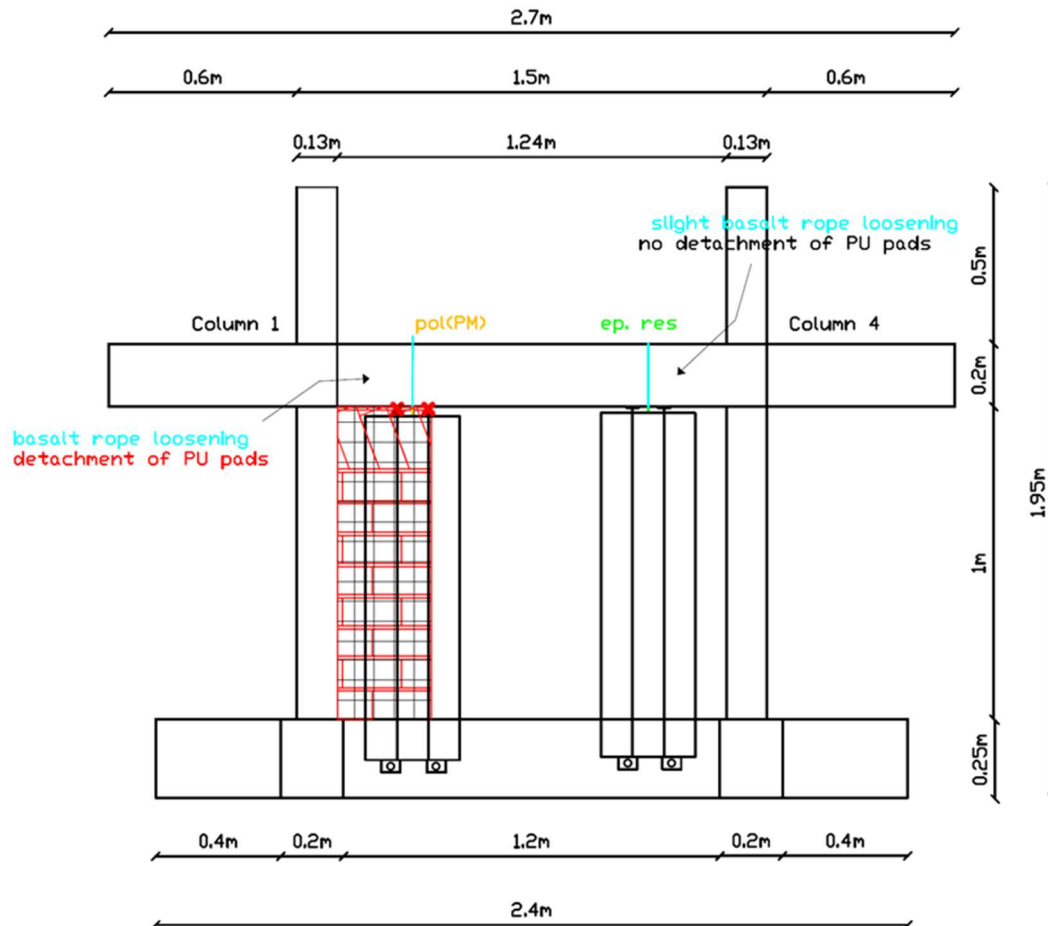
Figure 3.3.25 Observed damage after 1.4g test: Left living wall LW1-4L, showed basalt rope loosening leading to detachment of PU pads allowing micromovements for low direct horizontal loads (frequent wind) but no living wall collapse was observed. LW1-4R showed slight basalt rope loosening allowing

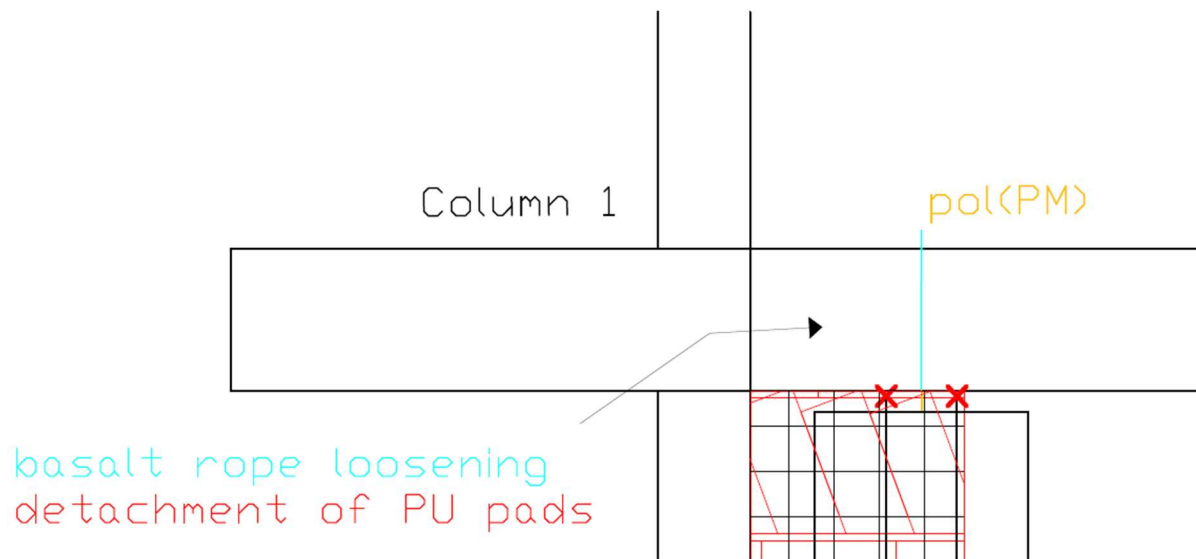
Figure 3.3.26 Anchoring details and PU pads dimensions (under the top slab), left living wall LW1-4L: detachment of PU pads after EQ1.4g

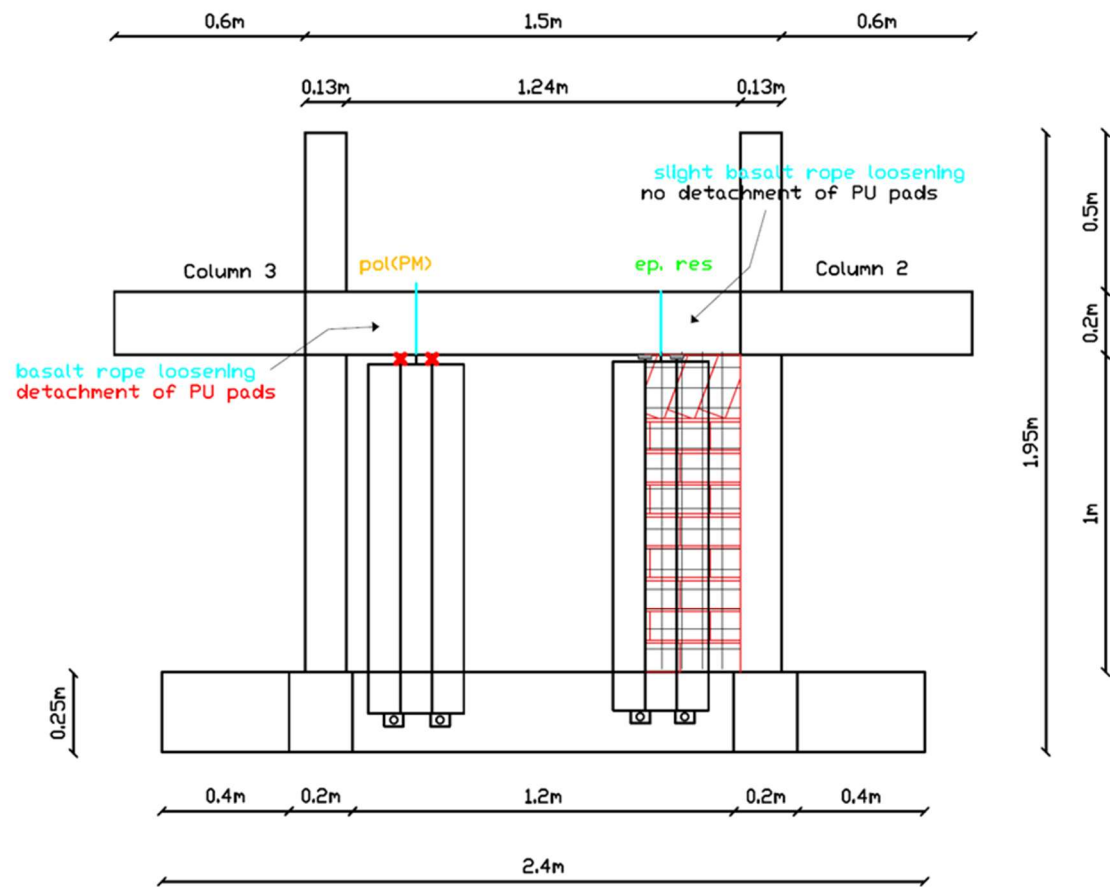
Figure 3.3.27 Observed damage after 1.4g test: Living walls LW2-3R showed slight basalt rope loosening allowing micromovements for high direct horizontal loads (severe wind), but no living wall collapse was observed. Left vertical living wall LW2-3L showed basalt rope loosening leading to detachment of PU pads allowing micromovements for low direct horizontal loads (frequent wind) but no living wall collapse was observed.

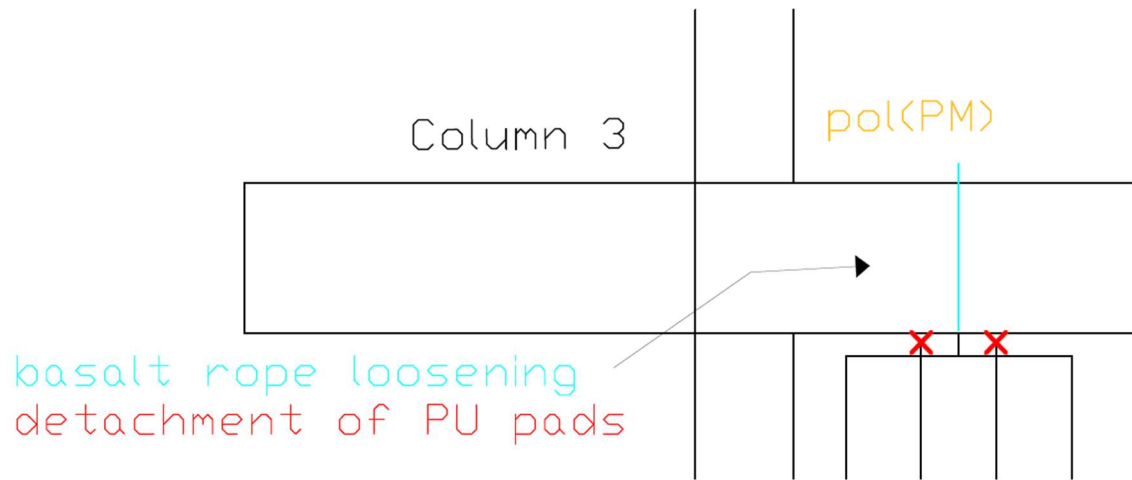
Figure 3.3.28 Anchoring details and PU pads dimensions (under the top slab), left living wall LW3-2L: detachment of PU pads after EQ1.4g

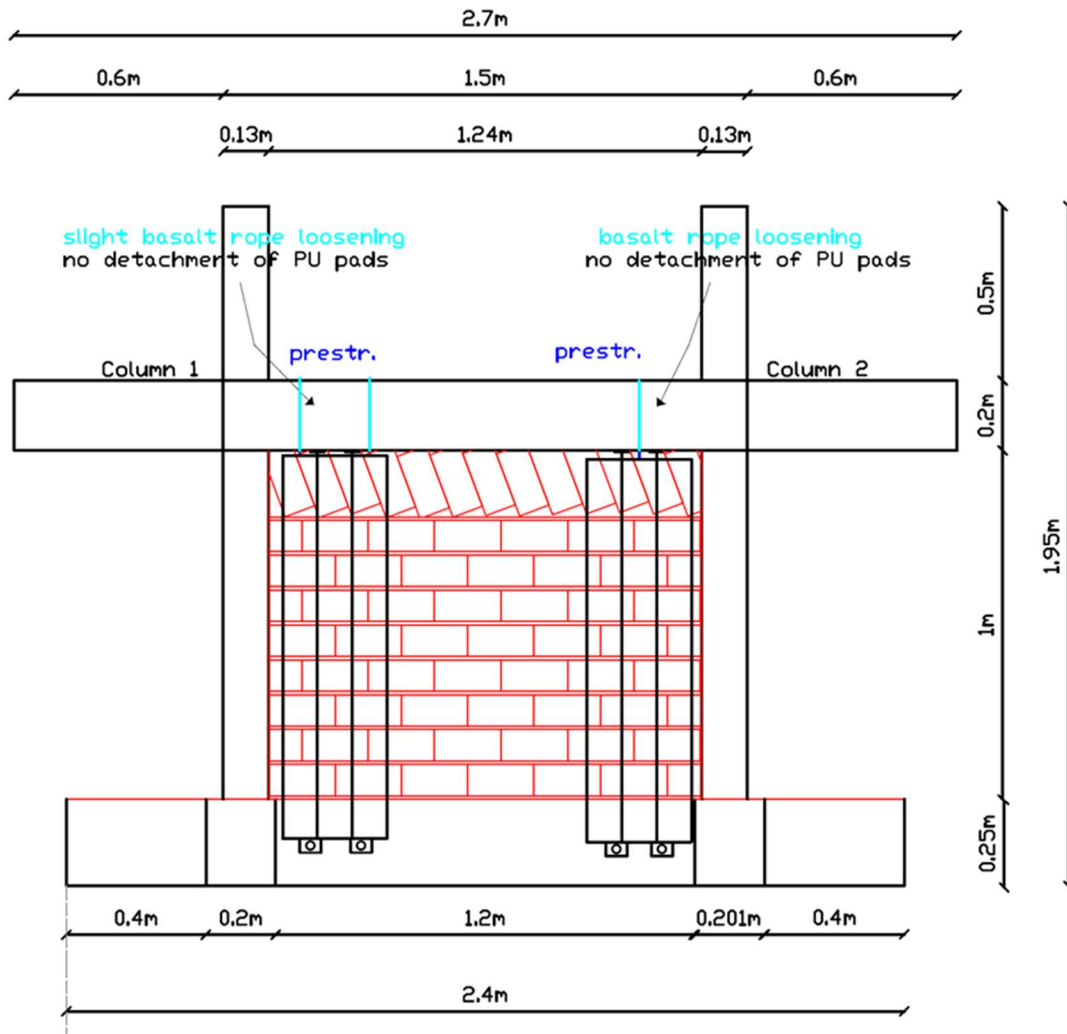
Figure 3.3.29 Observed damage after 1.4g test: Living walls LW1-2L showed slight basalt rope loosening allowing micromovements for high direct horizontal loads (severe wind), but no living wall collapse was observed. Living wall LW1-2R showed basalt rope loosening allowing micromovements for medium direct horizontal loads (intense wind), but no living wall collapse was observed.

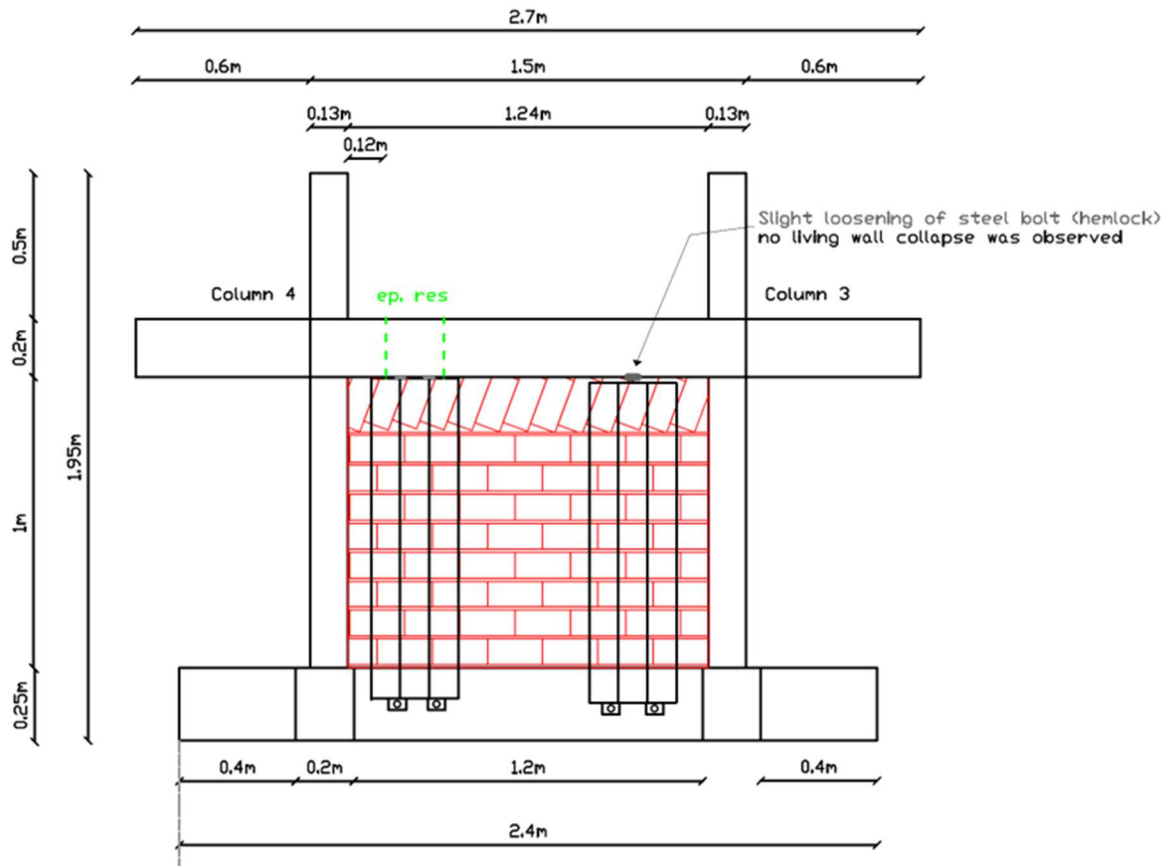
*Figure 3.3.30 Observed damage after 1.4g test: Steel rod (hemlock) slight loosening at the top of living wall LW4-3R allowing micromovements for low direct horizontal loads (frequent wind) but no living wall collapse was observed.*

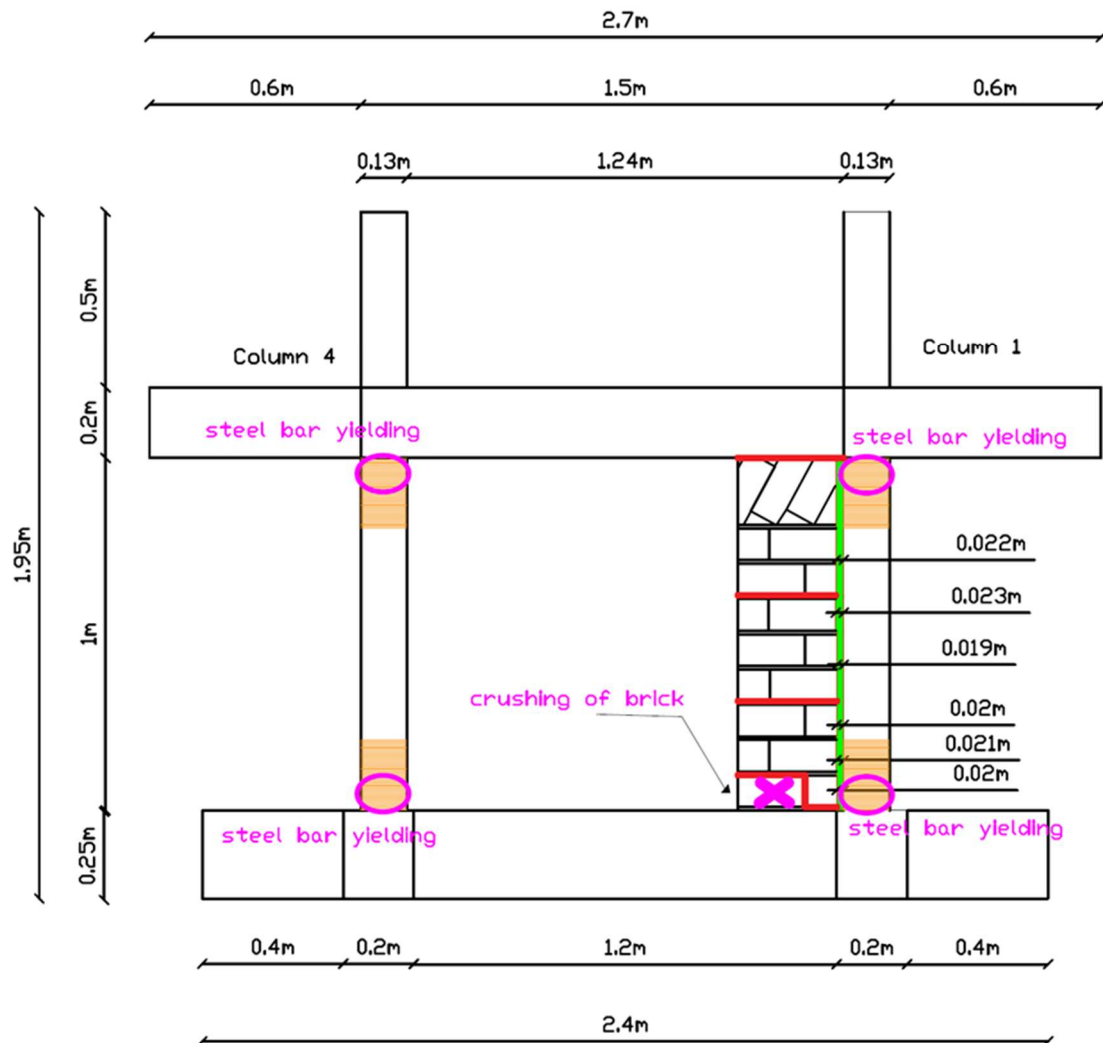
Figure 3.3.32 Observed damage after EQ1.3g(2) test: Damage with crushing of bottom brick at partial infill wall occurred. The columns entered yielding strain of their longitudinal steel reinforcements at the bottom and at the top critical regions (columns 1, 4).

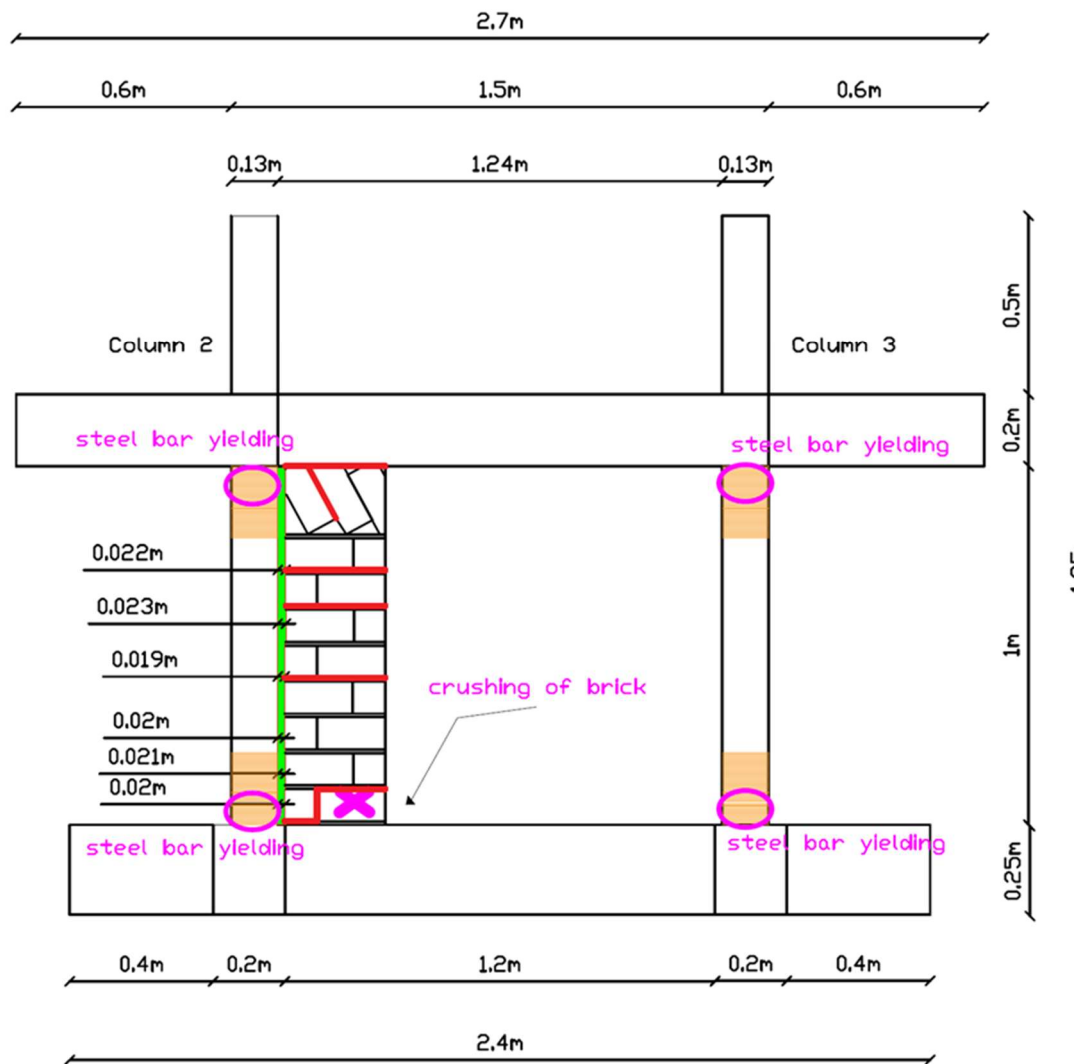
Figure 3.3.33 Observed damage after EQ1.3g(2) test: Damage with crushing of bottom brick at partial infill wall occurred. The columns entered yielding strain of their longitudinal steel reinforcements at the bottom and at the top critical regions (columns 2, 3).

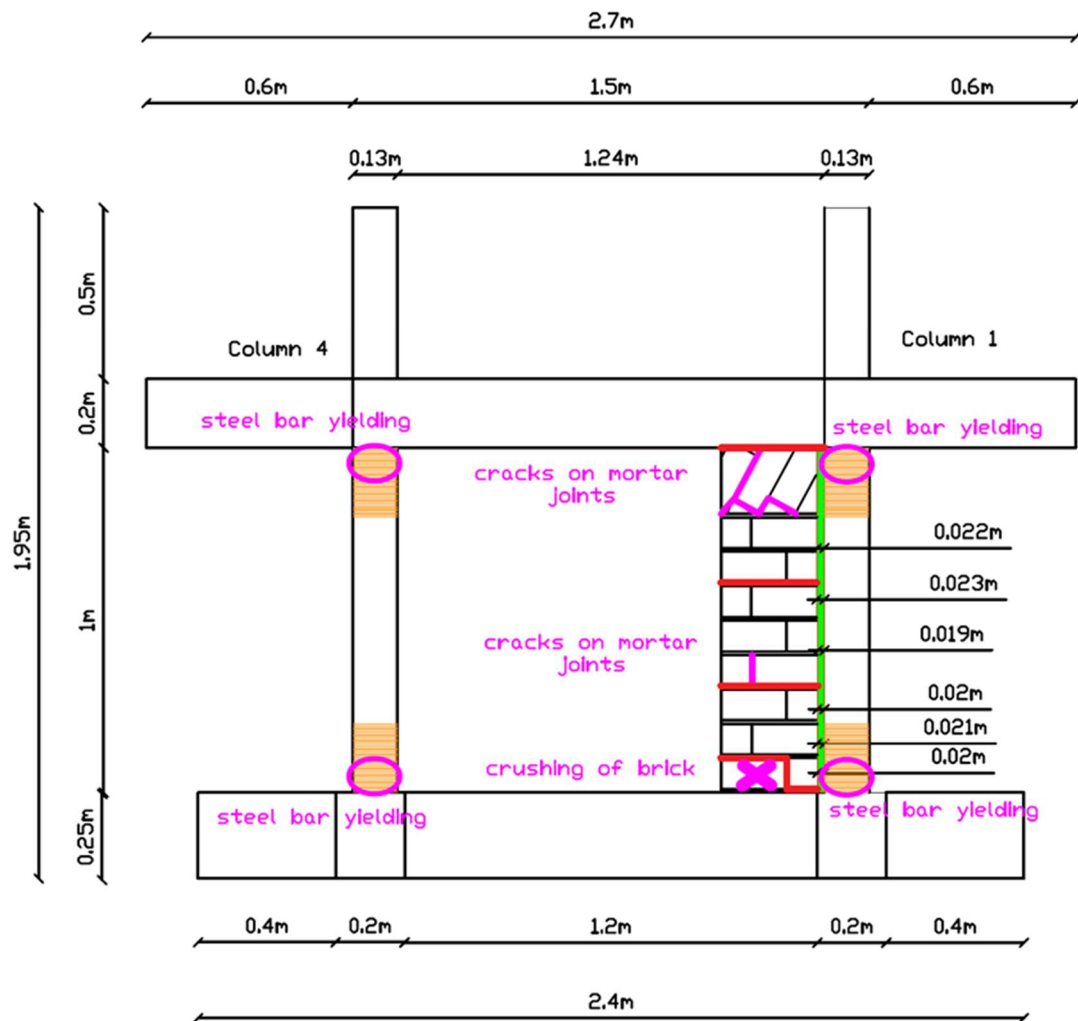
Figure 3.3.34 Observed damage after EQ1.4g test: Damage with crushing of bottom brick at both partial infill walls occurred at very high displacement drift levels (2,62%). Local fracture of the FRPU jacket at the boundary between the crushed brick and the bottom foundation beam. Additional cracks at some mortar joints between bricks of the partial infill walls at their internal face (side with no FRPU jacket). The columns entered yielding strain of their longitudinal steel reinforcements at the bottom and at the top critical regions (columns 1, 2, 3, 4).

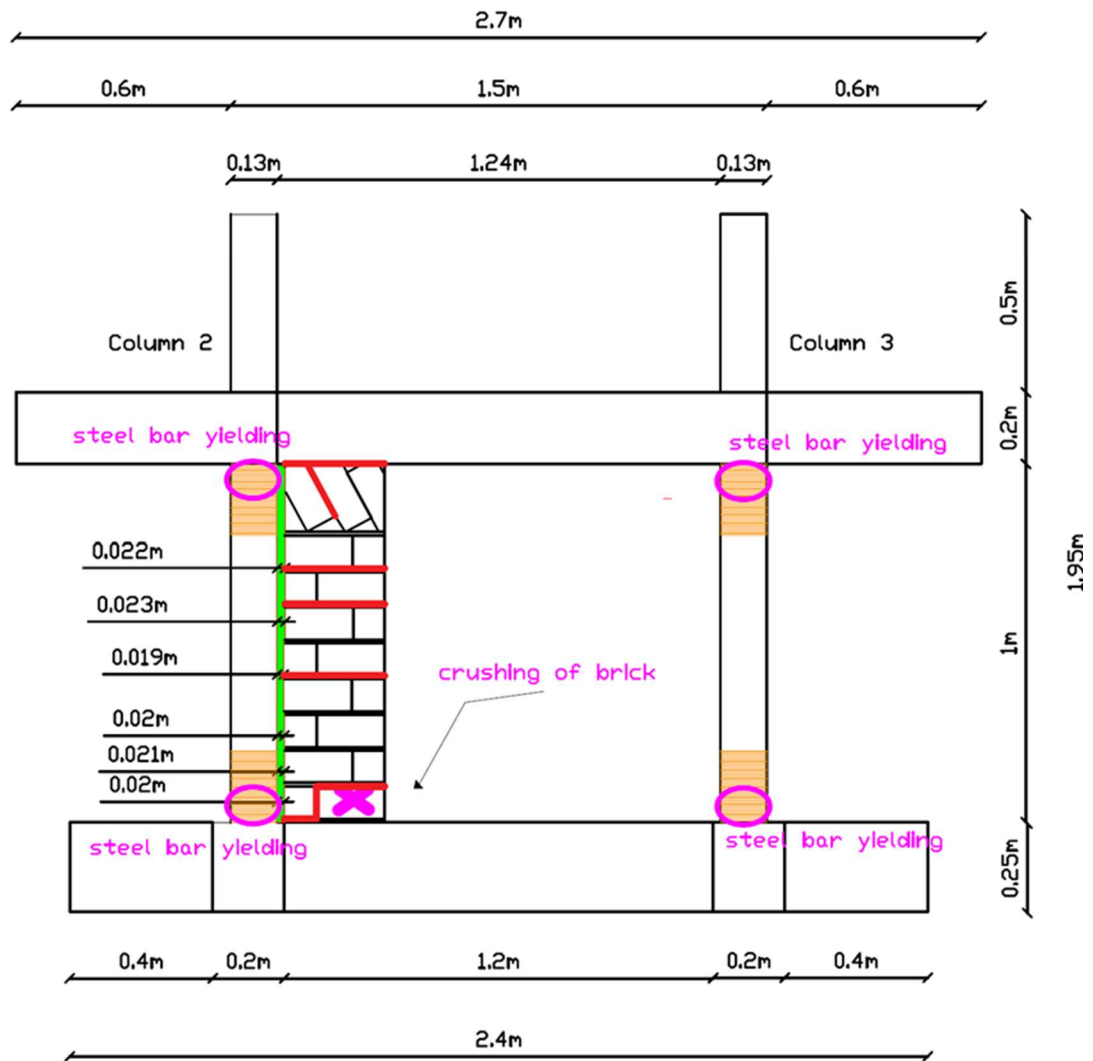
Figure 3.3.35 Observed damage after EQ1.4g test: Observed damage after 1.4g test: Damage with crushing of bottom brick at both partial infill walls occurred at very high displacement drift levels (2,62%). Local fracture of the FRPU jacket at the boundary between the crushed brick and the bottom foundation beam. Additional cracks at some mortar joints between bricks of the partial infill walls at their internal face (side with no FRPU jacket). The columns entered yielding strain of their longitudinal steel reinforcements at the bottom and at the top critical regions (columns 1, 2, 3, 4).

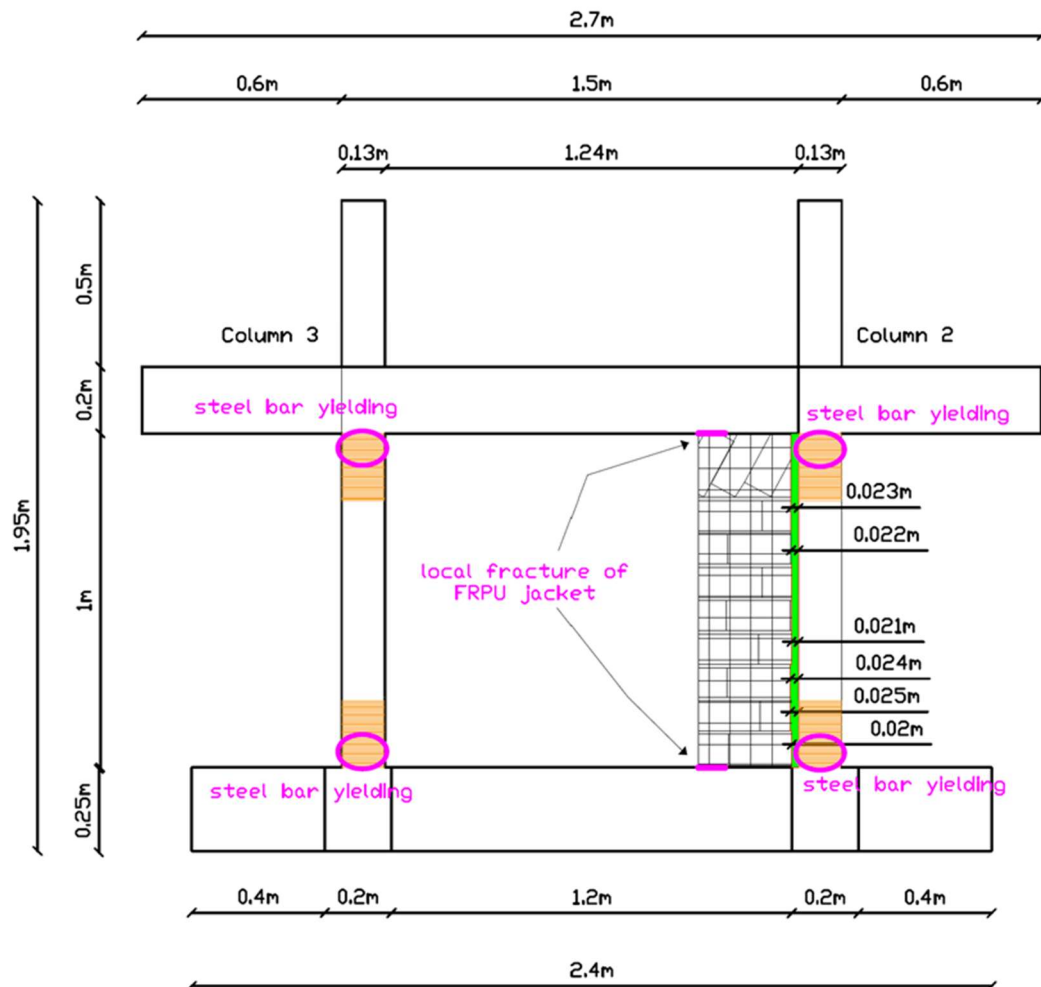
Figure 3.3.36 Observed damage after EQ1.4g test: Observed damage after 1.4g test: Damage with crushing of bottom brick at both partial infill walls occurred at very high displacement drift levels (2,62%). Local fracture of the FRPU jacket at the boundary between the crushed brick and the bottom foundation beam. Additional cracks at some mortar joints between bricks of the partial infill walls at their internal face (side with no FRPU jacket). The columns entered yielding strain of their longitudinal steel reinforcements at the bottom and at the top critical regions (columns 1, 2, 3, 4).

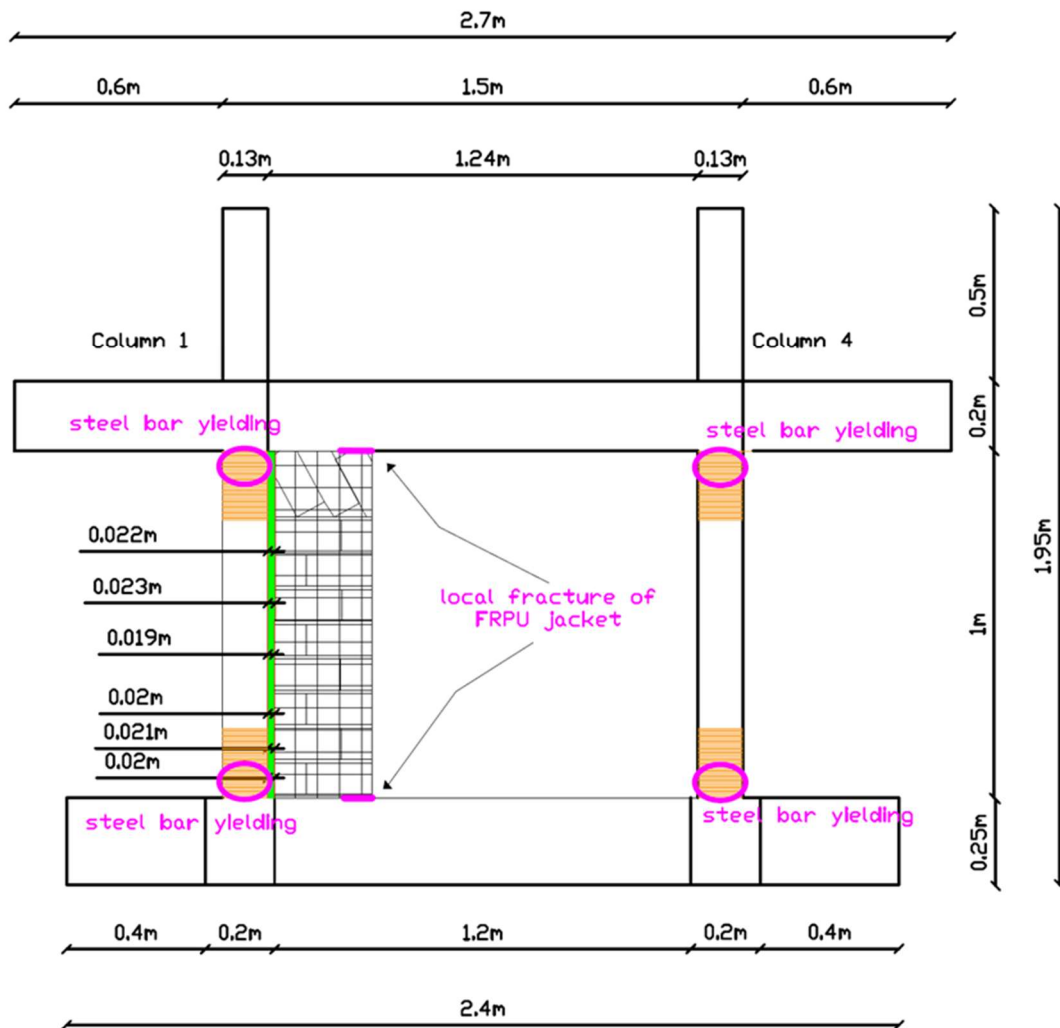
Figure 3.3.37 Observed damage after EQ1.4g test: Observed damage after 1.4g test: Damage with crushing of bottom brick at both partial infill walls occurred at very high displacement drift levels (2,62%). Local fracture of the FRPU jacket at the boundary between the crushed brick and the bottom foundation beam. Additional cracks at some mortar joints between bricks of the partial infill walls at their internal face (side with no FRPU jacket). The columns entered yielding strain of their longitudinal steel reinforcements at the bottom and at the top critical regions (columns 1, 2, 3, 4).
