Resilient Vertical Forest Renovation of Reinforced Concrete  
Structures in Seismic Prone Areas  
(H.F.R.I. Project Number 015376)

Recorded damages to common and VF buildings and  
lessons learned

Deliverable D1.4 Work package 1

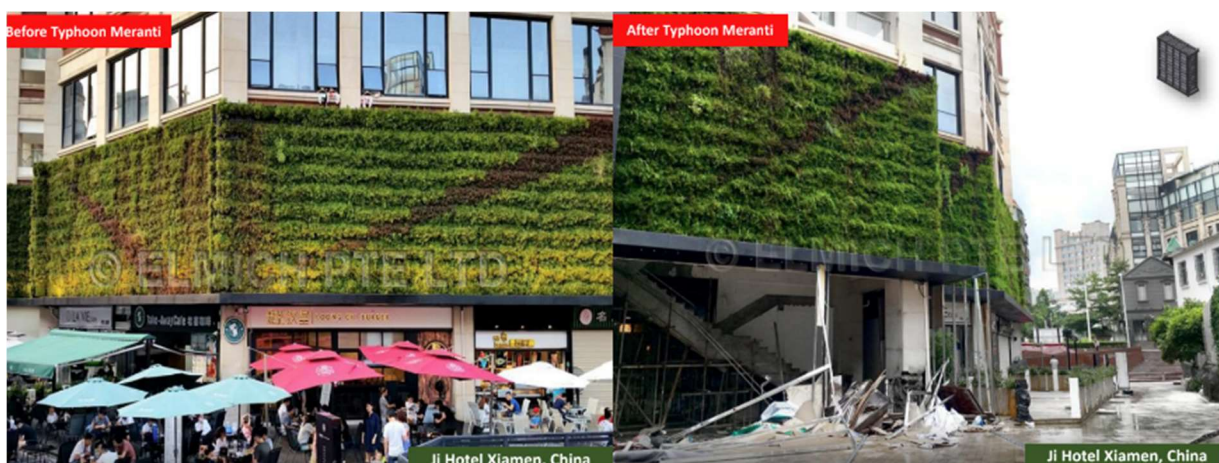
In contrast, in Figure 25, a damaged building is depicted after a typhoon occurred in China. It is observed that the building's facade has been severely damaged however the green wall was not affected.

Figure 25 Damaged building before (left) and after Typhoon (right), in China, where greenery remained undamaged (Tan, 2020).

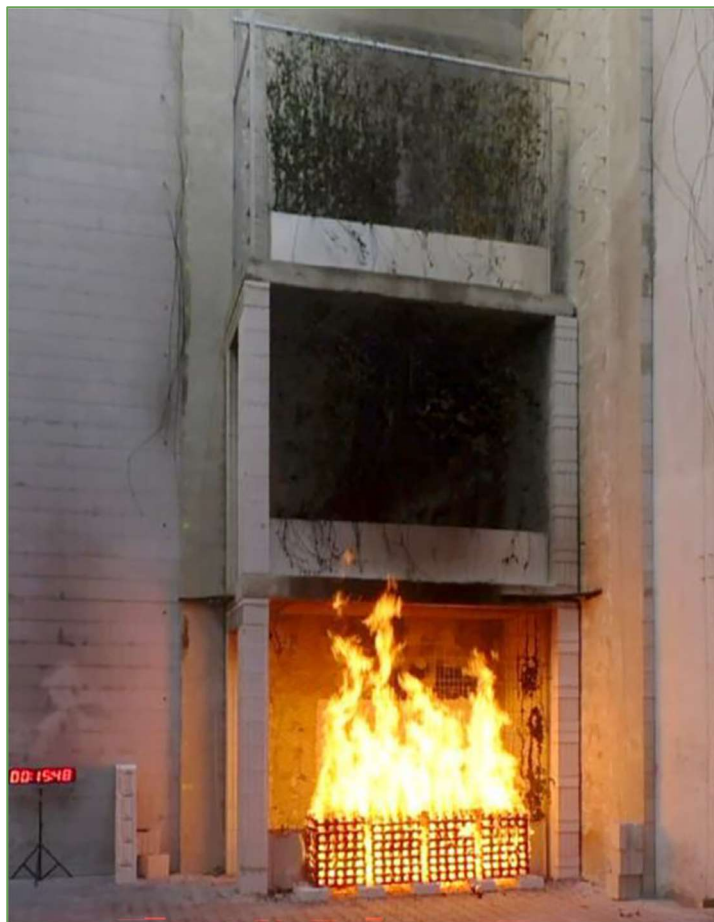
Figure 29 Full-scale fire test on a green façade (Engel & Werther, 2024).

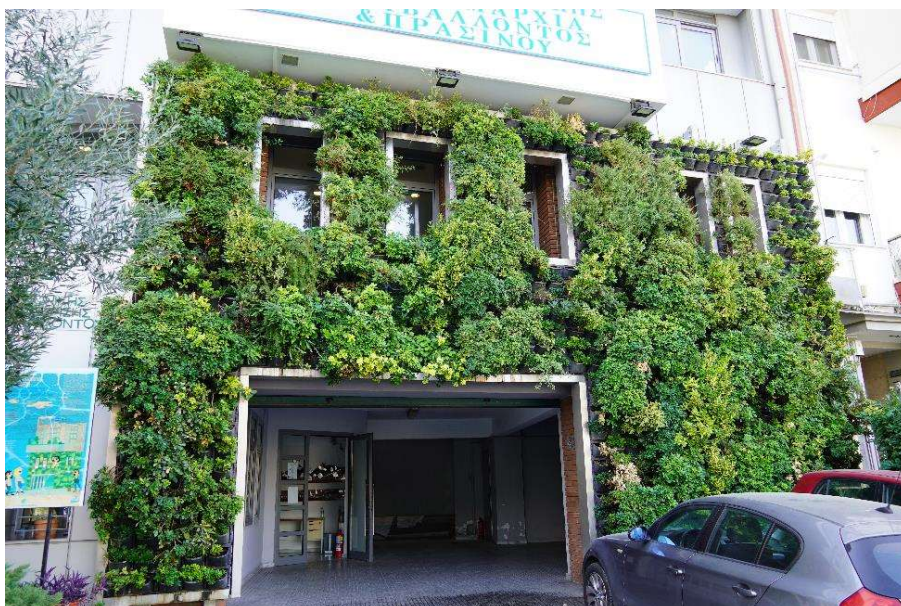
In Figure 37, the vertical garden that forms the face of the building of the Directorate of Urban Environment Management of the Municipality of Thessaloniki is presented. This intervention relates to the installation (2019) of a special grid on the outer shell of the building, with special recesses where removable pots (about 800) are placed and has special irrigation and drainage systems. The garden covers the external surface of the building over an area of 50 m<sup>2</sup>. In Figure 38, the building is shown in two different dates. It is observed that the plants have started to overgrow, hanging and covering the windows. Some dead plants haven't been removed as well, increasing the risk of fire propagation. In addition, the initial design of the garden aimed to highlight the colour changes of the plants throughout the year, however this was not maintained sufficiently, resulting in an aesthetic degradation.

Figure 37 Green façade implemented in a building of the Directorate of Urban Environment Management of the Municipality of Thessaloniki, <https://maps.app.goo.gl/EU3bcfW1n6J63NTx5> (Source: In situ survey for the GREENERGY project-October 2024).

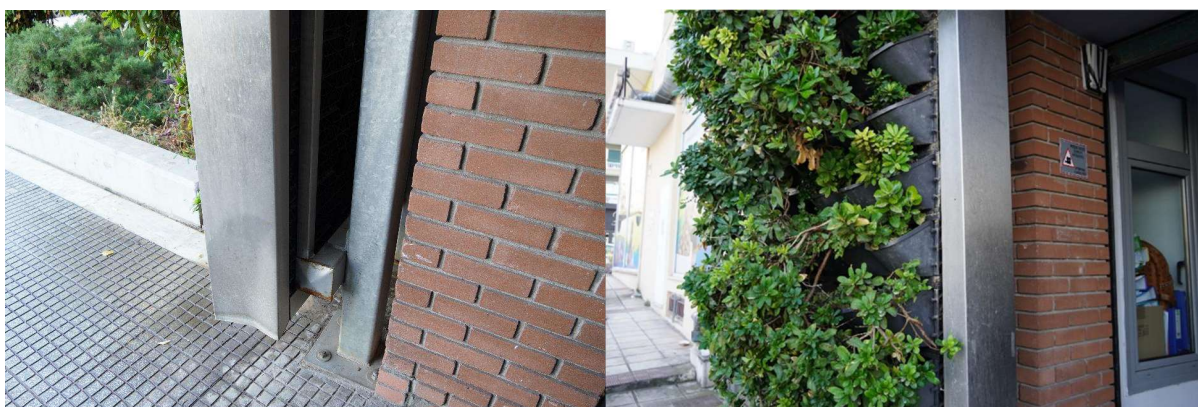
As can be observed in Figure 39 where details of the structure are shown, the condition of the green façade is considered satisfactory after 5 years, although some distortions in the supporting structure can be observed at the bottom of this figure.

Figure 39 Construction detail in the vertical façade applied in the building of the Directorate of Urban Environment Management of the Municipality of Thessaloniki <https://maps.app.goo.gl/EU3bcfW1n6J63NTx5> (Source: In situ survey for the GREENERGY project-October 2024).

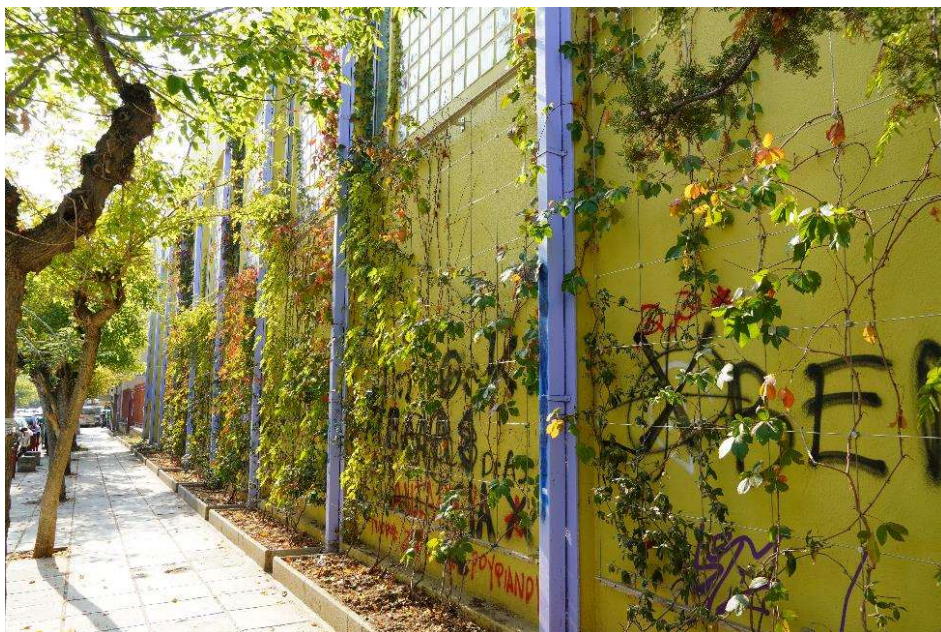
Another example of green façade can be found in the 16th primary school of Thessaloniki (Figure 41) and involves the installation (2023) of a metal mesh with special stainless-steel wires which is fixed to the wall and leaves a small gap from the wall (about 3cm). The garden covers the external surface of the building in an area of 90 square meters.

Figure 41 Green façade in the 16th primary school of Thessaloniki, <https://maps.app.goo.gl/yE7XmPaVT9eYURCV9> (Source: In situ survey for the GREENERGY project-October 2024).

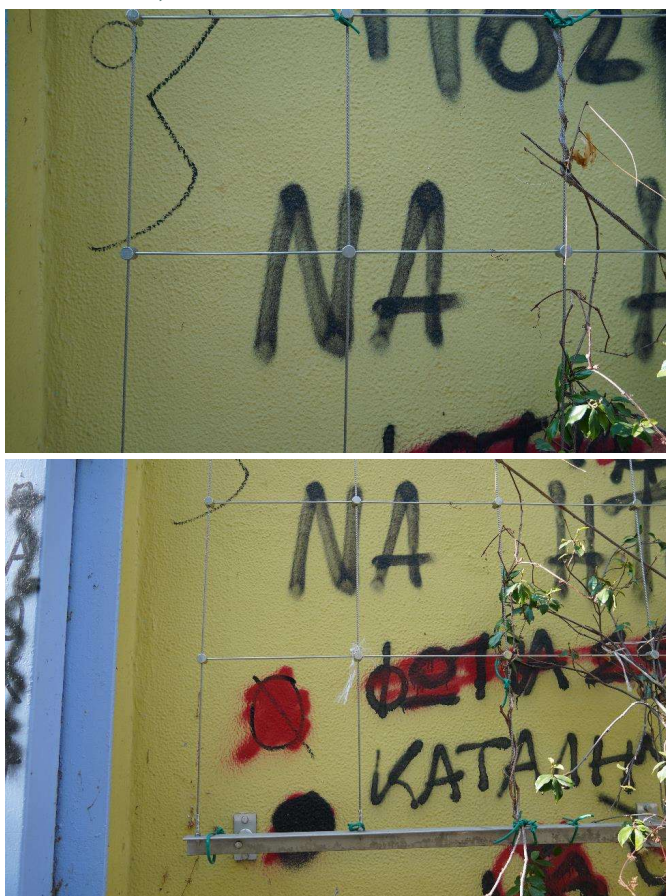
Figure 42 Green façade in the 16th primary school of Thessaloniki, <https://maps.app.goo.gl/yE7XmPaVT9eYURCV9> (Source: In situ survey for the GREENERGY project-October 2024).

As shown in this case, in Figure 42, the structure is in good working order, although it appears that banners etc. have been placed on the metal mesh, which in general in the future are likely to result in the deterioration of the metallic material, but possibly also to the building itself.

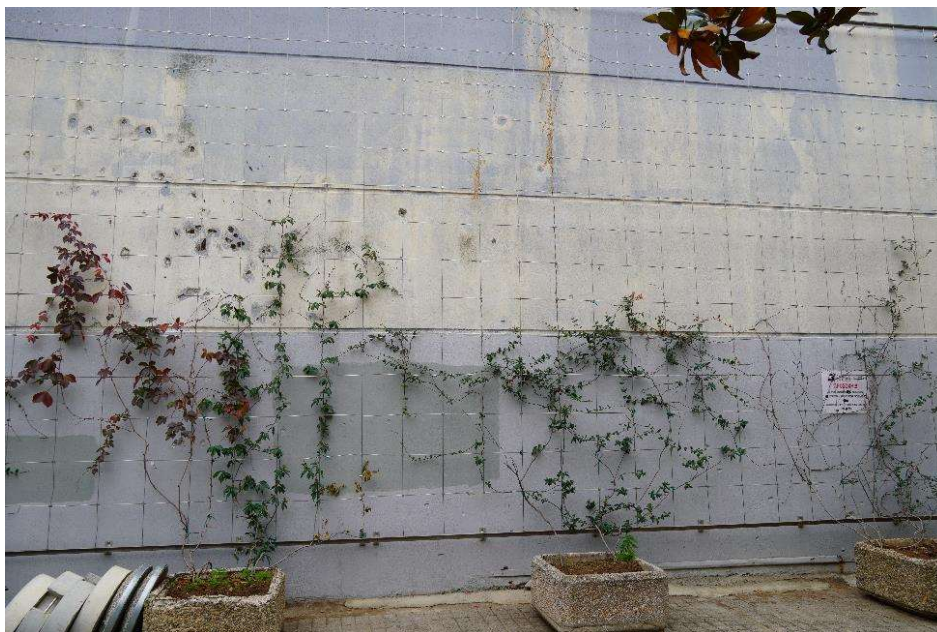
Figure 43 Green façade in the the Community Centre of the Municipality of Thessaloniki, <https://maps.app.goo.gl/cHY6b6JcR9s1svVD9> (Source: In situ survey for the GREENERGY project-October 2024).

This technology involves the installation of a metal mesh with special stainless steel wires which is fixed to the wall and leaves a small gap from the wall (about 3cm). The garden covers the external surface of the building in an area of 52 m<sup>2</sup>.

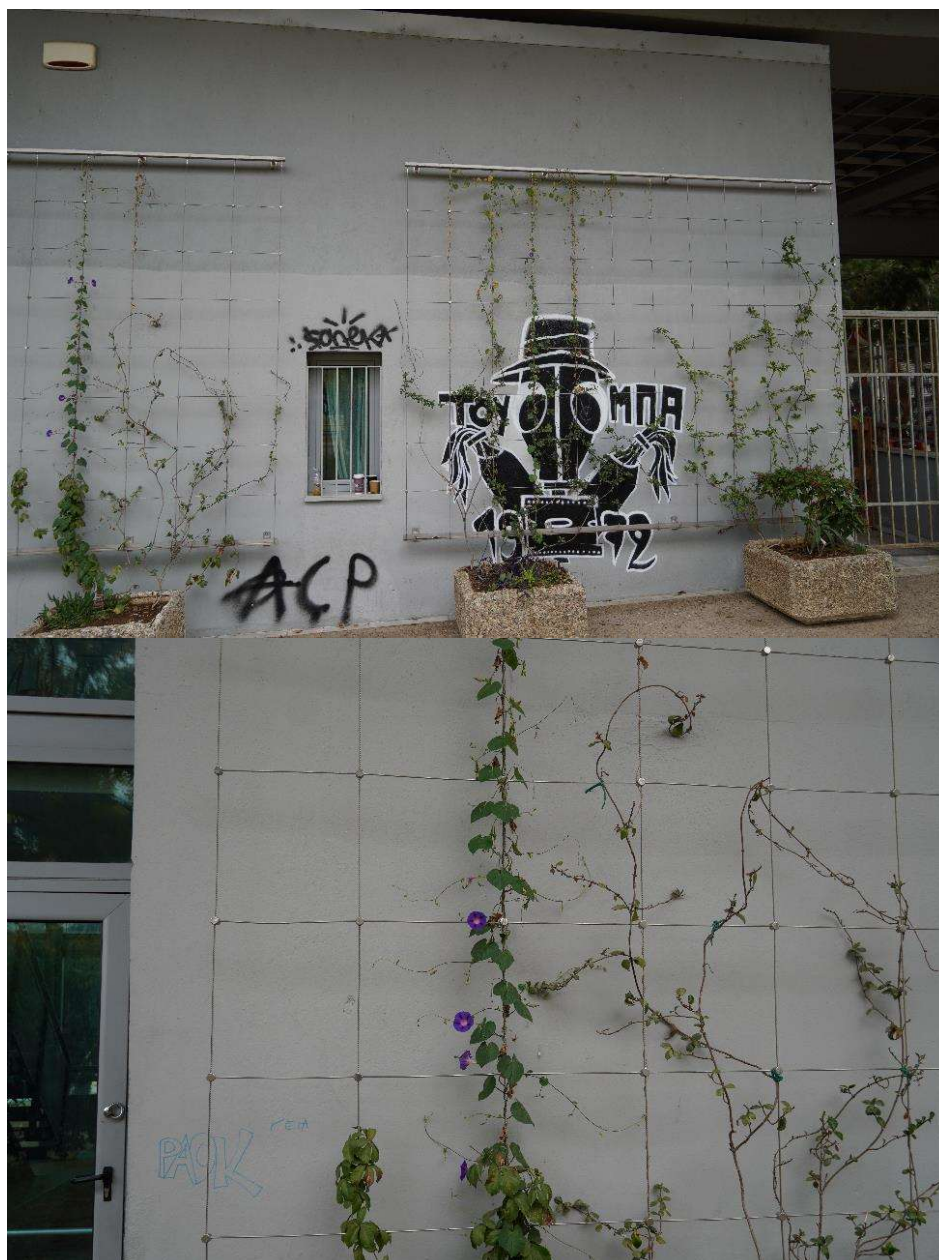
In the case of the municipal swimming pool, located on the site of the former Courtyard Toumba (Figure 45) no damages were also observed. The green façade develop in 2023, involves the installation of a metal mesh with special stainless steel wires which is fixed to the wall and leaves a small gap from the wall (about 3cm). The garden covers the external surface of the building in an area of 12 square meters.

Figure 45 Green façade in the municipal swimming pool of Toumba <https://maps.app.goo.gl/CBUG6hePugKjR5qV6> (Source: In situ survey for the GREENERGY project- October 2024).

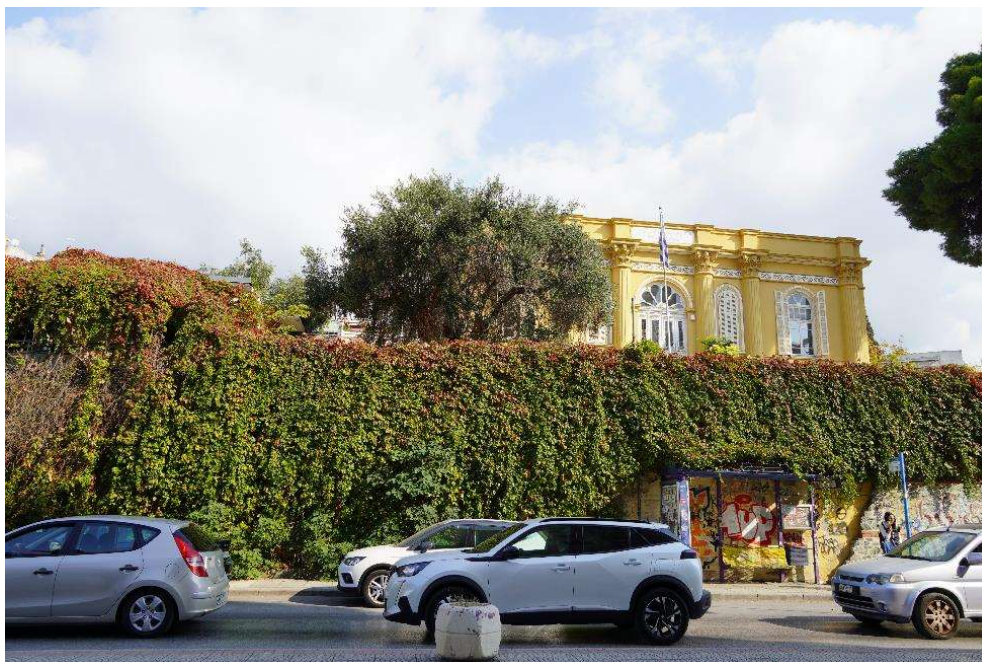
In the following pictures, the green façades (installed in 2008) over the building hosting the Historical Archives of Macedonia are presented

Figure 49 Green façade in the building hosting the Historical Archives of Macedonia <https://maps.app.goo.gl/SWY5F674hJ12NqnJ9> (Source: In situ survey for the GREENERGY project-October 2024).

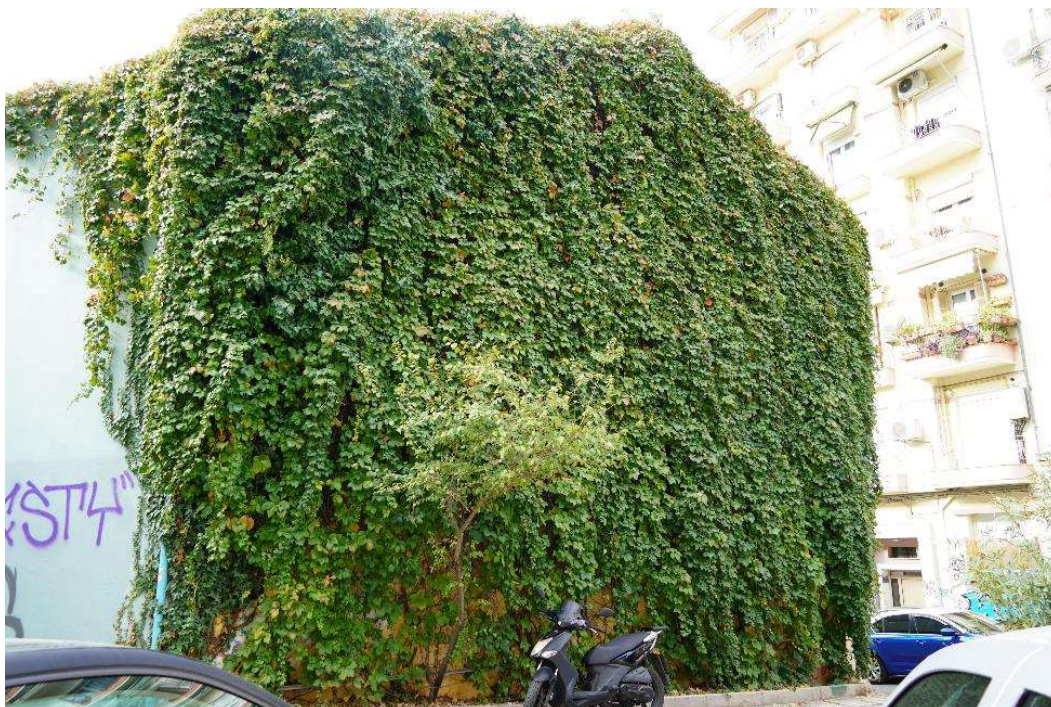
Finally in the case of the 35<sup>th</sup> and 37<sup>th</sup> primary schools of Thessaloniki (Figure 52) we identified erosion and mould development

Figure 52 Green façade in the 35<sup>th</sup> and 37<sup>th</sup> primary schools of Thessaloniki <https://maps.app.goo.gl/oZELaqJDvpm4TUyU6> (Source: In situ survey for the GREENERGY project-October 2024).

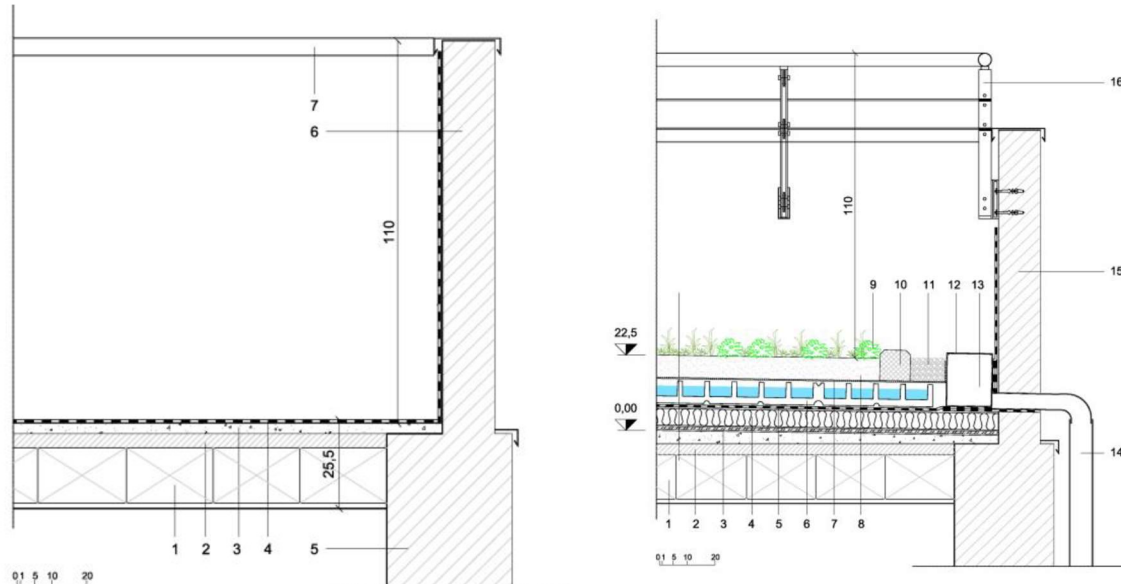
Figure 54 Flat roof (left) and flat green roof after retrofitting (Santi et al., 2020).

While uplifting the perimeter edges of a roof, a cant of the ribs can be provided through the mechanical connection of the structures, along the perimeter of the existing structure, to which the new roof flashings could be anchored. The roofs could also be incorporated into the existing ledges, taking into account the building legislation to prevent the risk of falling from high buildings to ensure stability and safety requirements. Furthermore, for the accumulation of rainwater and irrigation water, the correct sizing of the existing downspouts must be taken into account, which, if necessary, must be integrated with new ones by interfering with the existing structures, by creating holes to allow the connection of the covering to the downspouts installed along the perimeter of the building; in addition, in order to allow accessibility and maintenance of the drains, some control wells must be installed (Santi et al., 2020).
