Resilient Vertical Forest Renovation of Reinforced Concrete  
Structures in Seismic Prone Areas  
(H.F.R.I. Project Number 015376)

Designs and photos of detailing and instrumentation  
and structural, energy, forestry retrofit of renovated 3d  
VF structure

Deliverable D2.2 Work package 2

June 2025

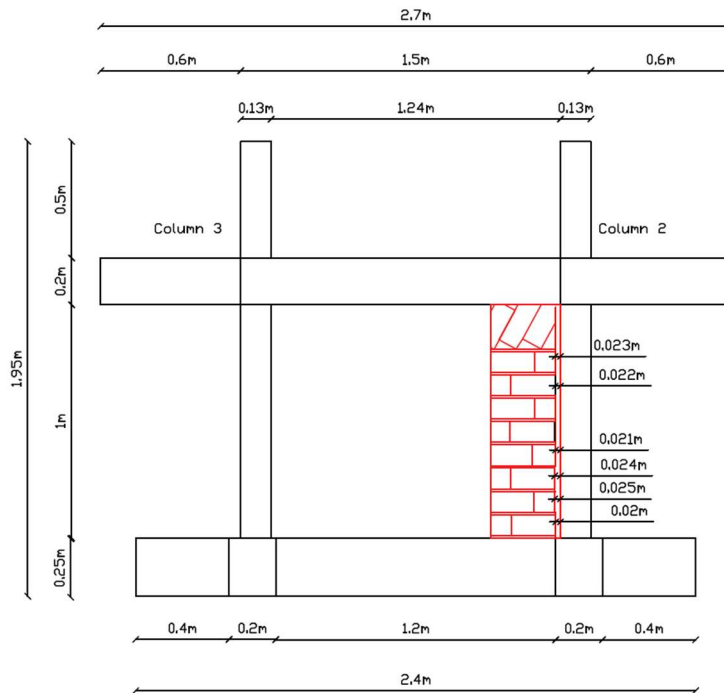
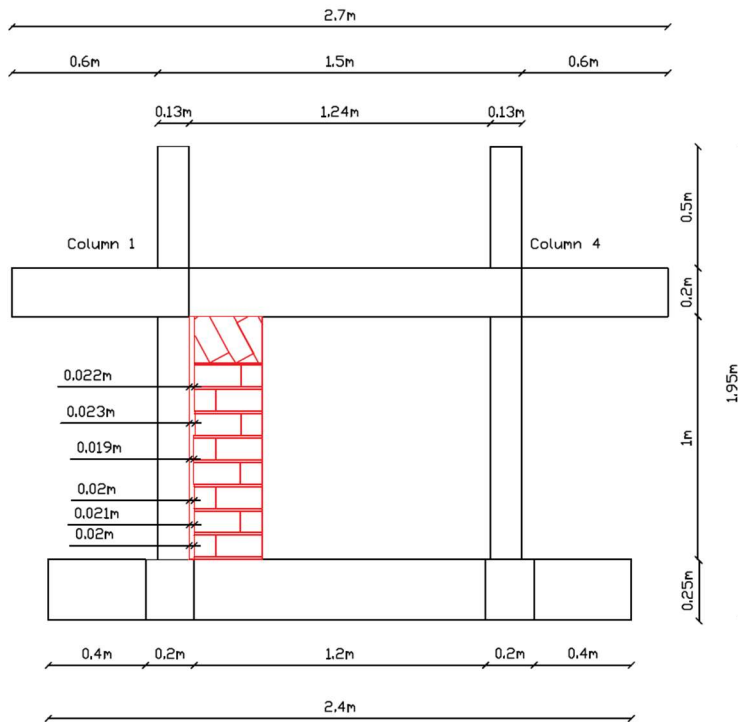
Figure 3.4 Construction of gap of joint in partial infill (a) between columns 3-2, and (b) 1-3

At first a structural joint (gap) was created in both the partial and full masonry. The joint was constructed between the columns and the masonry. The width of the joint varies along the length of the columns. In the partial masonry it ranges from 0.09 m - 0.025 m, as shown in Figure 3.4. In the full masonry it ranges from 0.019 m - 0.025 m, as shown in Figure 3.5. The minimum joint width was 1.9% of the clear height of the columns.
