Resilient Vertical Forest Renovation of Reinforced Concrete  
Structures in Seismic Prone Areas  
(H.F.R.I. Project Number 015376)

Assessment of the performance of tested renovated  
3d VF structure.

Deliverable D2.6 Work package 2

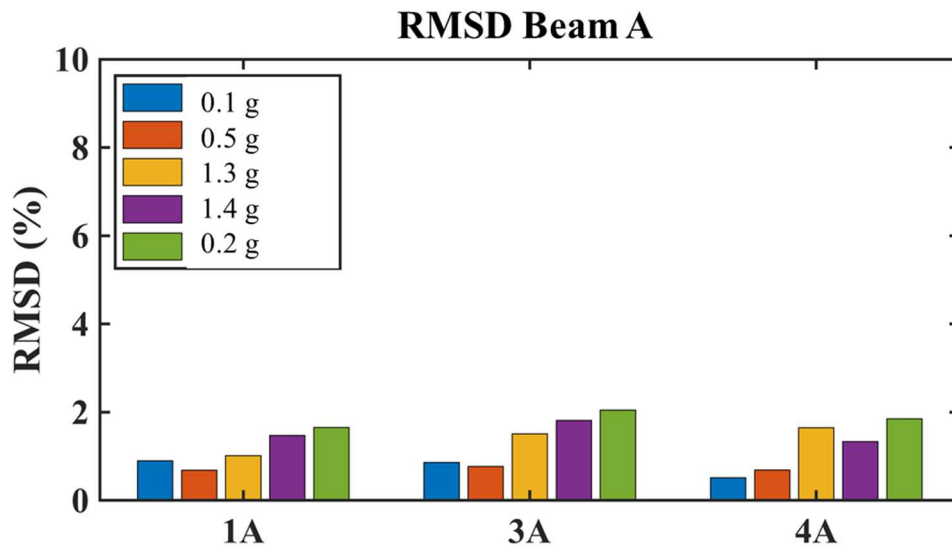
*Figure 3.4.1: Voltage frequency responses of the PZT sensors inside beam B14*

No significant values were observed in the RMSD indices for the PZT cases installed on the beams, where no structural damage was detected. However, there is a trend of increasing RMSD values that could trigger further actions to assess internal micro damages in the beams. The same is valid for the slab sensors. The PZT installed in the middle of the slab, shows increased RMSD values, indicating that damage has developed in this vicinity. The PZTs reveal remarkable sensitivity to the damage accumulation inside the concrete core feeling the rocking behavior of planters. Lower values were observed in the RMSD for the PZT cases installed on the edge of the slab.
